CS/CTI18015772/Rlsd302

SLH 9495L

Veh No: SLH 9495L Yr Regn: 2016 Nov  
 Type: M. Car / M. Cycle / Bus / Van / Lorry / Taxi / Prime Mover /  
 Truck / Trailer or  
 Make: Honda City 1.5 C.C. 1497  
 Colour: Silver A/C Insured / Std / NI / NA  
 Sp. Reading: 30074 T/Radio Insured / Std / NI / NA  
 Eng/No: W  
 C/No: MR HG m6 704P.000060  
 Gen. Cond: Good / Fair / Poor / Burnt  
 Steering: In order / Jammed / Leaked / Burnt or  
 Brake: In order / Jammed / Leaked / Burnt or  
 Modi: Nil / S/Rim / STD A/Rim or  
 Tyre Size: F: 175/65R15  
 R: \_\_\_\_\_  
 BS / DUN / EXNOVA / GY / FS / LIZA / MIC / OHTSU / PIR / SUMI /  
 TOYO / YOKO or

## VEHICLE DAMAGE INSPECTION REPORT

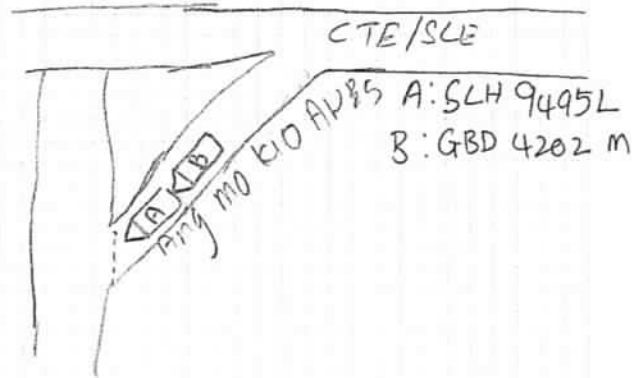
## SKETCH PLAN

LICENSE PLATE: SLH 9495L	ACCIDENT DATE & TIME: 22/8/2018 1610 Hrs
CONTACT NUMBER: 92964409	E-MAIL ADDRESS: Suria-prakashrao@yahoo.com
LOCATION: SLE - CTE at Ang mo Kio Ave 5.	
on 22/8/2018 around 1610 I am Heading towards Hougang, I took the Exit along SLE-CTE at Ang mo Kio Ave 5. When I turned left waiting at the Filter Lane for the main road oncoming vehicles to clear, Ong Chye Hoon (S1450537G) owner of Nissan NV200 (GBD 4202 M) hit the back of my car	
NOTE: PLEASE NOTE THAT YOUR INSURER MAY HAVE 14 DAYS TIME FRAME FOR YOU TO SUBMIT AN OWN DAMAGE CLAIM UNDER YOUR OWN POLICY. PLEASE CHECK YOUR POLICY FOR MORE INFORMATION	
Please state:	
<input type="checkbox"/> Claim Own Policy <input checked="" type="checkbox"/> Claim Third Party <input type="checkbox"/> Claim OD/TP at other workshop <input type="checkbox"/> Reporting Only

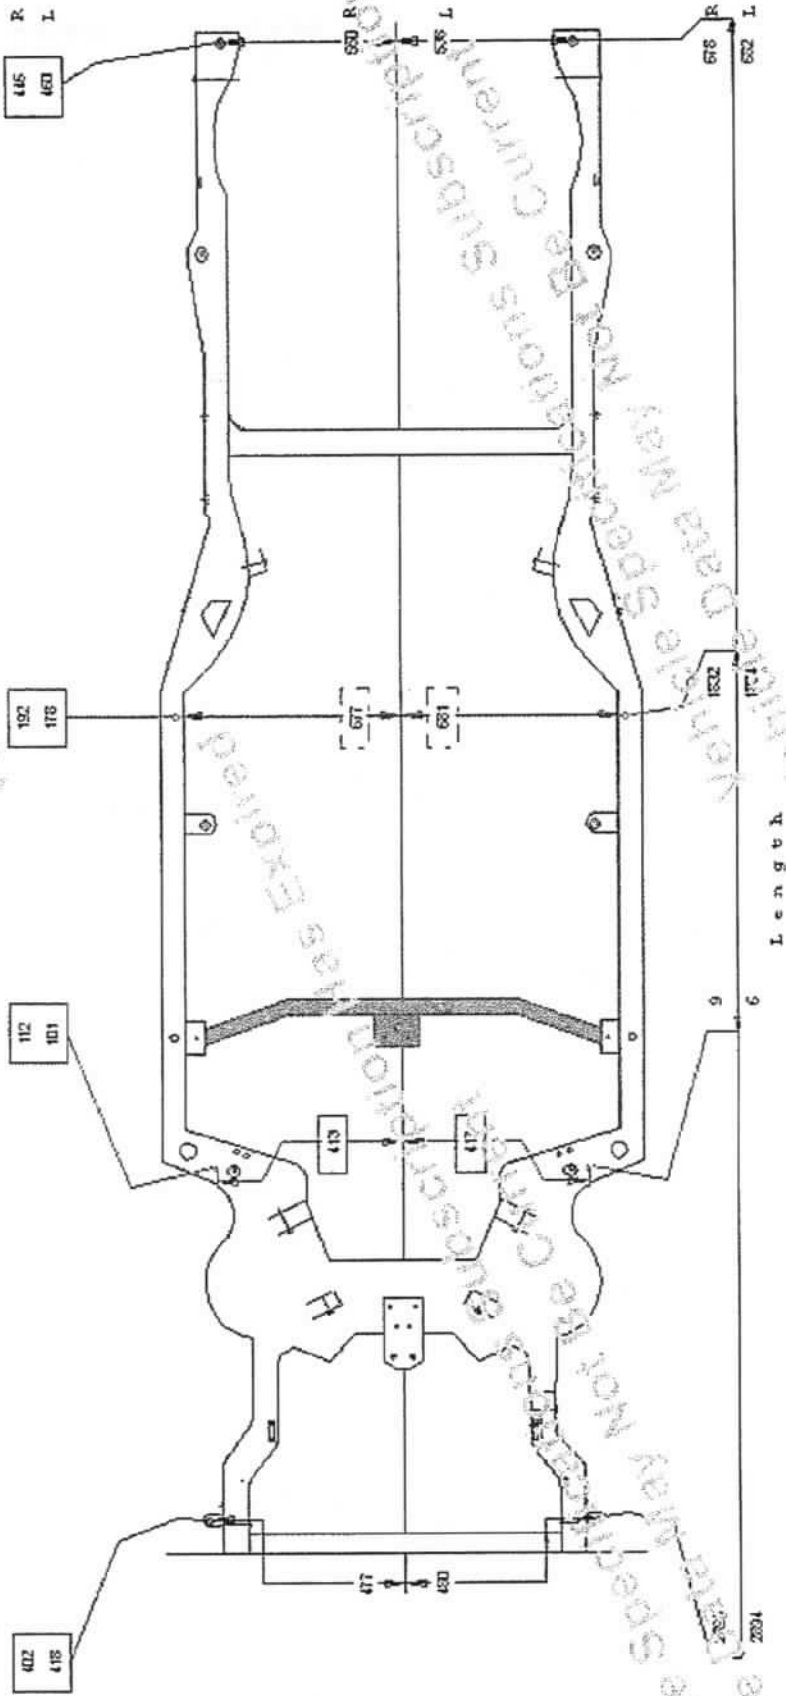
Customer.....: SLH9495L, CITY  
Vehicle.....: 2016-HONDA-CITY-3/L  
VIN: .....: NH-830M  
Work Order #: 22503  
Technician.....: -  
Odometer.....: 0

H e i g h t

L e n g t h
