SLQ 7203D

## Policy Particulars :- THIRD PARTY CLAIM

Please be informed that we have inspected the vehicle SLQ 7203D on 30/08/2018.

## VEHICLE DAMAGE INSPECTION REPORT

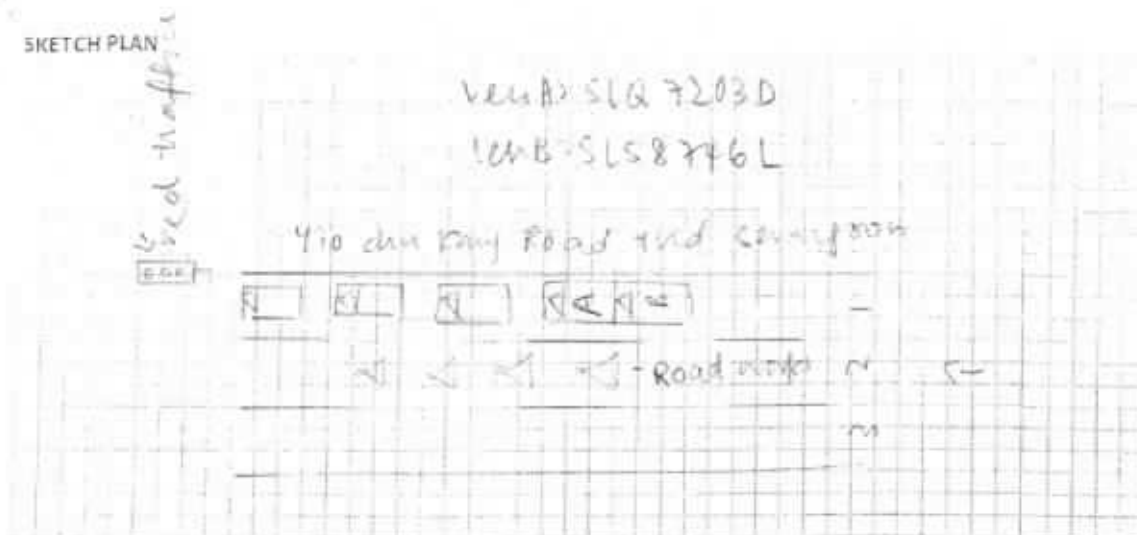
SKETCH PLAN

| Type Of Accident | COLLISION - HEAD TO REAR |

I was stationary along lane 1 of Yio Chu Kang Road towards Serangoon on 28.08.2018 @ 1445hrs. Suddenly, I heard a bang sound and felt an impact from my rear. Vehicle B was collided onto rear portion of my vehicle.
