Date of Accident: 04/07/2018
 Vehicle No: SLB2013Y
 Place of Accident: PASIR RIS DRIVE 3
 Involving Vehicle No: SGX3592D

4. DESCRIPTION OF DAMAGE

VEHICLE DAMAGE INSPECTION REPORT

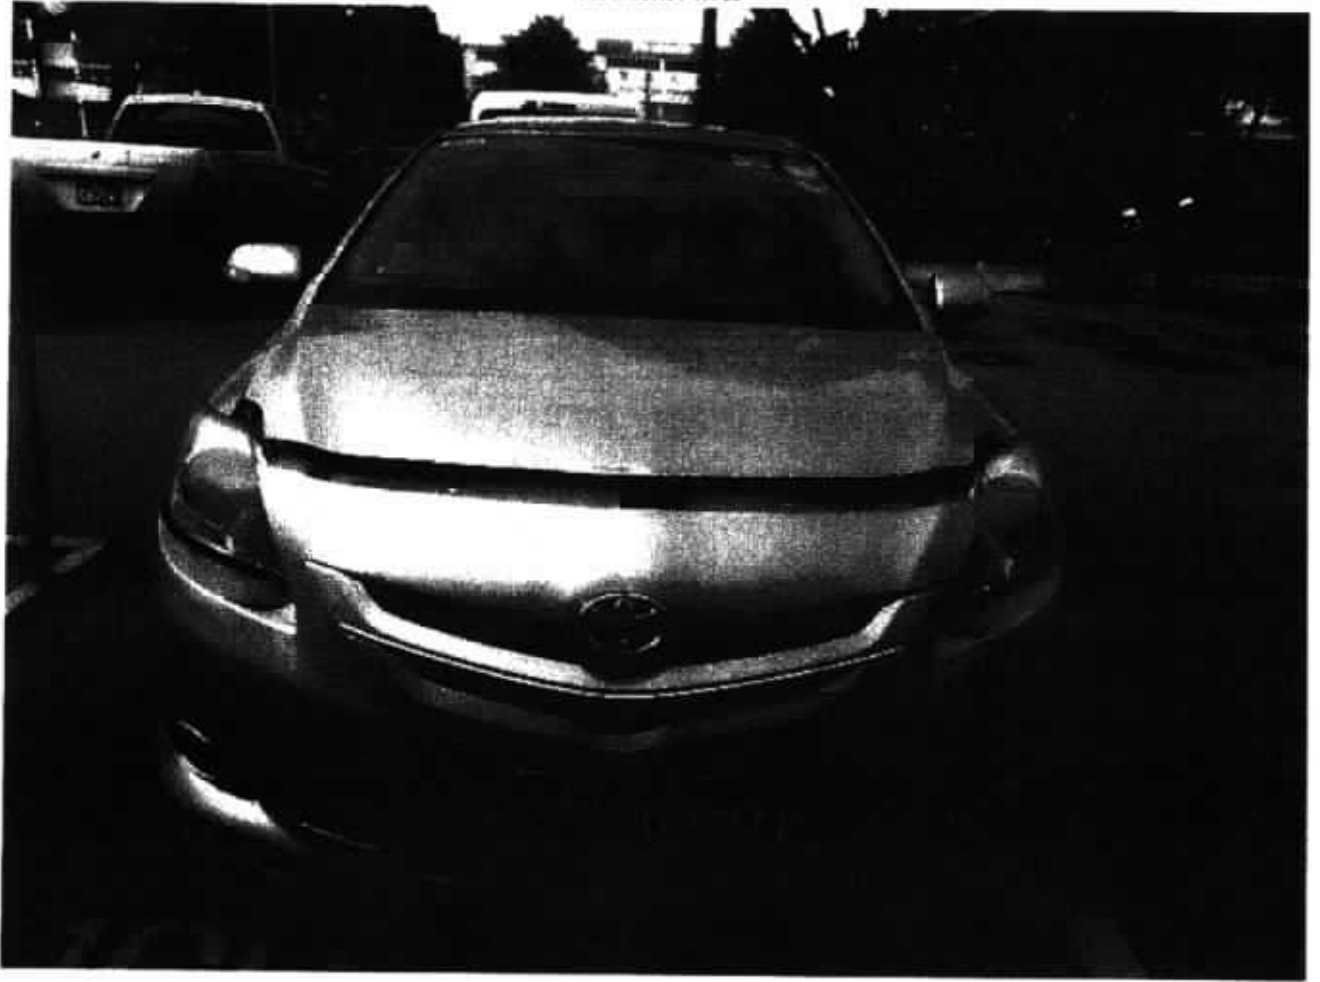
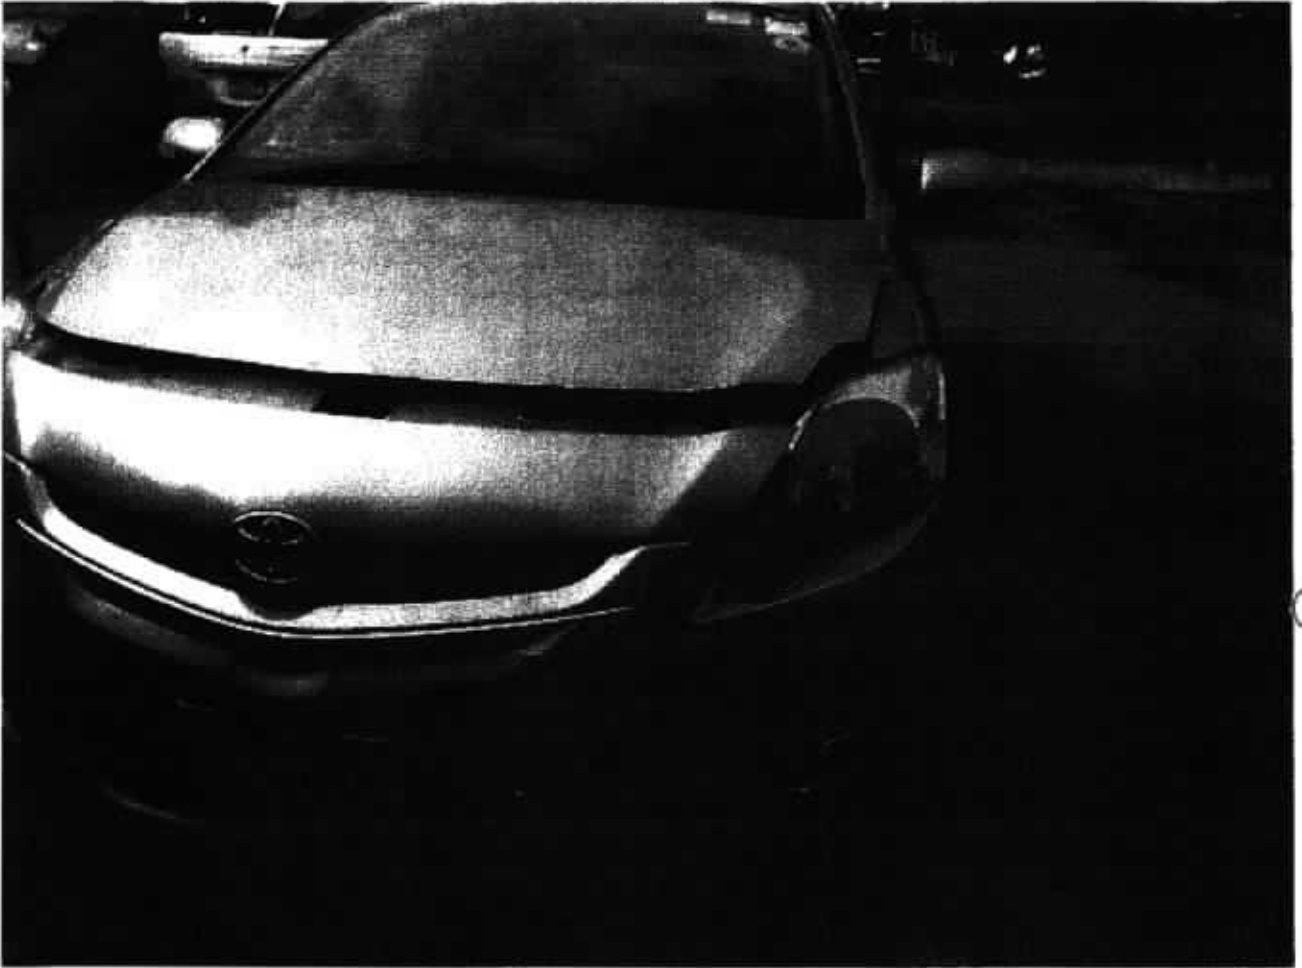
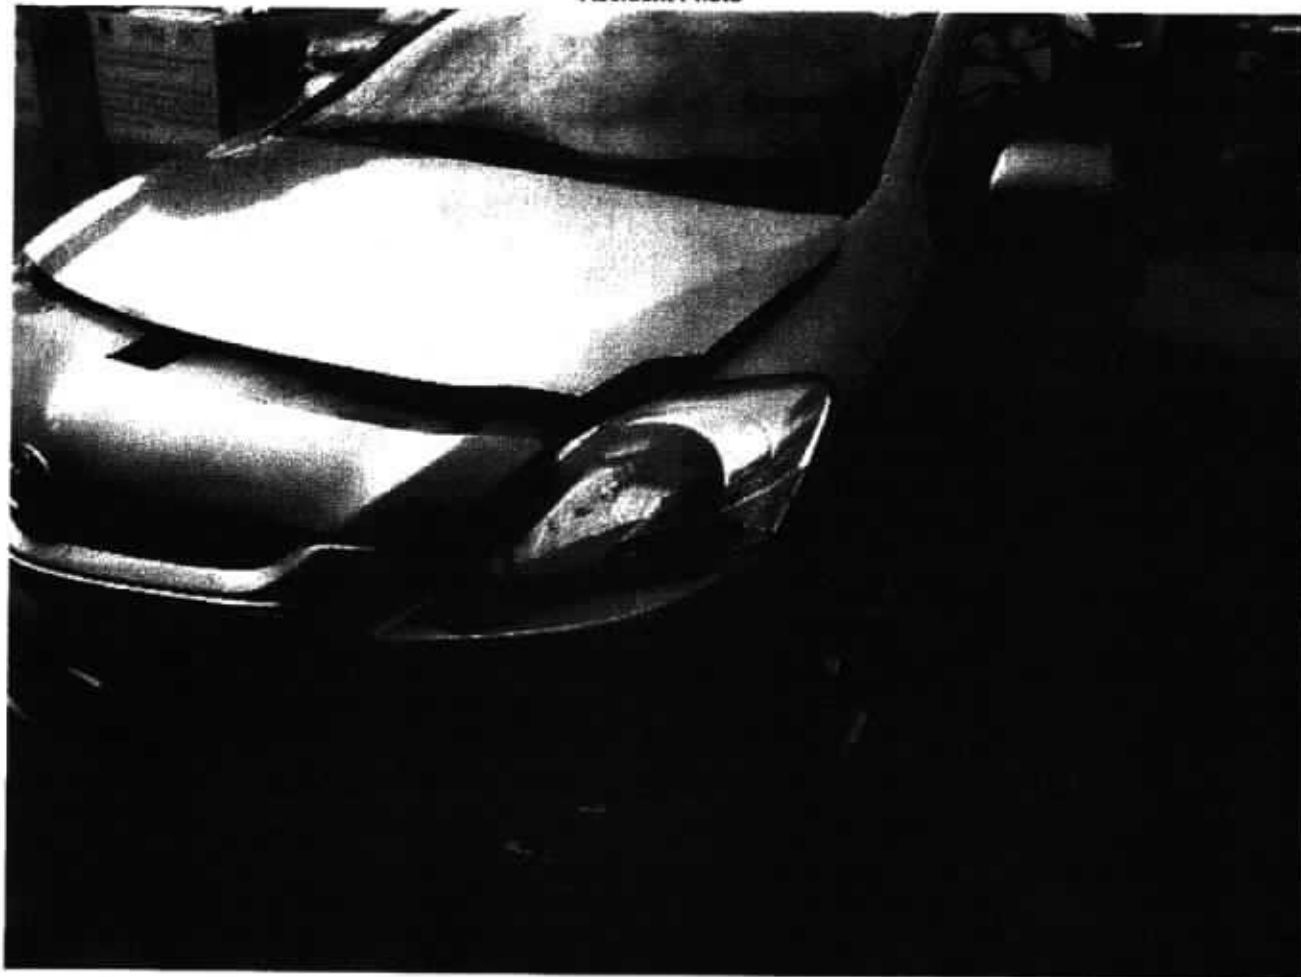
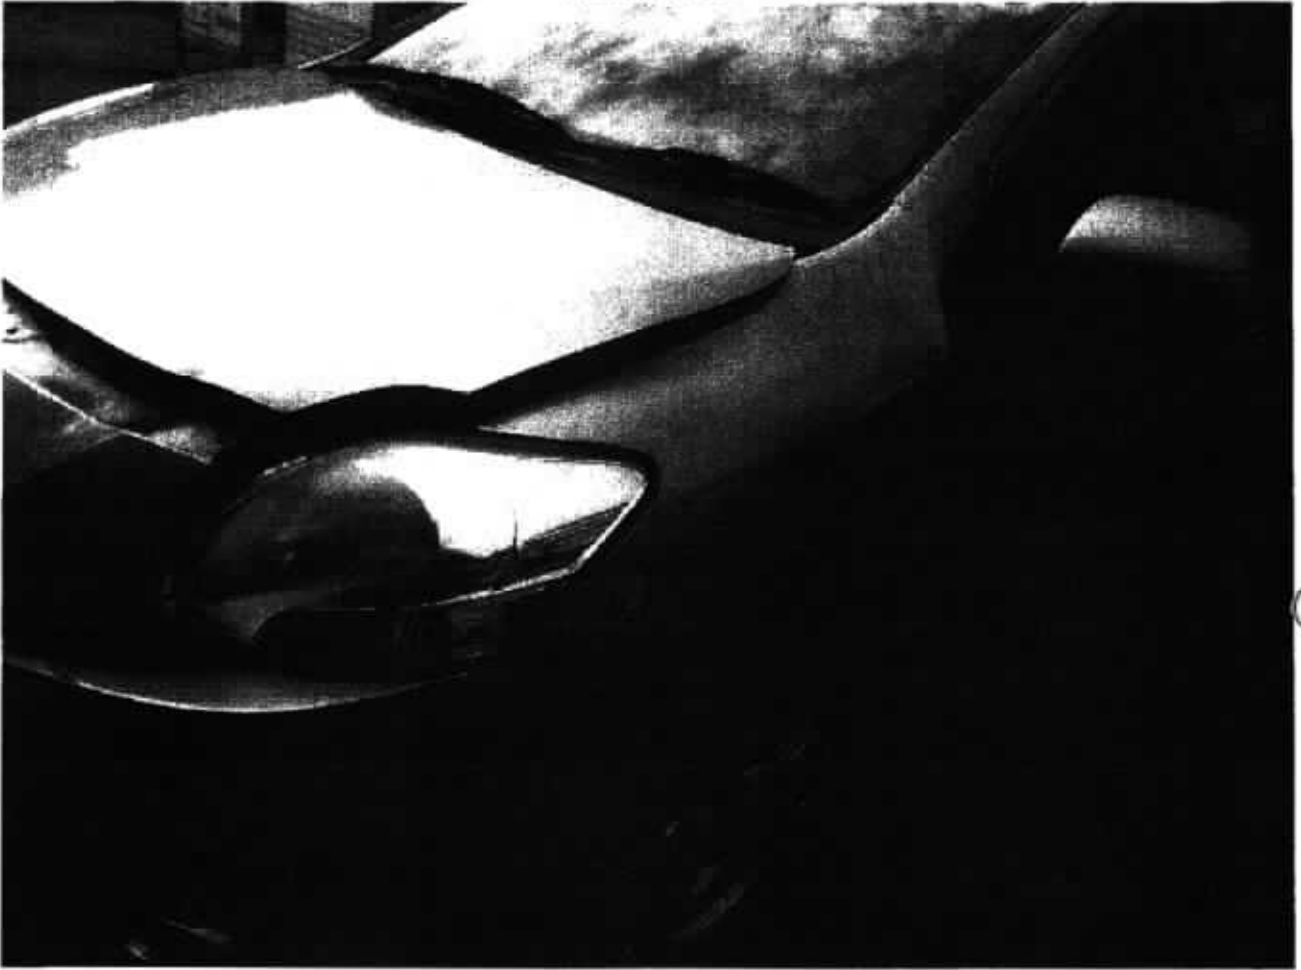
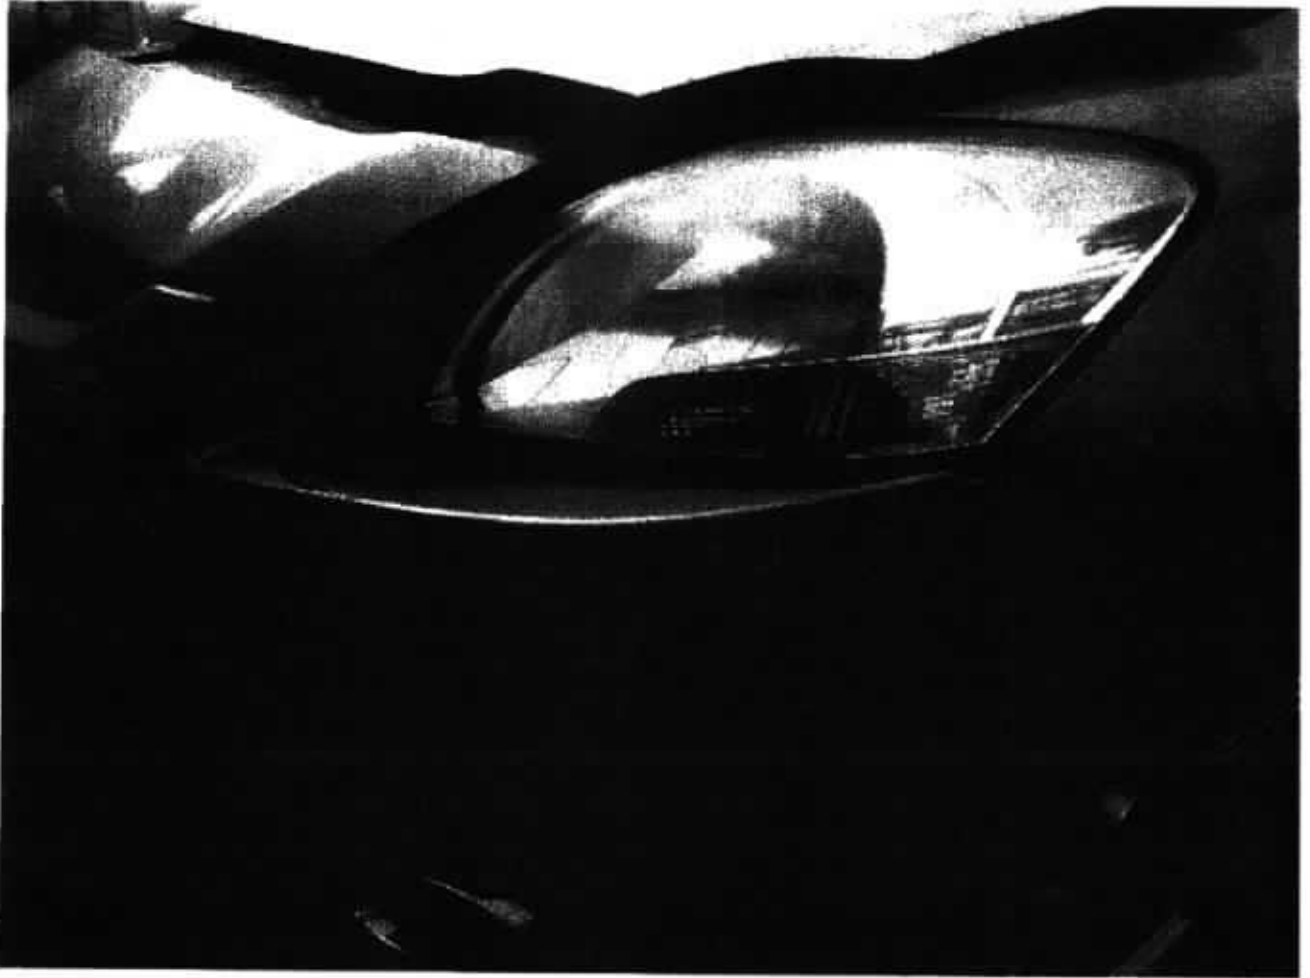
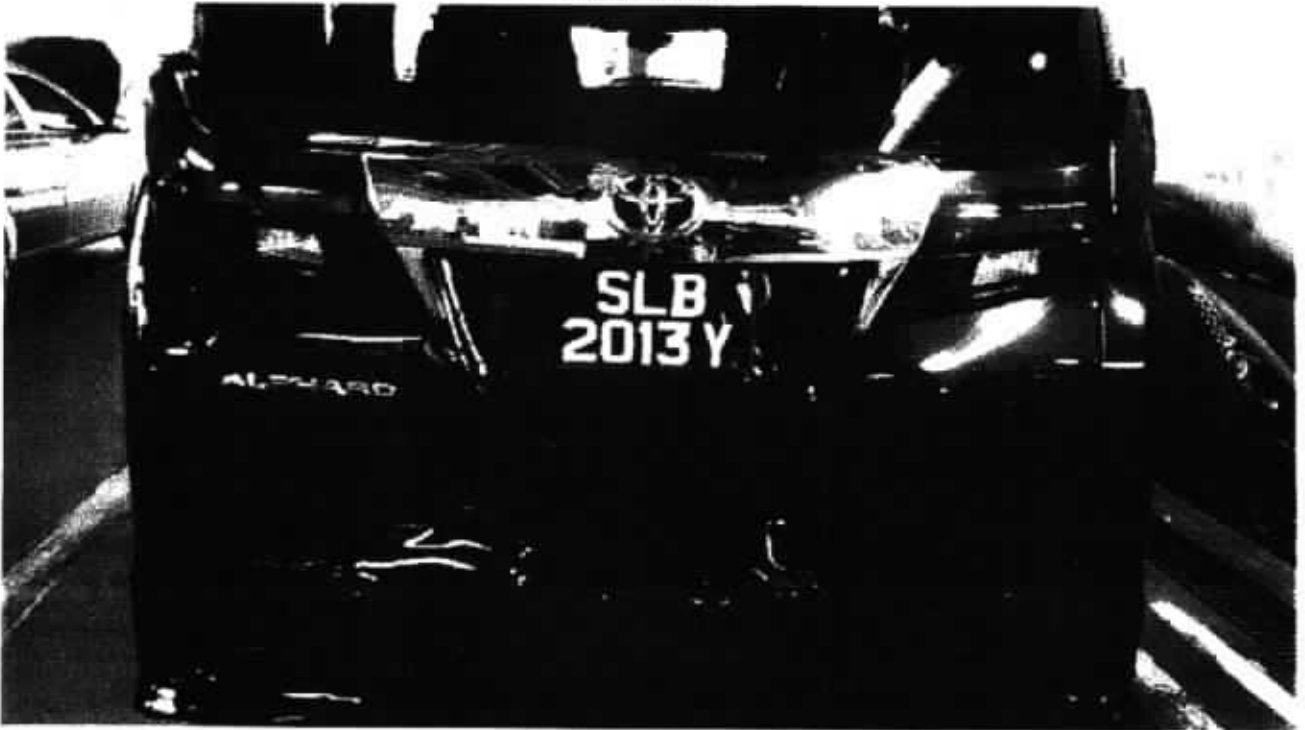
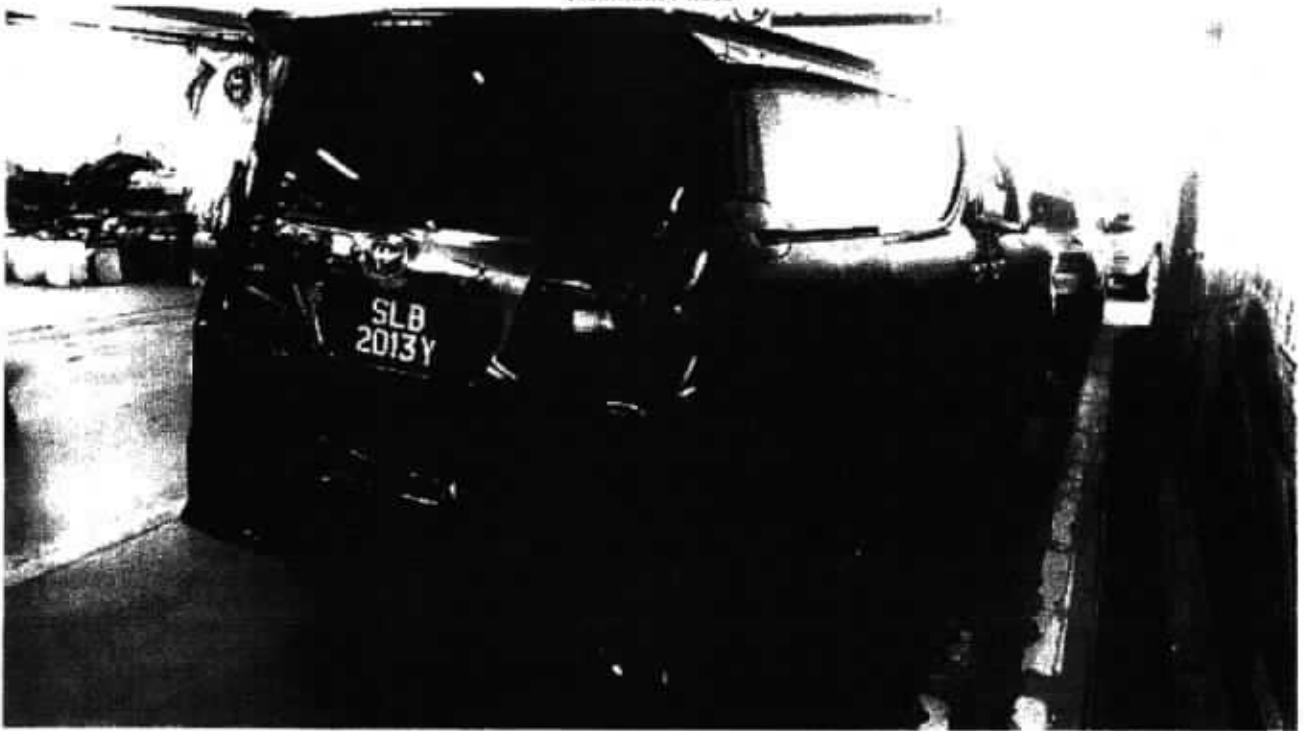
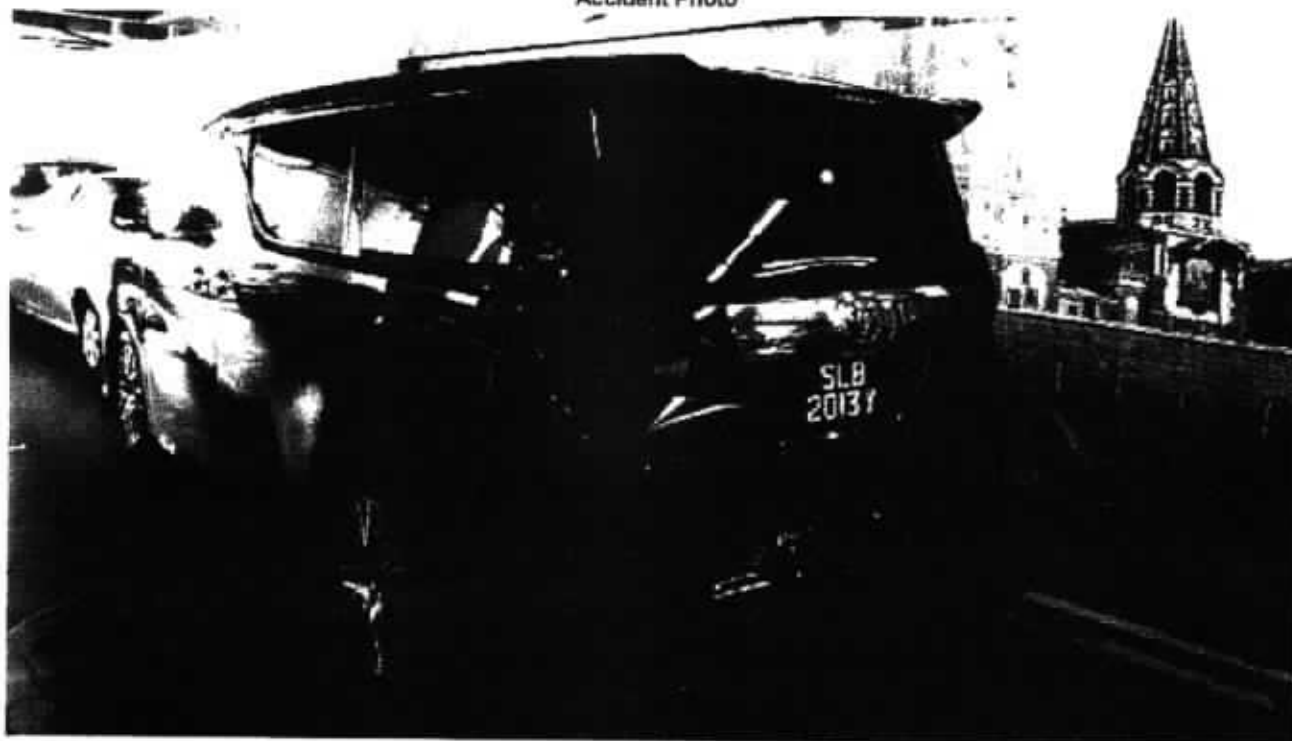
Accident Photo

ON STATED DATE AND TIME, I WAS TRAVELLING ALONG LANE 2 PASIR RIS DR 3. SUDDENLY VEHICLE B BRAKE HIS VEHICLE. IN A RESULT, I COULDN'T BRAKE MY VEHICLE IN TIME AND HIT ONTO VEHICLE B REAR PORTION.

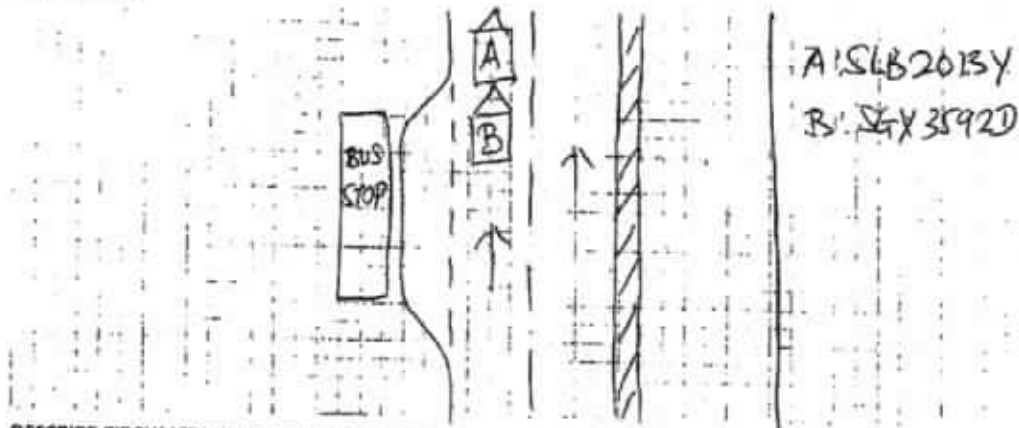
SKETCH PLAN

On 04/07/2018 at about 07:00hrs along Panr Ra Drive 3.
 My vehicle 'A' (SLB20BY) was stationary in my lane.
 Suddenly there was a huge impact at my rear, we got
 shocked. I checked on my passengers if they were okay and went
 out to check. Then I realized vehicle 'B' collided onto my
 vehicle 'A'.
