CLAIMANT : LOO WAI KHONG
ACCIDENT INVOLVING SJZ 8398 U & GBD 6332 H ON 13-OCT-2017 ALONG GEYLANG ROAD
TOWARDS KALLANG ROAD AT ABOUT 1515HOURS

<i>Vehicle Reg No.:</i>	SJZ8398U	<i>Odometer:</i>	273594km
<i>Make & Model:</i>	BMW 730LI	<i>Colour:</i>	Beige
<i>Chassis number:</i>	WBAKB22040CN74415	<i>Date of accident:</i>	13/10/2017
<i>Year of Regn.:</i>	19/08/2010	<i>Date Inspected:</i>	16/10/2017
<i>Repairer at:</i>	N-51 Automotive Pte Ltd 2 Kaki Bukit Ave 2 #01-18 Kaki Bukit Auto Hub Singapore 417921	<i>Date Inspected (After Repair):</i>	25/10/2017

VEHICLE DAMAGE INSPECTION REPORT

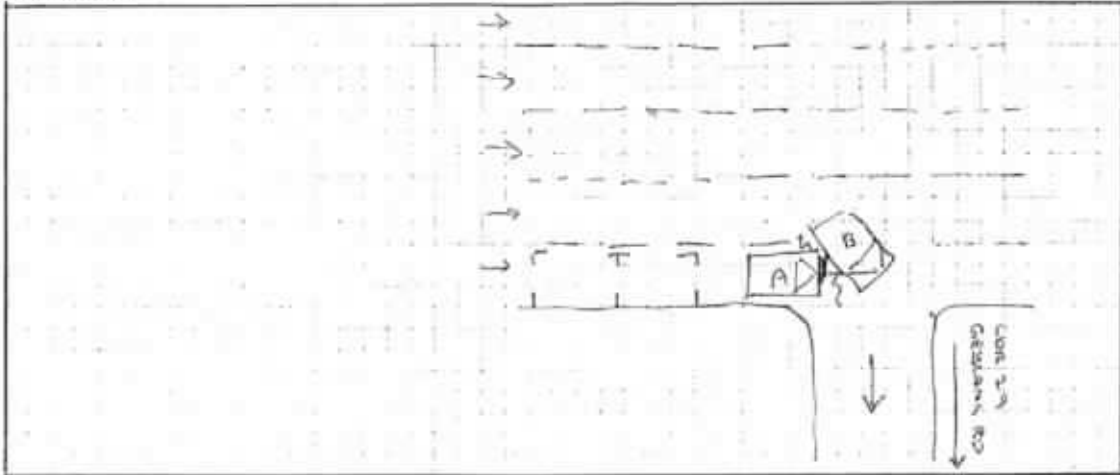
Accident Sketch Plan Pg. 1

I WAS MOVING OUT FROM THE CAR PARKING LOT, BEFORE TURNING INTO LOR 29, WHILE MOVING STRAIGHT AHEAD, SUDDENLY A VEHICLE TURNED FROM THE LEFT SIDE LANE OF MY VEHICLE, AND CUTTED INTO MY LANE AND HIT ONTO THE LEFT FRONT PORTION OF MY VEHICLE. WHILE I AM IN THE RIGHT OF WAY, AS I WAS INTENT TO TURN RIGHT INTO LOR 29 GEDJANG ROAD.
