SKR 1345Z

Vehicle No	: SKR1345Z	Accident Date	: 28/08/2018
Make	: TOYOTA COROLLA ALTIS	Policy No.	: MPC18A00079400
Assignment Date	: 04/09/2018	Excess	: S\$500.00
Date of Inspection	: 05/09/2018	Est. Duration of Repair	: 5 days
Inspection At	Ricardo Auto Centre Pte Ltd (HQ) 160 Sin Ming Drive, #02-02, Sin Ming AutoCity Singapore 575722

VEHICLE DAMAGE INSPECTION REPORT

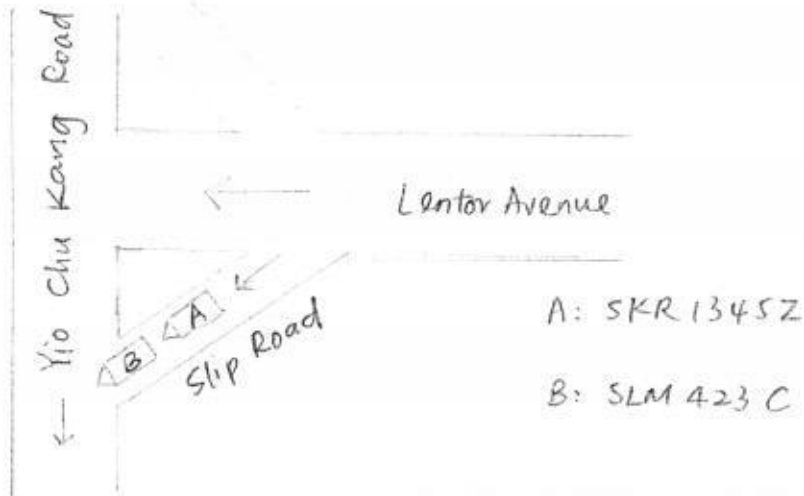
Sketch Plan Pg. 1

REFER TO SKETCH PLAN.

When I moved off my car, the other driver's car was sudden brake out of the waiting line. Eventually, my car cannot stop in time and hit on the left side of his car's bumper. There is no injury for myself and the other ~~other~~ driver. There is no passenger for my car and also no passenger in other driver's car.
