SYNOPSIS RICHARD

## VEHICLE INSPECTION REPORT

Vehicle Registration No: SGZ 118 A

## ADJUSTMENT ON REPAIR COST FOR VEHICLE NO. SGZ 118A

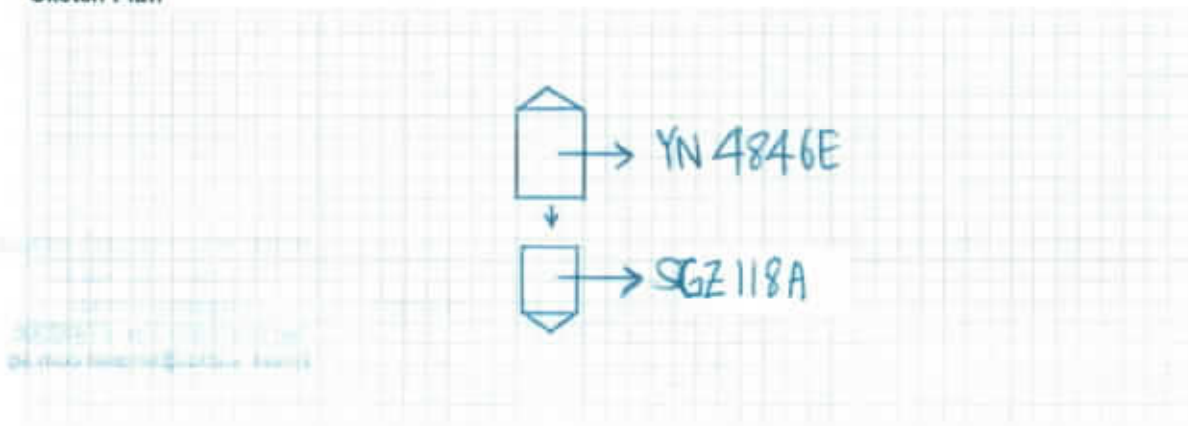
**Sketch Plan**

Owner car number should be SGZ118A as stated wrongly  
in the sketch plan drawing.

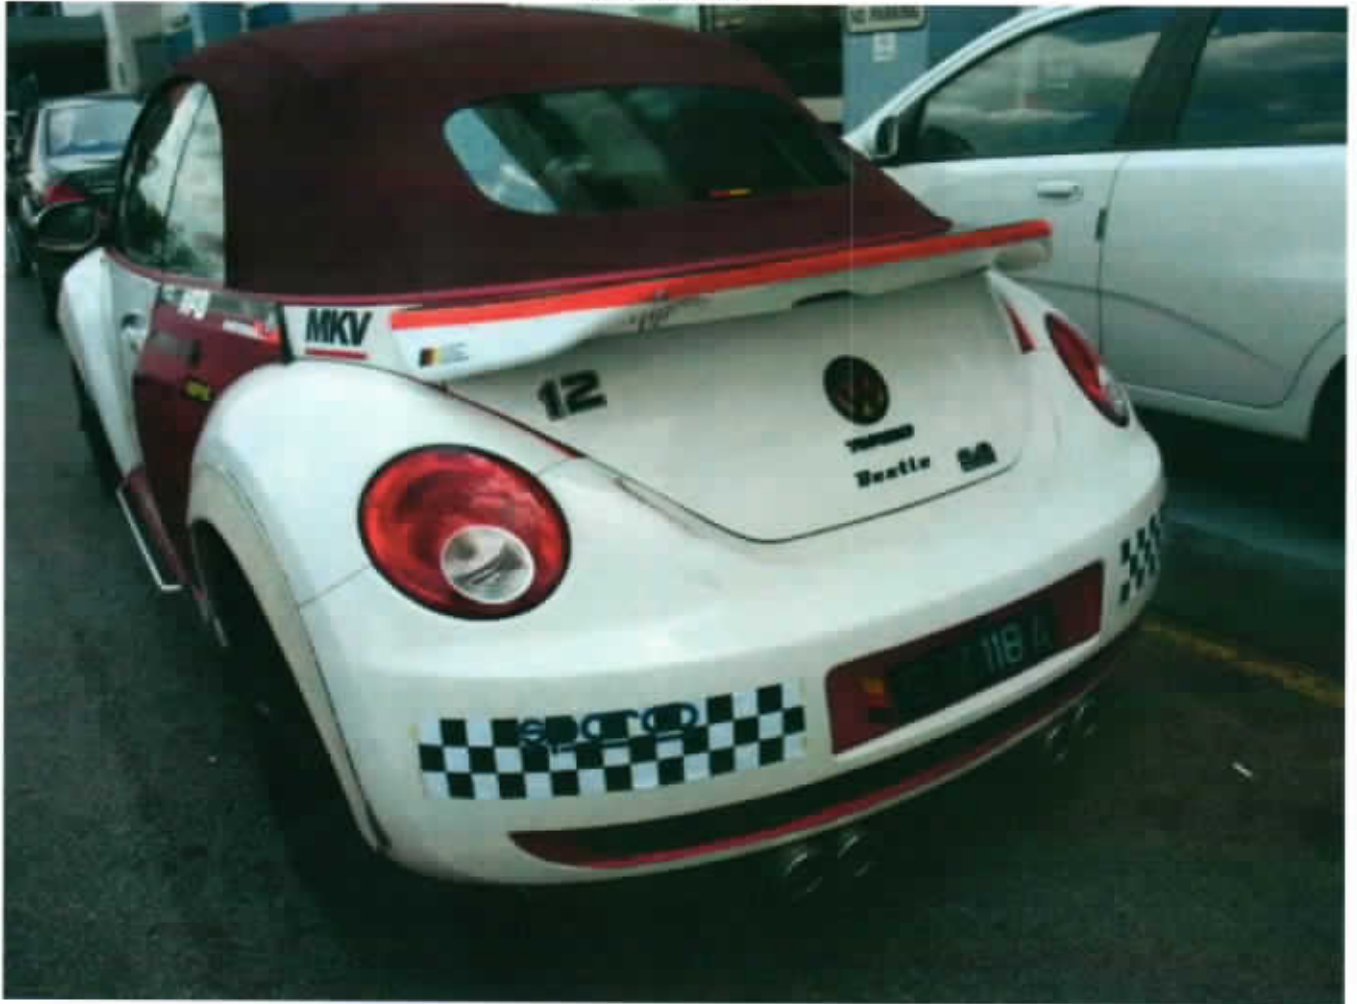
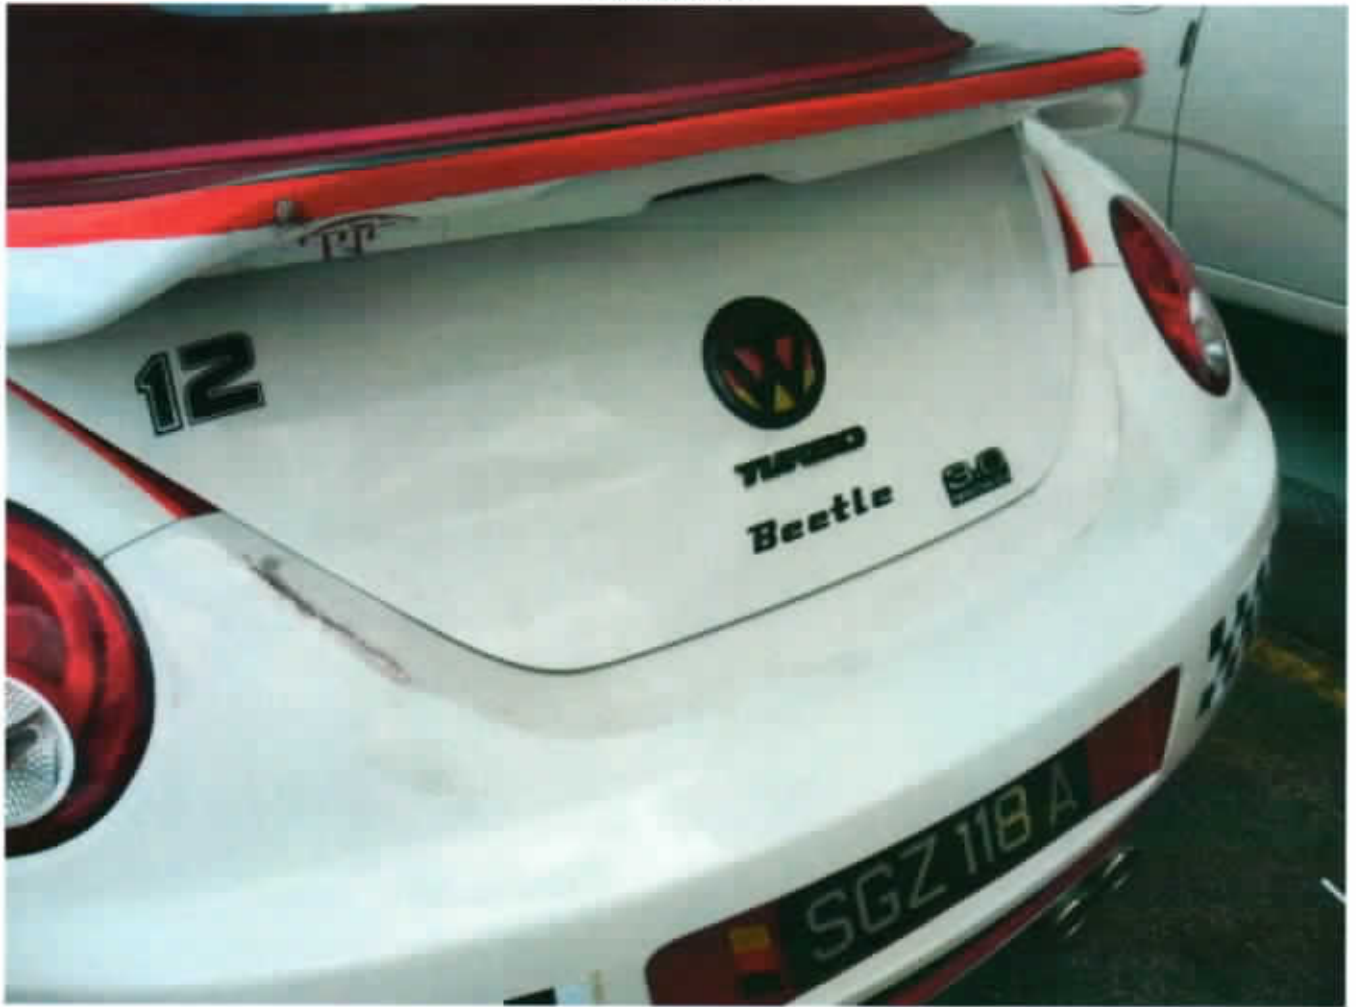
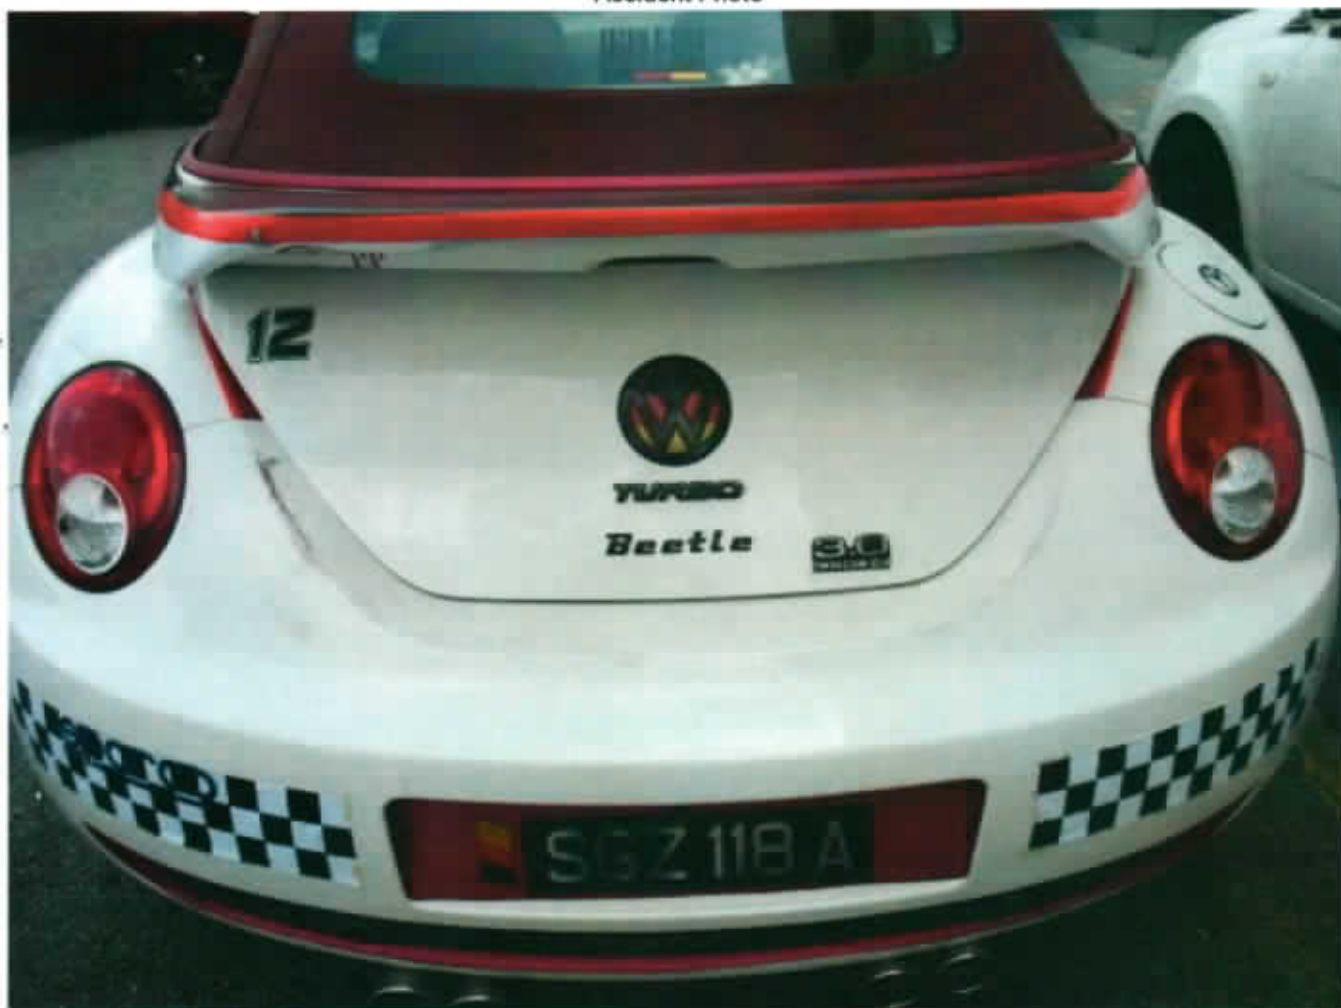
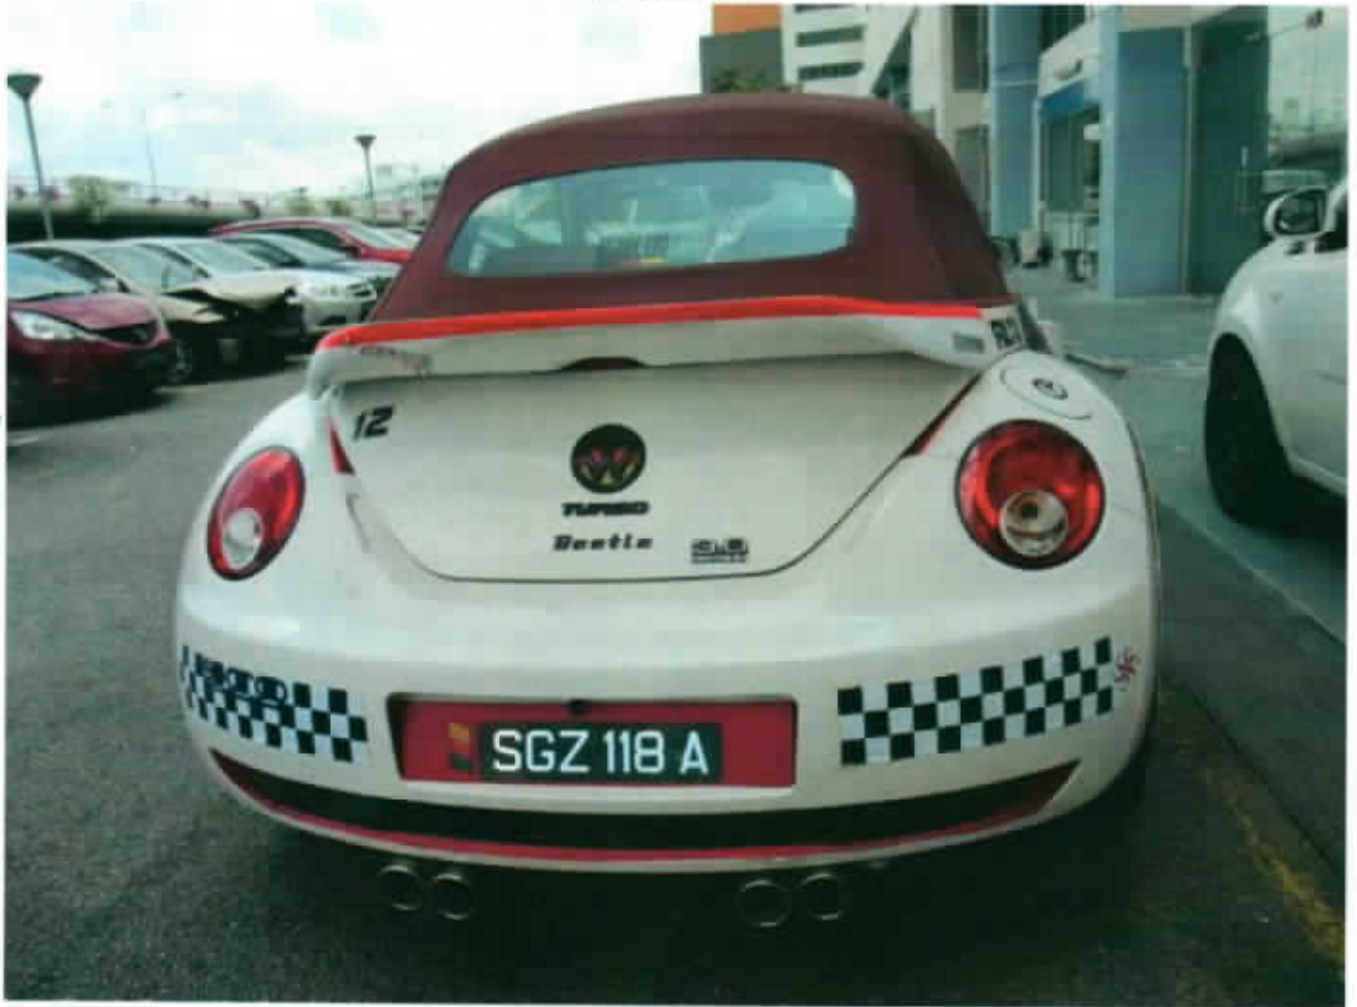
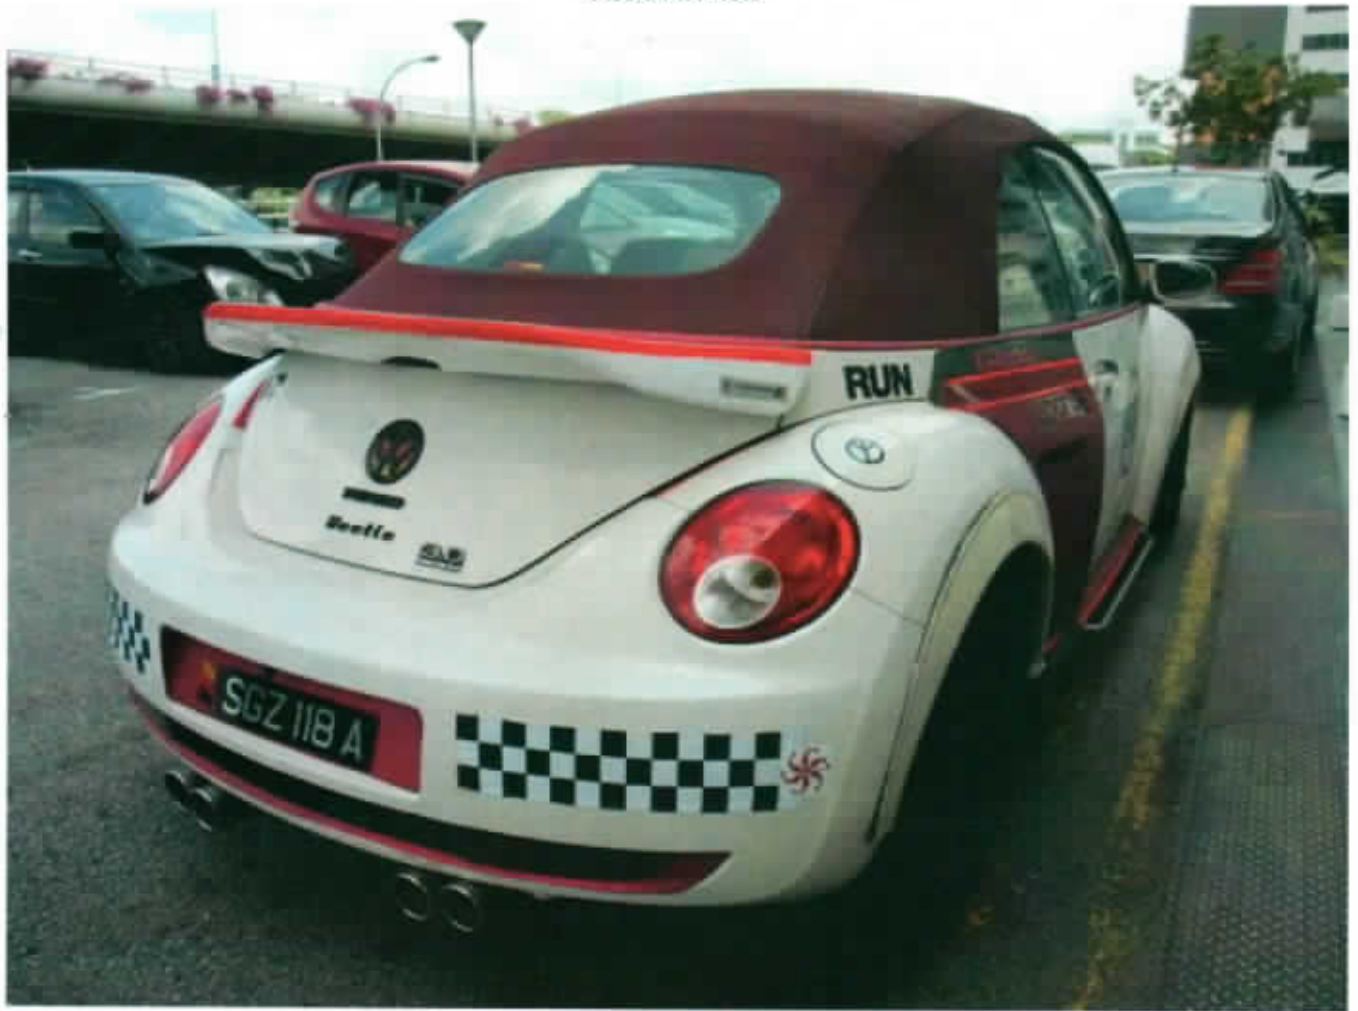
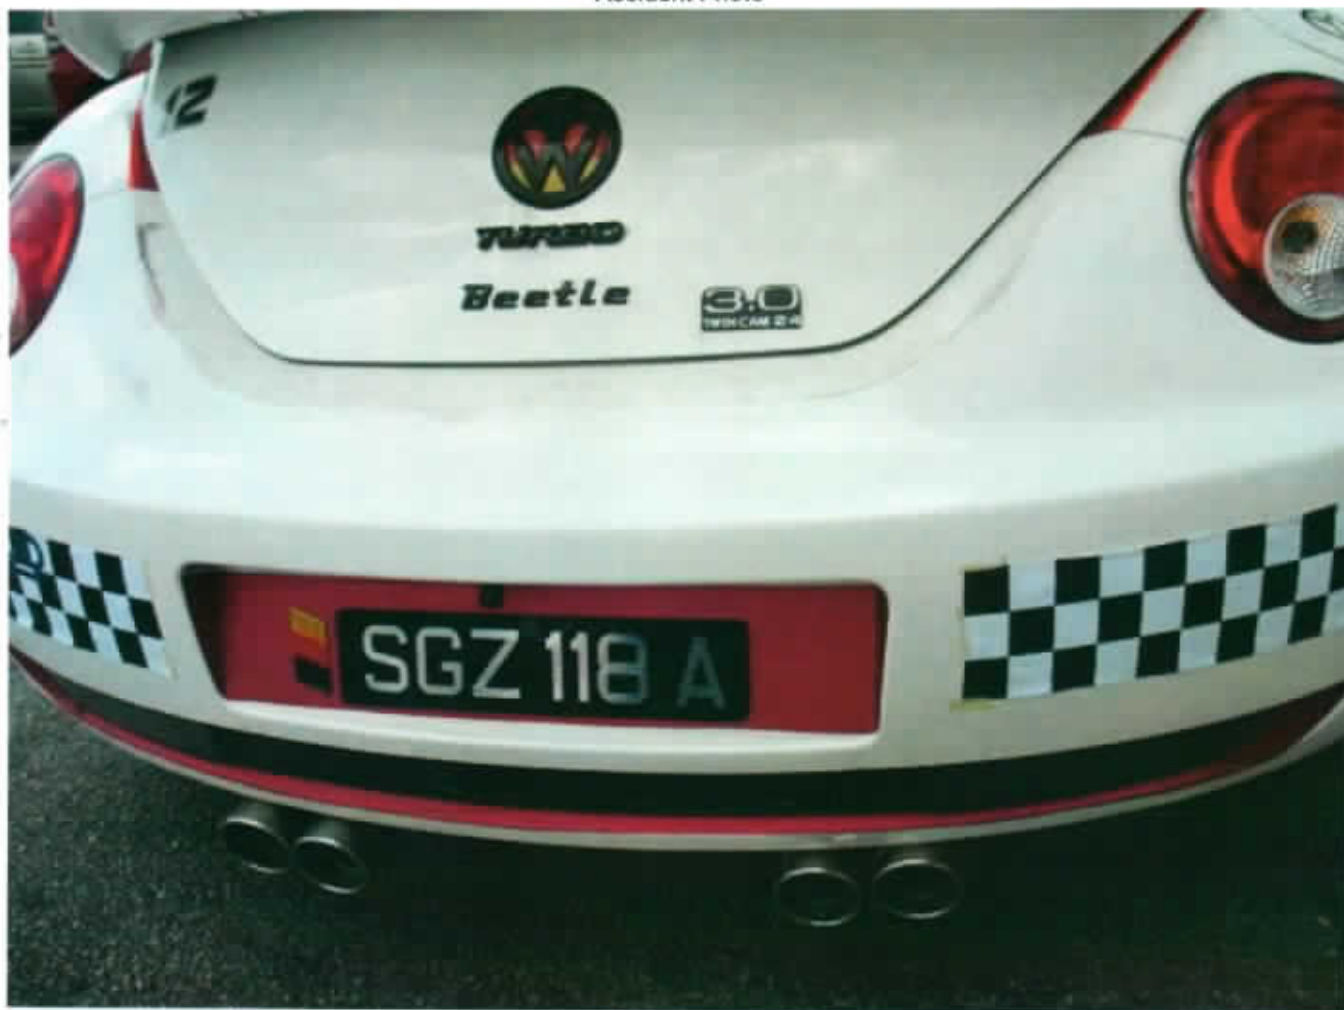
Accident Photo

MY CAR WAS PARKED ALONG PASIR RIS FARMWAY 3. A LORRY(YN4846E) WHICH WAS BEHIND MY CAR, REVERSED AND HIT THE REAR OF MY CAR. ATTENDED BY AINI

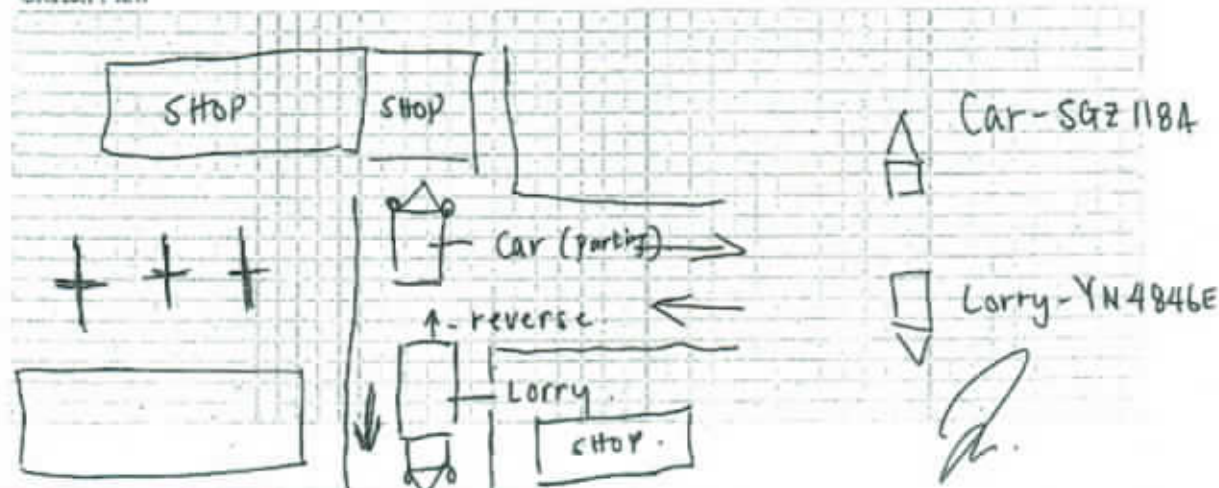
#### Sketch Plan

On 8/6/2017 at about 4.55pm.  
I deliver goods at No 22 Pasir Ris Farm 2.  
After deliver, I reverse my vehicle. I did not  
notice SG 2 118A is just behind my vehicle  
and accidently the rear bumper and spoiler of  
SG 2 118A

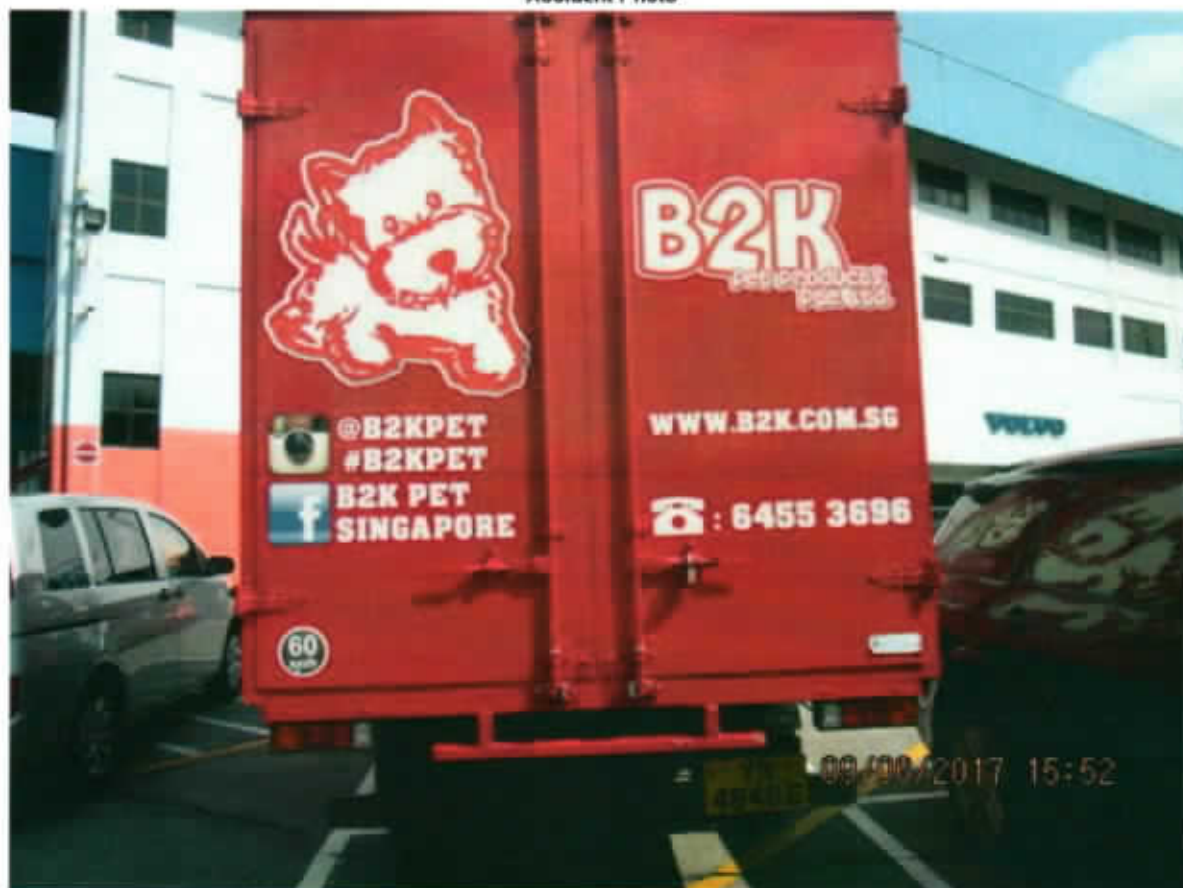
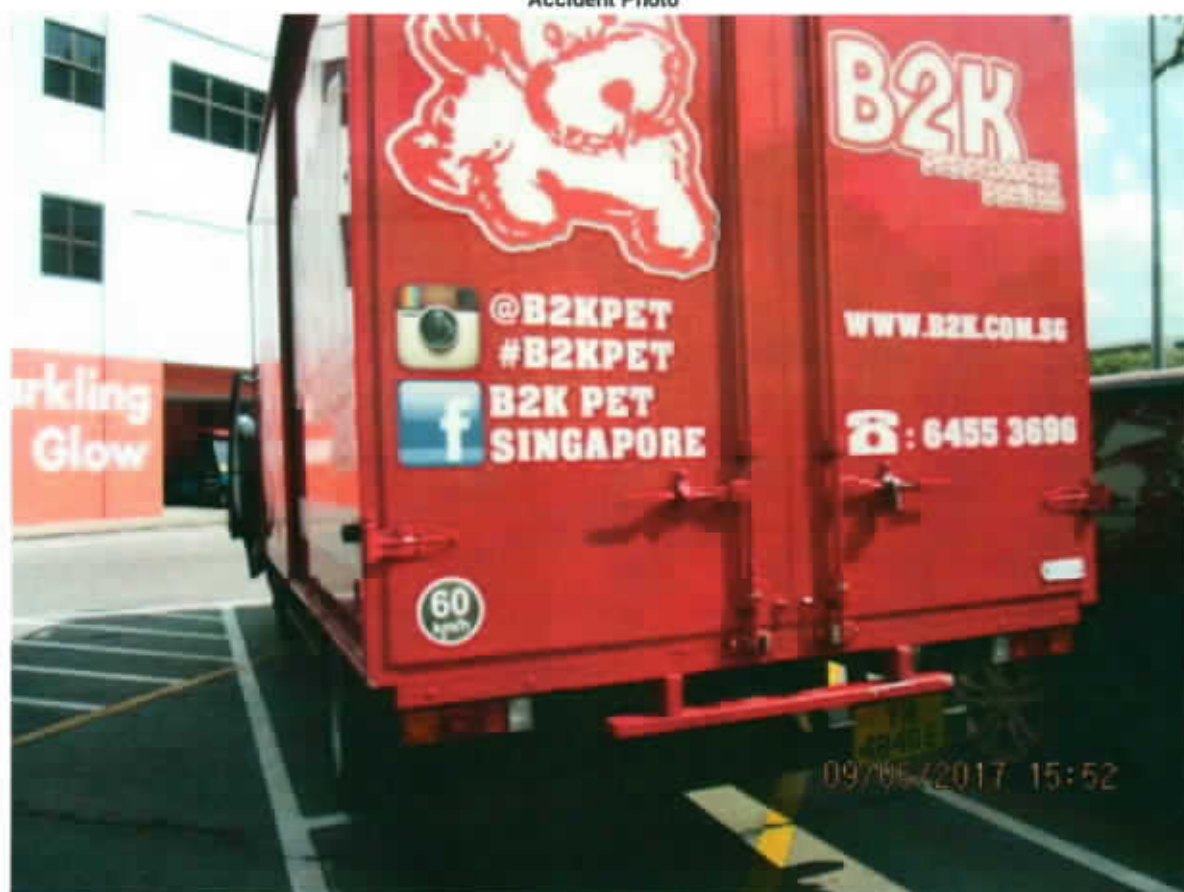
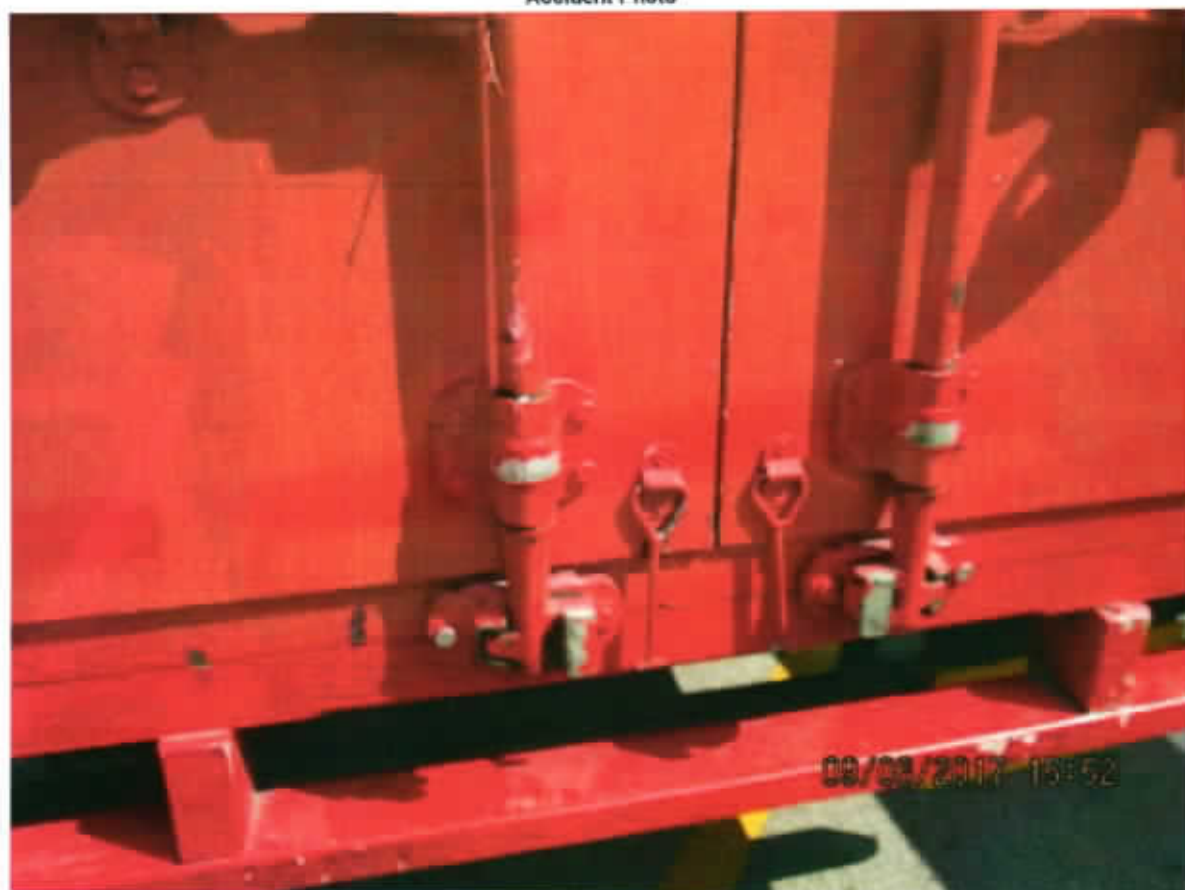
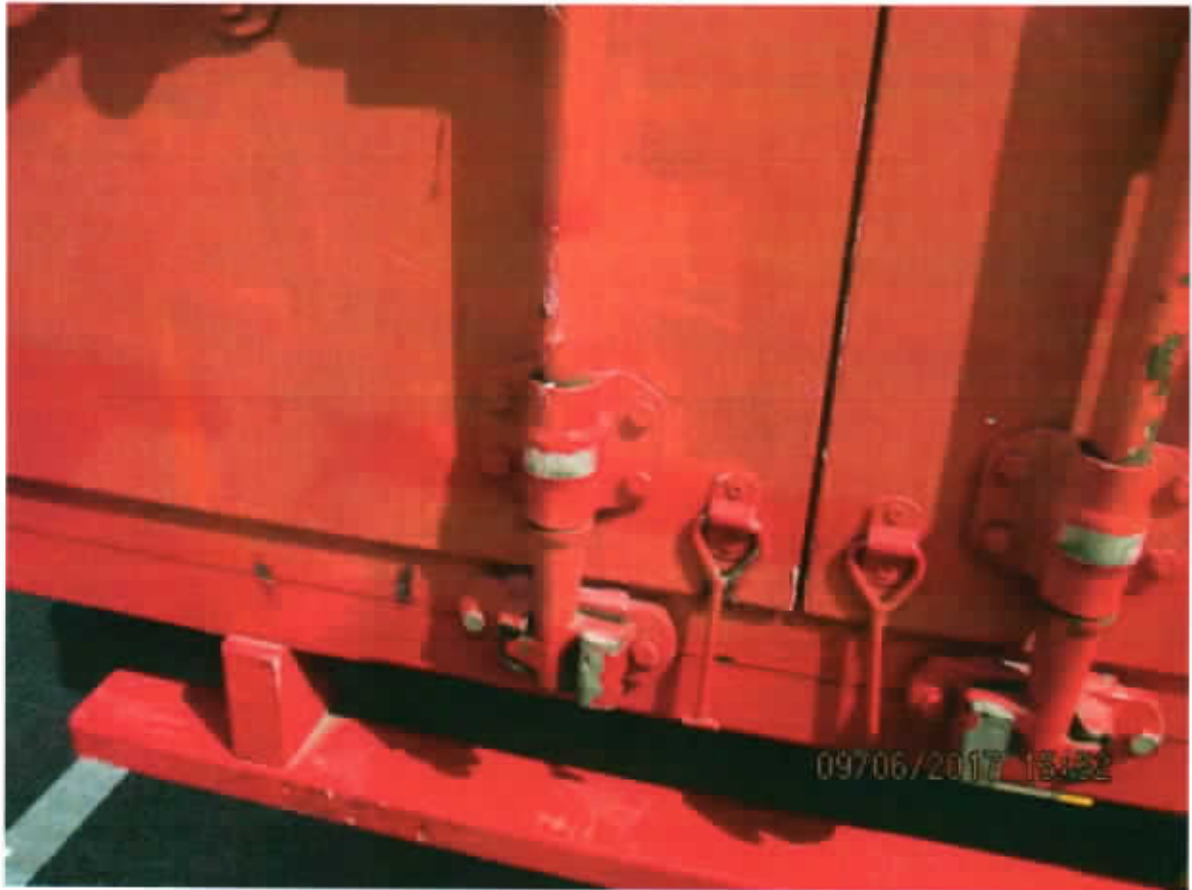
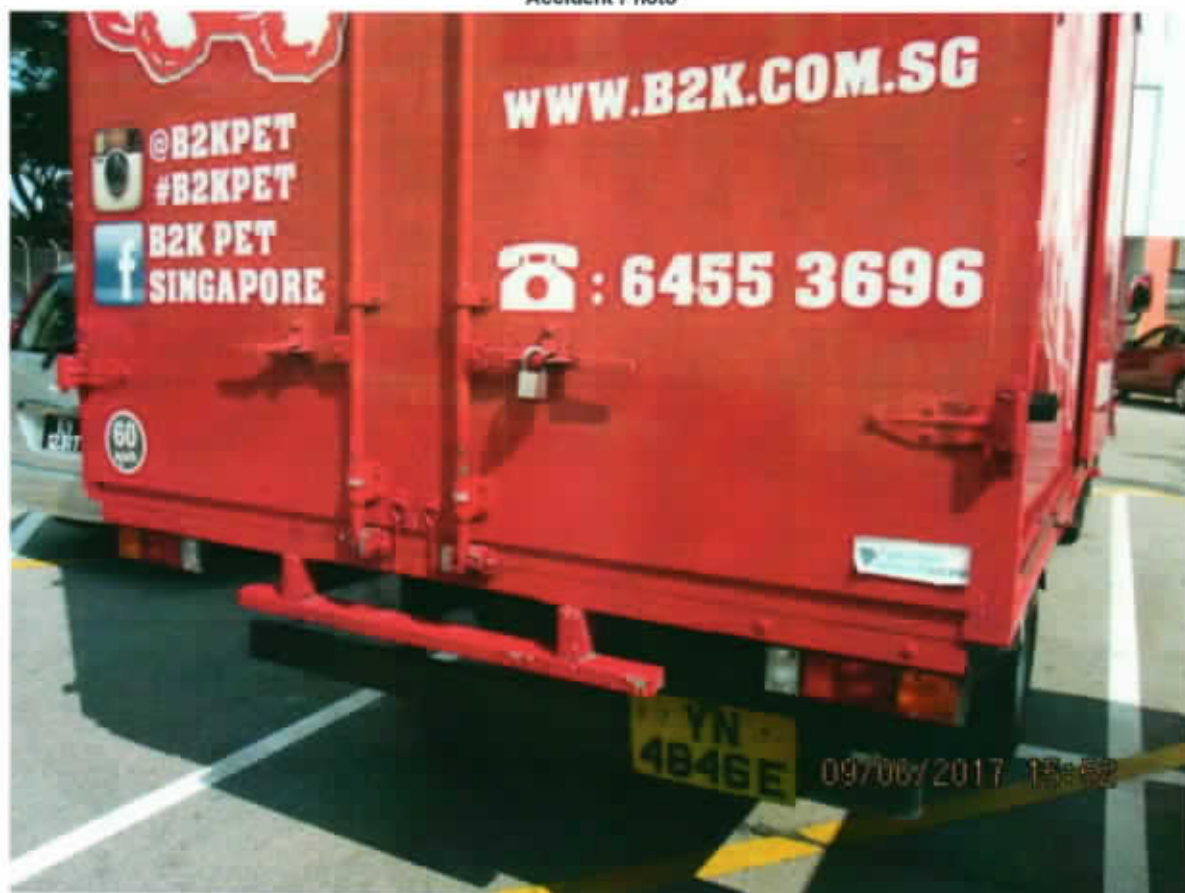
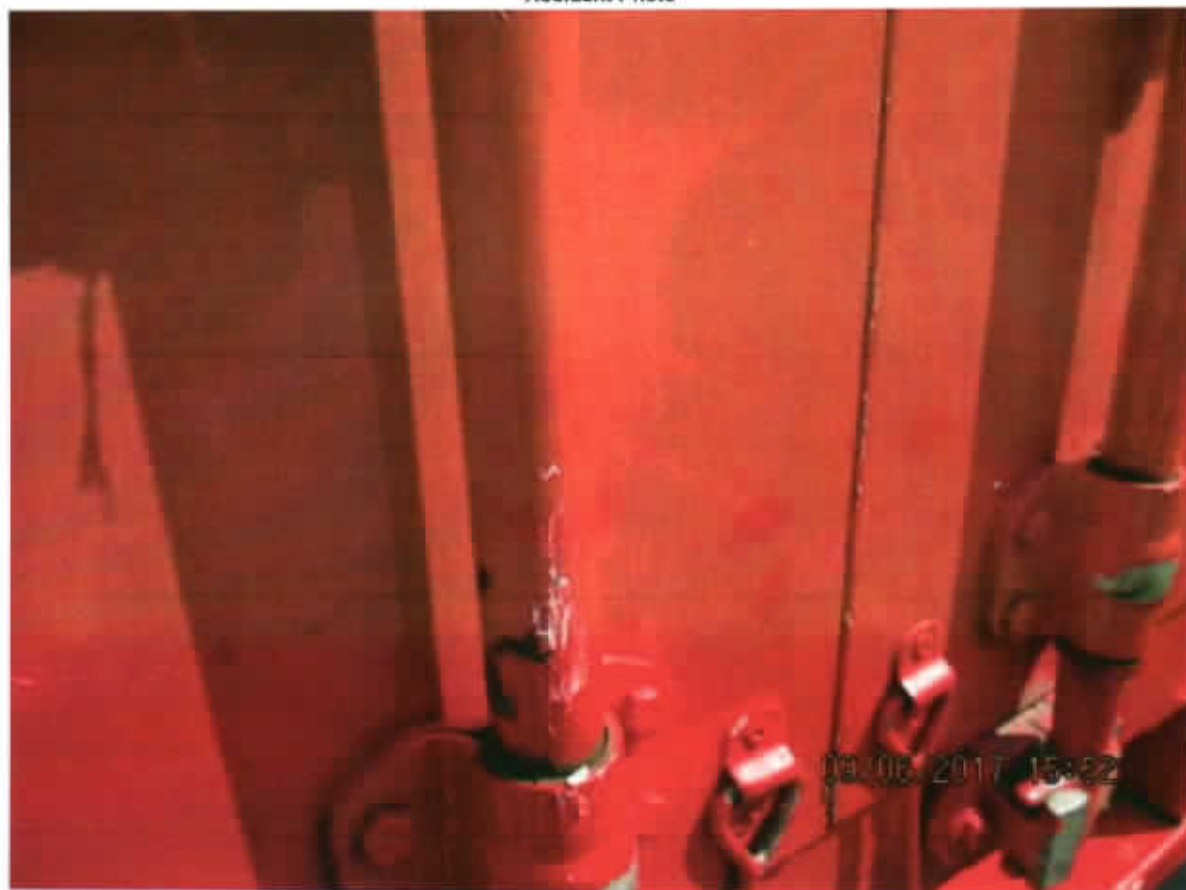
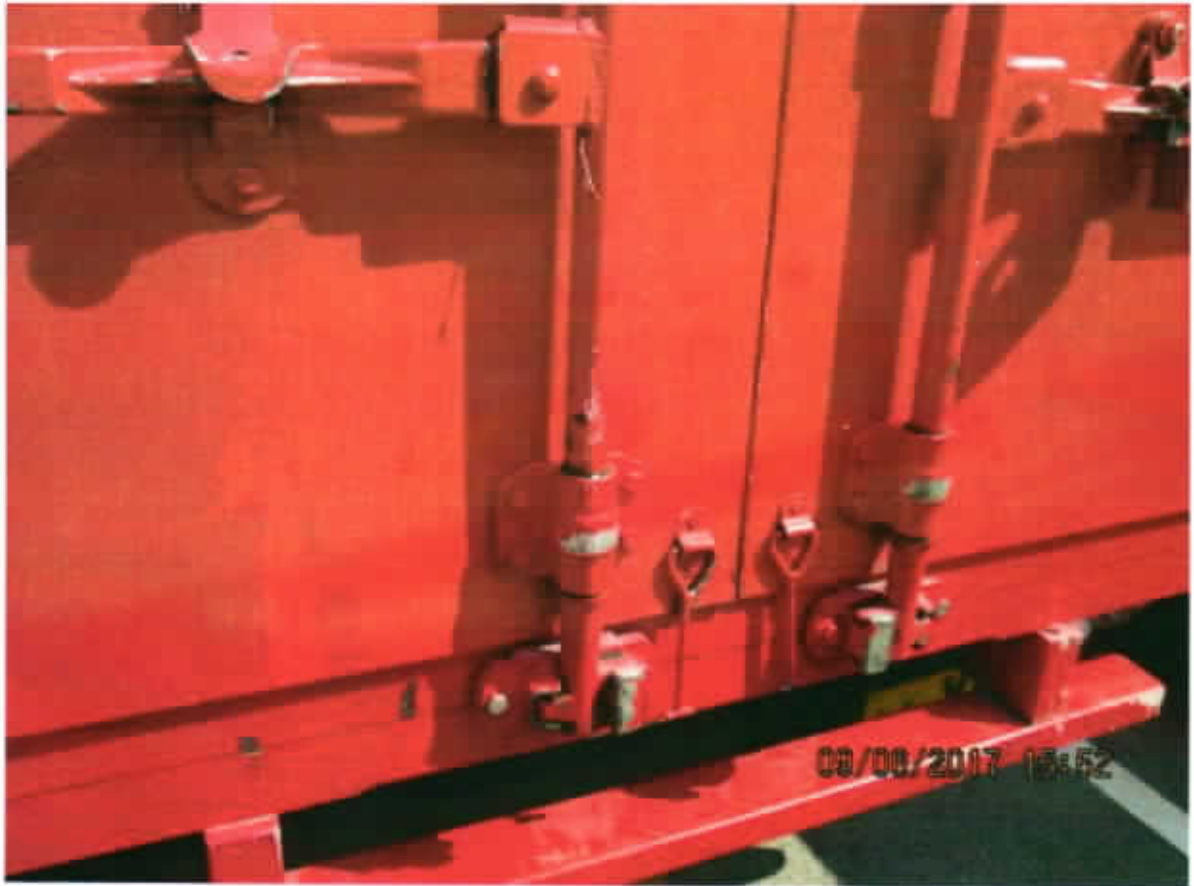
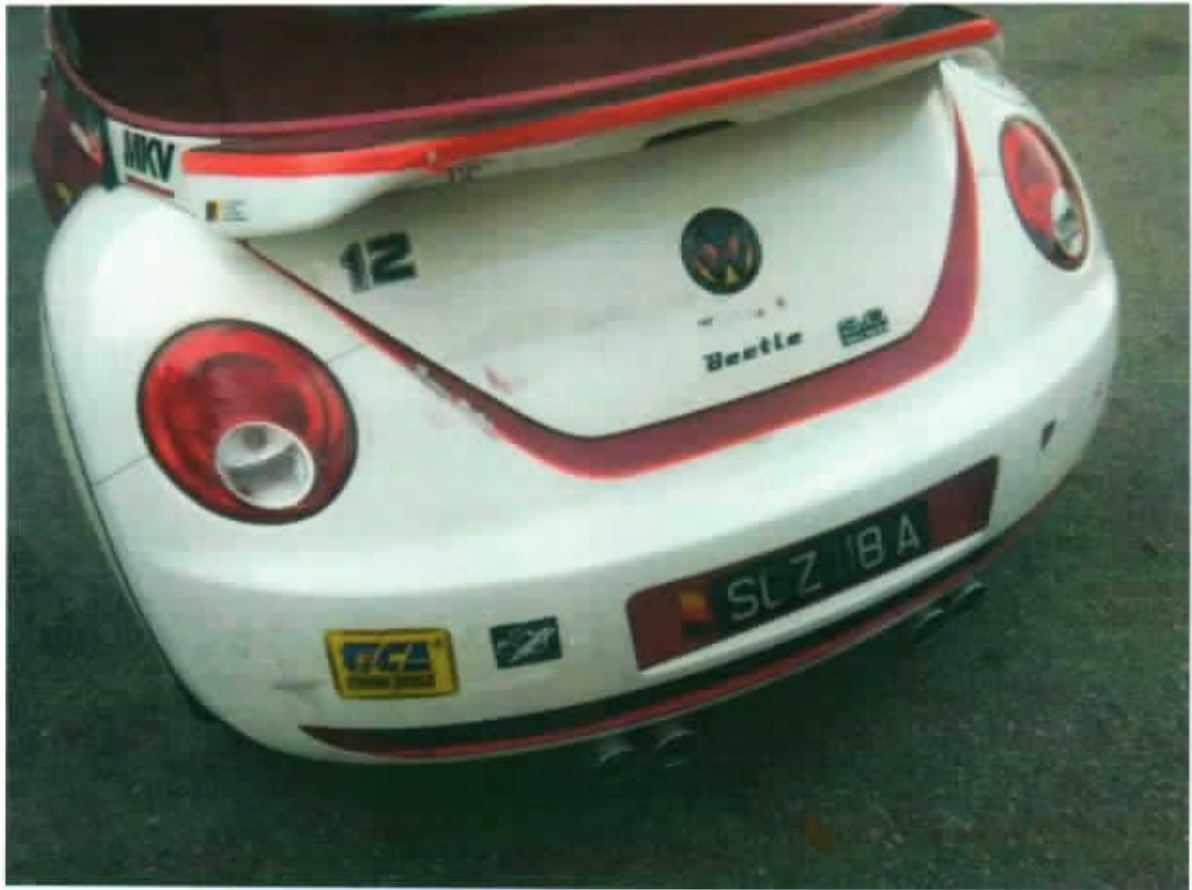
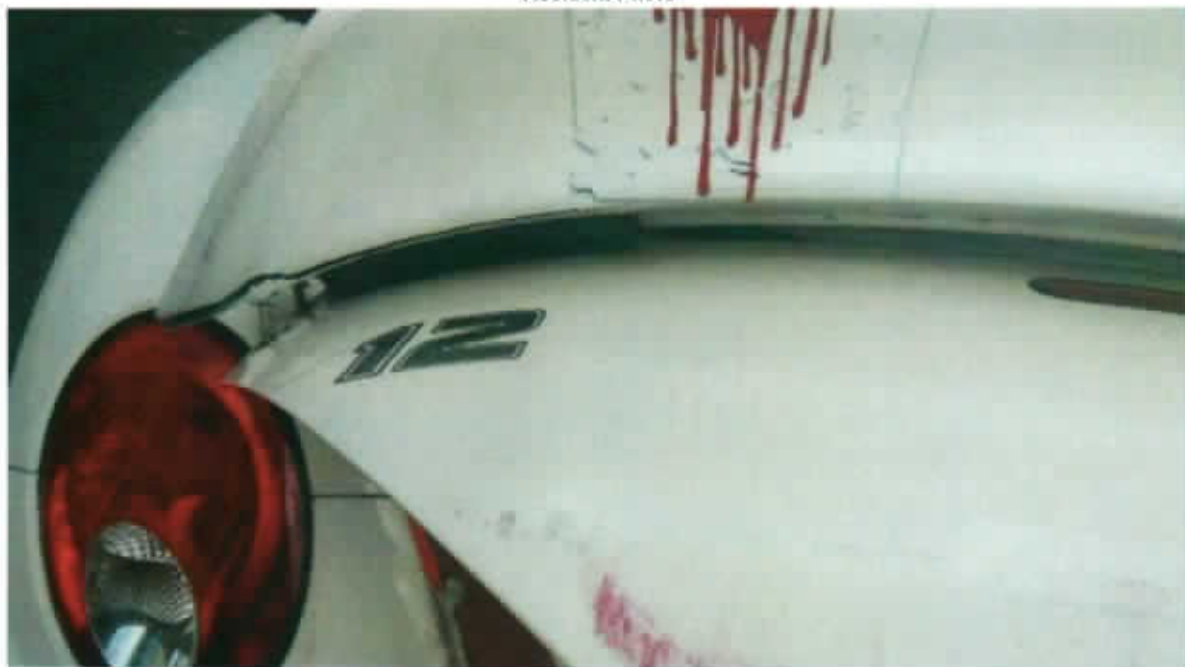
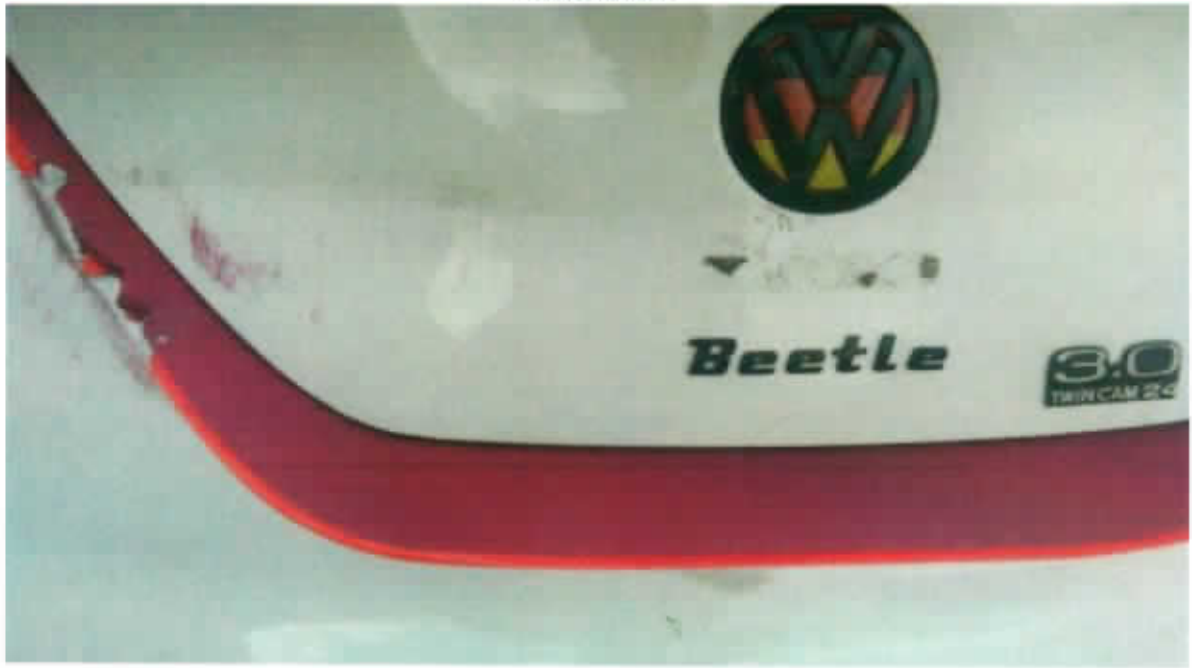
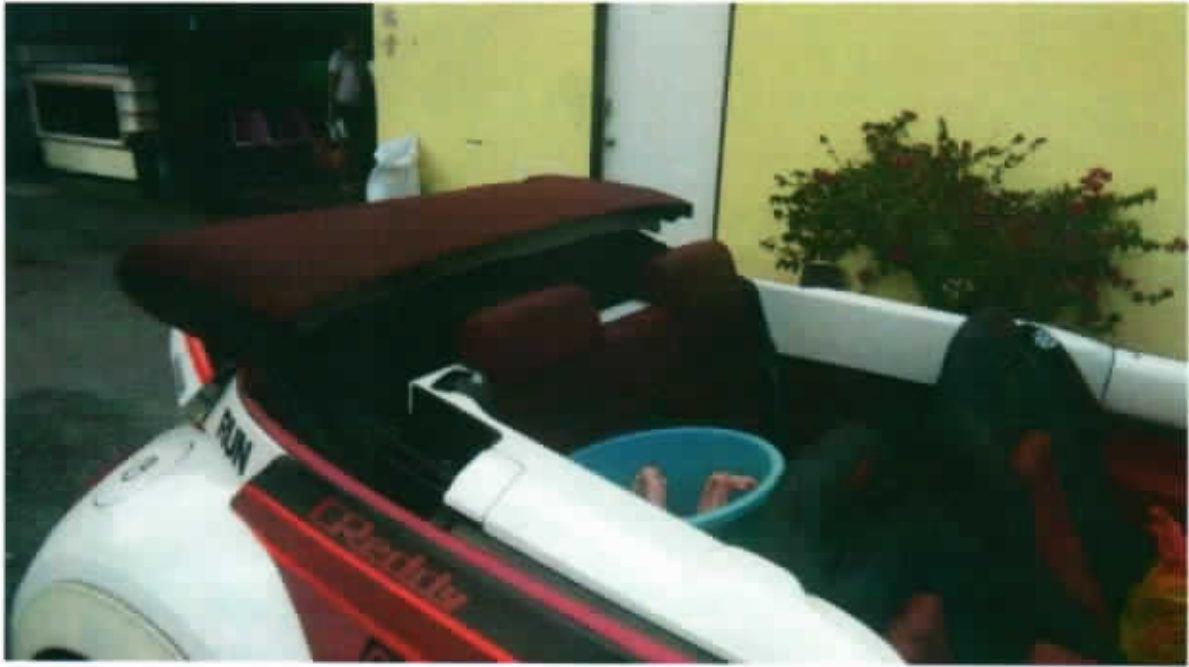
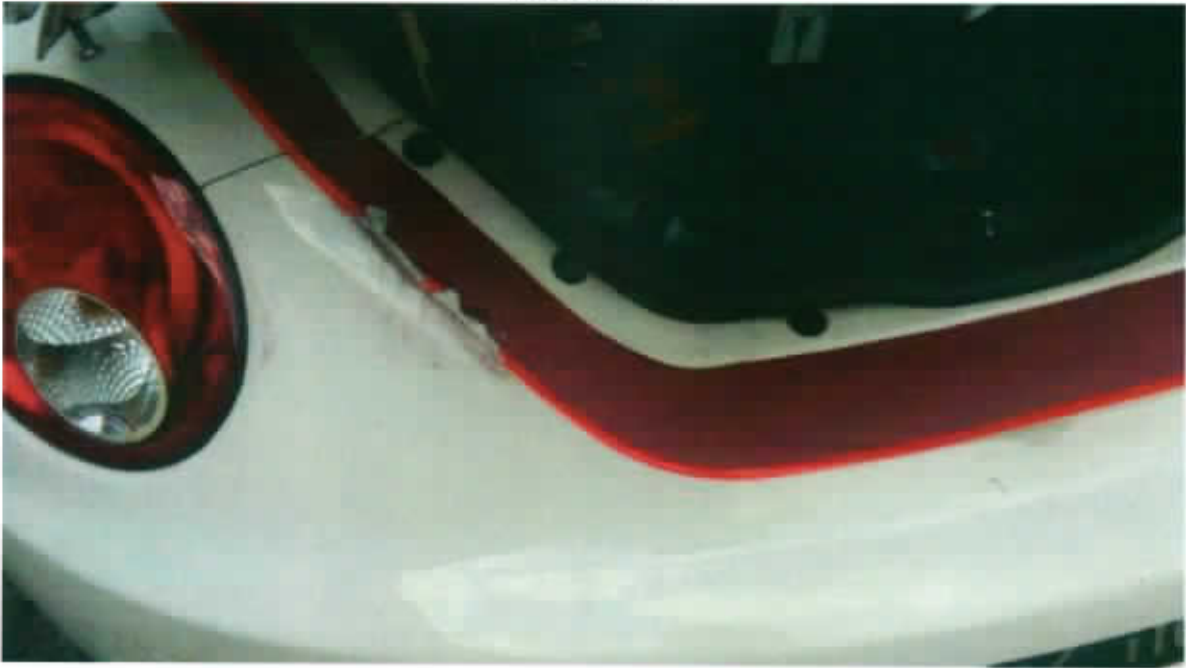
Accident Photo

<b>4. Description of Damages</b>				
THE VEHICLE SUSTAINED DAMAGES AT THE REAR PORTION.				
DAMAGES SEE DETAILS.				
<b>5. General Information</b>				
Accident Date	08/06/2017	Inspection Date	21/06/2017	
Survey held at	25 KAKI BUKIT RD 4# 07-47			
Repairer	H & H AUTO SERVICES			
<b>5a. Remarks</b>				
A)THE INSPECTION WAS CONDUCTED ON A"WITHOUT PREJUDICE" BASIS.				
B)IN ACCORDANCE TO YOUR INSTRUCTIONS, WE HAVE NOT AUTHORISED REPAIRS.				
<b>5b. Estimate Days of Repair</b>				
ESTIMATED NORMAL PERIOD FOR REPAIR:		6 Working Days

<b>RECOMMENDED COST OF LUMP SUM REPAIRS (TO ITS PRE-ACCIDENT CONDITION)</b>			<b>6,300.00</b>
