To Inspect Vehicle No: JSA1888

From: Shu Pei (LKKAuto) <shupeil@lkkauto.com>
Sent: Thursday, 6 September 2018 4:14 PM
To: assignments
Subject: FW: Paper RI for JSA1888 (DM18HO01347-JG)
Attachments: DM18HO01347 - SURVEY REPORT FOR JSA1888.pdf; SGP9838Z.pdf

THIRD PARTY VEHICLE INSPECTION REPORT

ADJUSTMENT ON REPAIR COST FOR VEHICLE NO. JSA 1888

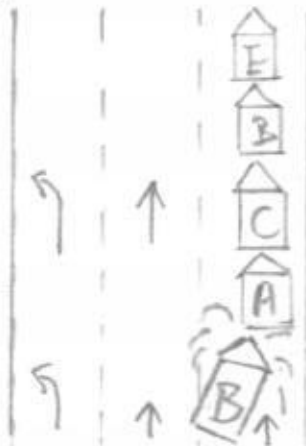
Sketch Plan #2

Vehicle A SGP 9838Z
 Vehicle B G84 9163T
 Vehicle C JSH 1888
 Vehicle D JPT 2593
 Vehicle E SLQ 5309X

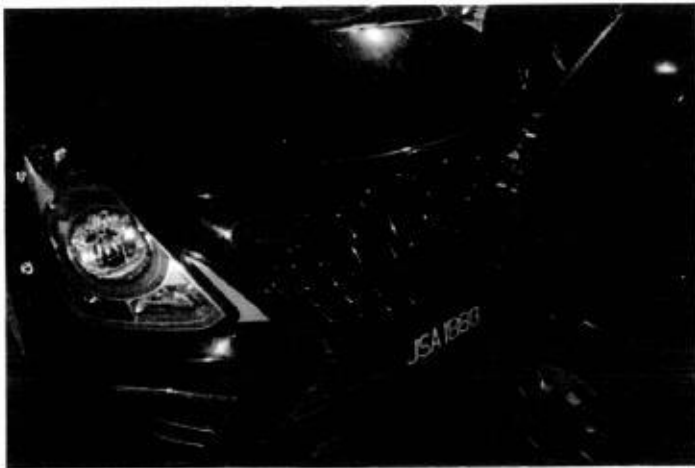
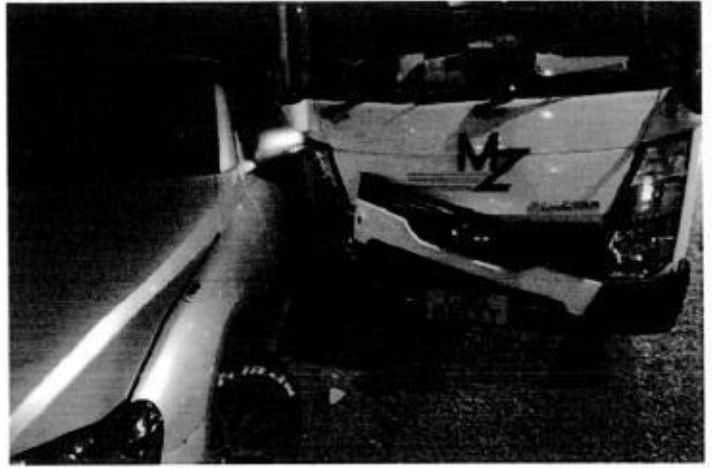
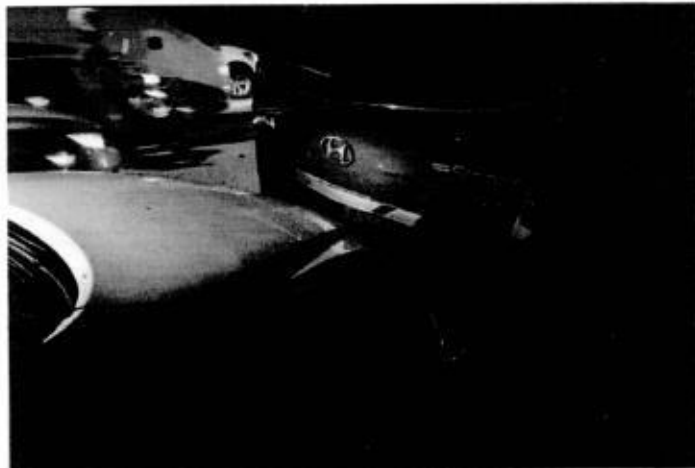
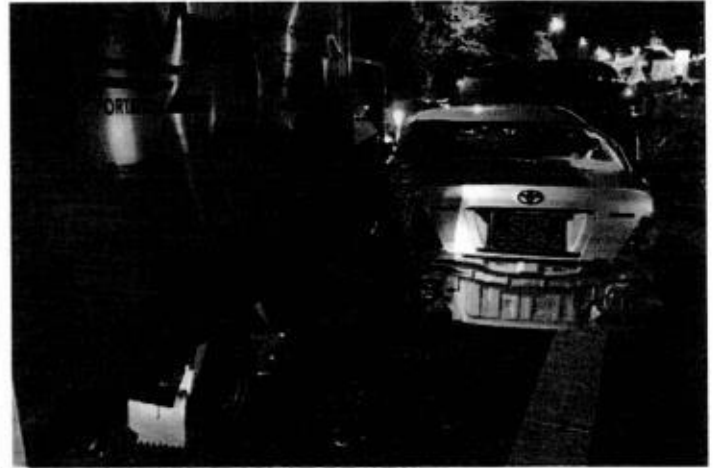
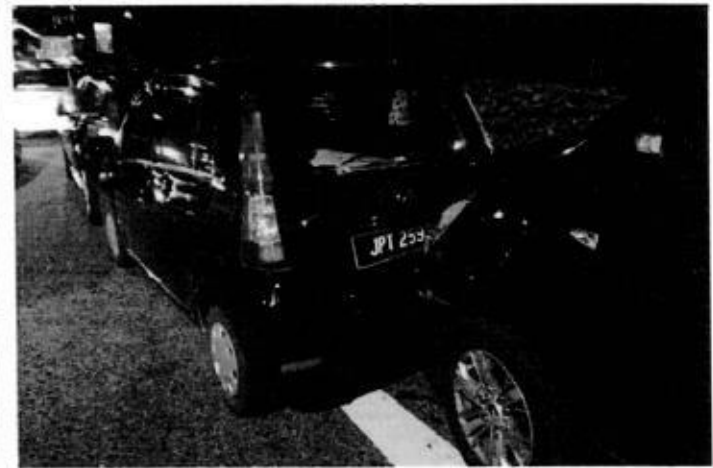
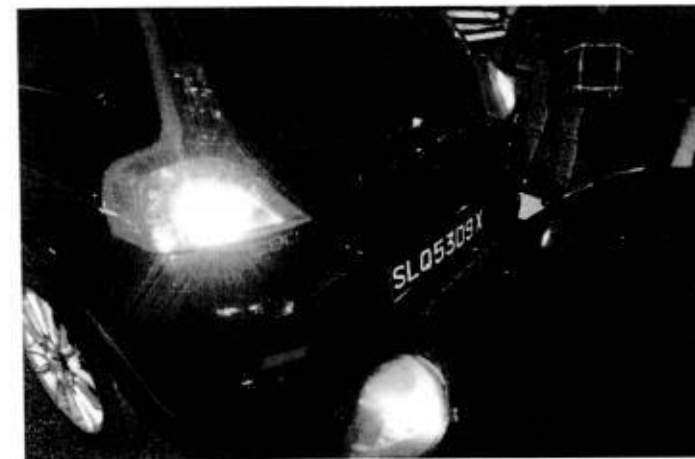
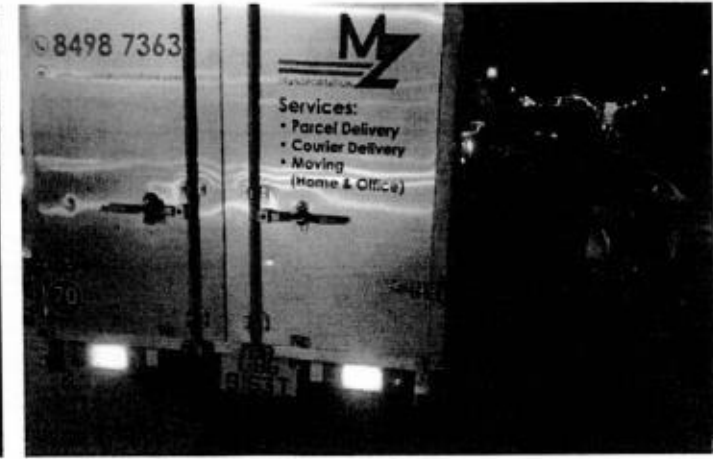
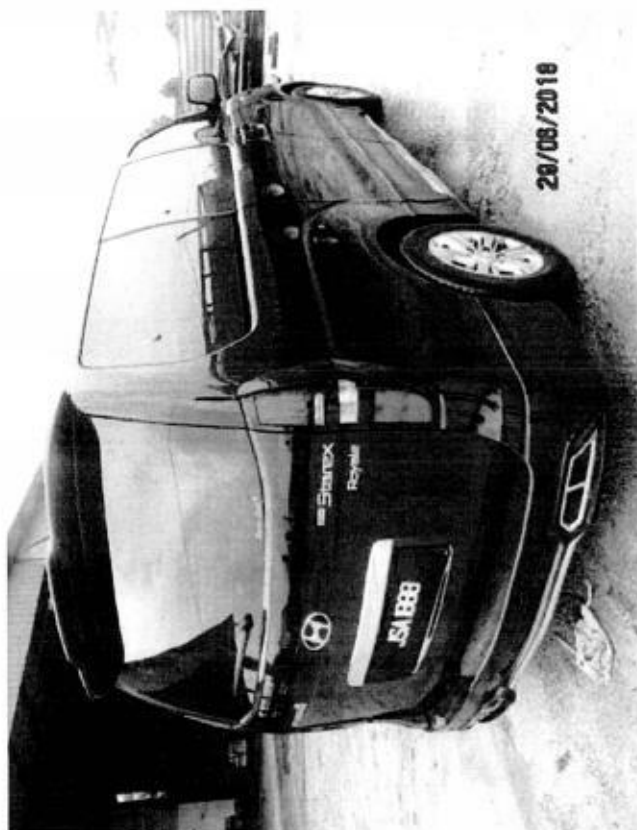
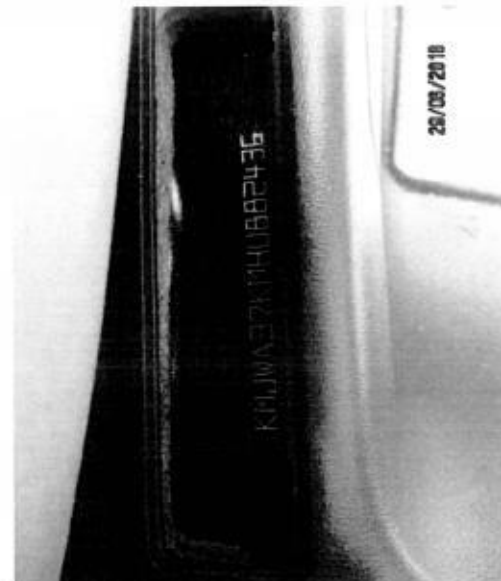
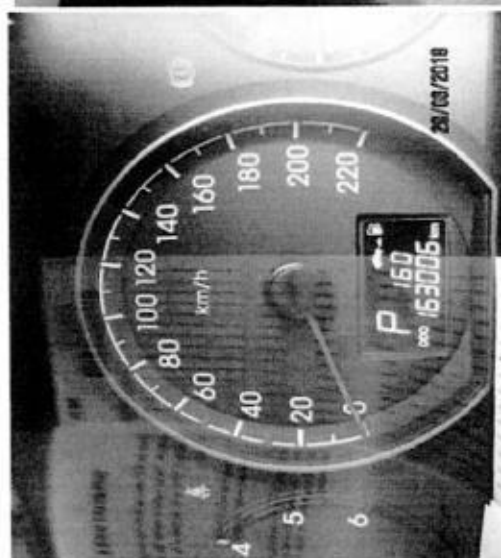
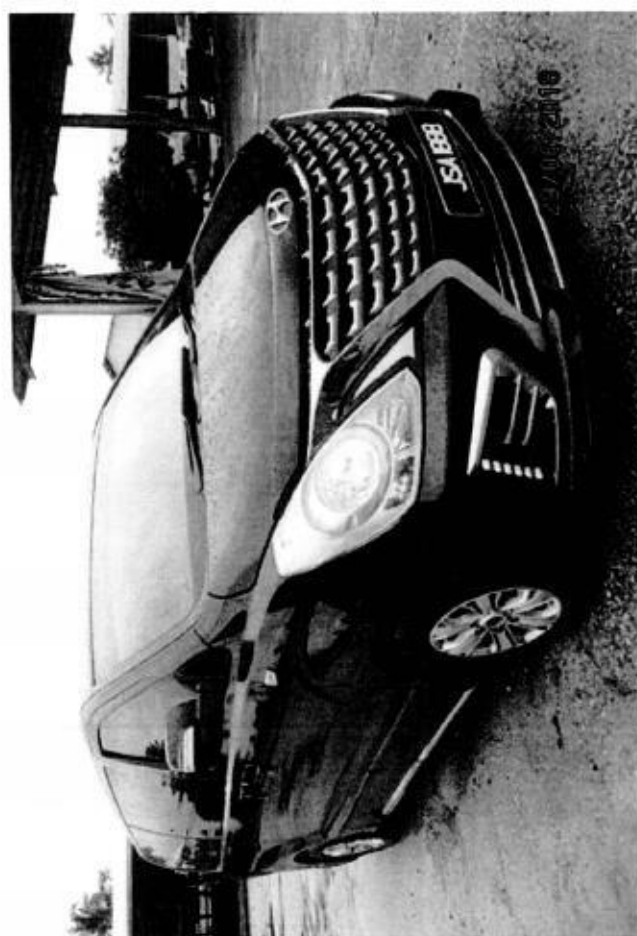
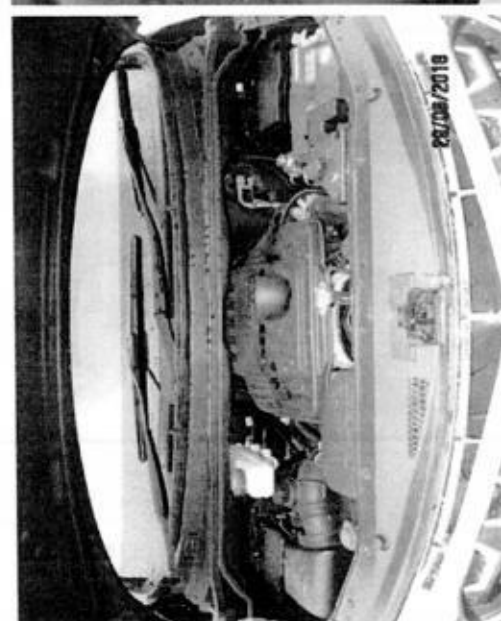
Visual inspection noted damages to the front and rear of your vehicle.

From documents sighted, the damages were inflicted in a vehicular chain collision.

Our visual inspection of the subject vehicle upon sighting the police report No: T/20180525/2006 revealed that the damage noted is consistent with the reported accident.

Qty	Description of Parts	Condition	Estimate By Workshop (\$)	Our Adjusted (\$)
	REPLACEMENT OF PARTS			
1	FRONT BUMPER	DENTED	1,210.00	1,210.00
1	BONNET HINGE RH	SERVICEABLE	67.20	-
1	BONNET HINGE LH	SERVICEABLE	67.20	-
1	BONNET MOULDING	SCRATCHED	453.00	453.00
1	RADIATOR GRILLE	BROKEN	2,853.00	2,853.00
1	BONNET BADGE	SCRATCHED	57.20	57.20
1	HEADLAMP ASSY LH (HOLDER BROKEN)	NOT CONSISTENT WITH THE IMPACT	973.00	-
1	PARKING LAMP	BROKEN	430.00	430.00
1	FRONT BUMPER COVER	BROKEN	1,346.00	1,346.00
1	ENERGY ABSORBER, FRONT BUMPER	BROKEN	188.00	188.00
1	BUMPER FRONT REINFORCEMENT	BENT	509.00	509.00
1	SIDE BRACKET, FRONT BUMPER LH	NOT NECESSARY	48.60	-
1	FRONT BUMPER LOWER GRILLE	BROKEN	299.00	299.00
1	BUMPER FRONT PARKING SENSOR INNER LH	BROKEN	133.00	133.00
1	RADIATOR AIR DEFLECTOR LH	CRACKED	47.60	47.60
1	FRONT BUMPER UPPER BRACKET LH	NOT NECESSARY	25.40	-
1	A/COND CONDENSER	DENTED	1,670.00	1,670.00
1	ENGINE OIL COOLER	BENT	1,200.00	1,200.00

1	FRONT PANEL ASSY	BROKEN	1,560.00	1,560.00
1	TAILGATE	DENTED	3,690.00	3,690.00
1	TAILGATE TRIMBOARD	BROKEN	572.00	572.00
1	TAILGATE LOCK	BENT	324.00	324.00
1	TAILGATE LOCK STRIKER	BENT	25.20	25.20
1	TAILGATE FINISHER	CRACKED	129.00	129.00
1	TAILGATE RELEASED HOLDER COVER	CRACKED	34.00	34.00
1	TAILLAMP RH	CRACKED	569.00	569.00
1	TAILLAMP LH	CRACKED	569.00	569.00
1	REAR BUMPER COVER	BROKEN	1,085.00	1,085.00
1	REAR BUMPER UPPER SECTION RH	CRACKED	171.00	171.00
1	REAR BUMPER UPPER SECTION LH	CRACKED	171.00	171.00

Qty	Description of Parts	Condition	Estimate By Workshop (\$)	Our Adjusted (\$)
1	REVERSE SENSOR RH }	CUT	133.00	210.00
1	REVERSE SENSOR LH }		133.00	-
1	CORNER SENSOR RH }		133.00	-
1	CORNER SENSOR LH }		133.00	-
1	REAR BUMPER CHROME FINISHER RH	BROKEN	199.00	199.00
1	REAR BUMPER CHROME FINISHER LH	CUT	199.00	199.00
1	SIDE BRACKET, REAR BUMPER RH	CRACKED	37.70	37.70
1	SIDE BRACKET, REAR BUMPER LH	CRACKED	37.70	37.70
1	FOAM, REAR BUMPER	BROKEN	152.00	152.00
1	BUMPER REAR REINFORCEMENT	BENT	710.00	710.00
1	REAR END PANEL OUTER	DENTED	409.00	409.00
1	REAR END PANEL INNER	DENTED	328.00	328.00
1	TRIM, REAR END PANEL	BROKEN	324.00	324.00
1	WEATHERSTRIP, TAILGATE OPENING	BROKEN	217.00	217.00
1	BOOT SIDE TRIM RH	BROKEN	1,270.00	1,270.00
1	BOOT SIDE TRIM LH	BROKEN	1,270.00	1,270.00
1	A/COND AIR DUCT, REAR BOOT FLOOR	BENT	378.00	378.00
1	REAR STABILIZER BAR	SERVICEABLE	377.00	-
1	REAR LOWER ARM RH	SERVICEABLE	662.00	-
