Preliminary Advice

Insured Vehicle No	: SLM9108D		
TP Vehicle No	: SJL838T	Accident Date	: 08/09/2018
Make	: HONDA VEZEL	Assignment Date	: 04/10/2018
Date of Inspection	: 10/09/2018	Est. Duration of Repair	: 4.00
Inspection At	: FASTECH AUTO PTE LTD (HQ) 1 KAKI BUKIT AVE 6, #01-46/48/50 AUTOBAY SINGAPORE 417883

Point of Impact / General Description of Damages

VEHICLE DAMAGE INSPECTION REPORT

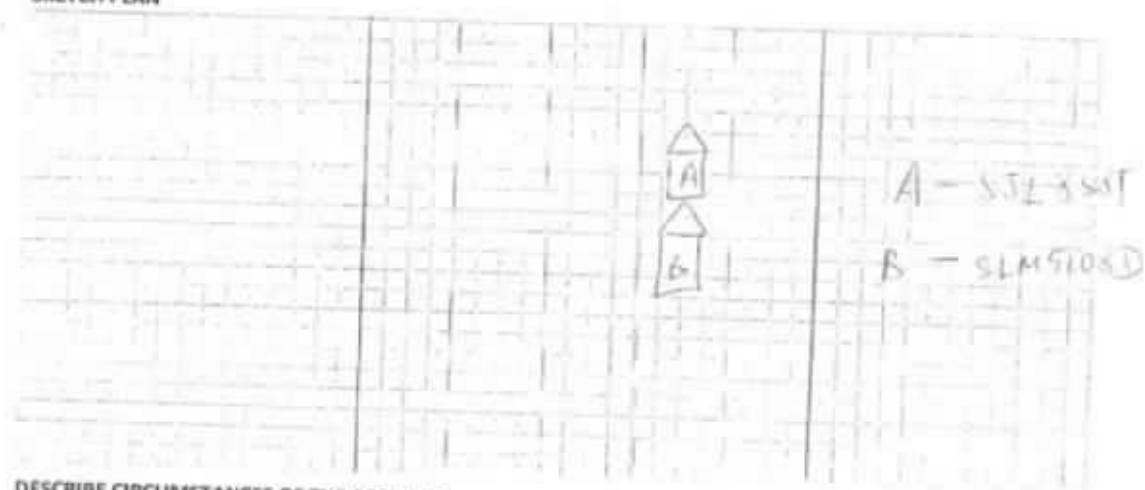
Sketch Plan #2

on 8/4/18 at 9am. I was driving my vehicle A along Park Drive 12. I stop my car at the traffic light. Suddenly vehicle B hit my rear portion.

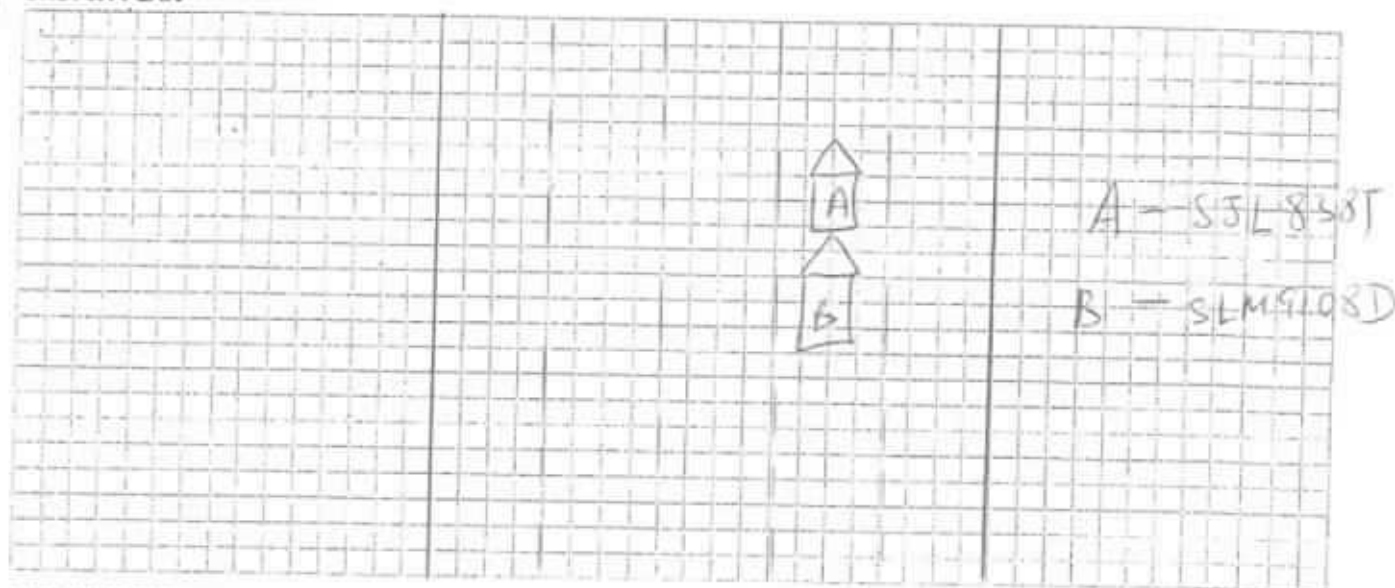
SKETCH PLAN

on 8/9/18 at 9am, I was driving my vehicle A
 along Pasir Ris Drive 12. I stop my car at the traffic
 light. Suddenly vehicle B hit on my rear portion.
