Preliminary Advice

Insured Vehicle No	: YN2167U	Accident Date	: 07/09/2018
TP Vehicle No	: YN924P	Assignment Date	: 11/09/2018
Make	: HINO FD8JLKA	Est. Duration of Repair	: 3.00
Date of Inspection	: 11/09/2018		
Inspection At	: TAN LIM MOTOR PTE LTD (DEFU) 51 DEFU LANE 10 SINGAPORE 539216

VEHICLE DAMAGE INSPECTION REPORT

Our File No: CS/MSG18016519/URBN2

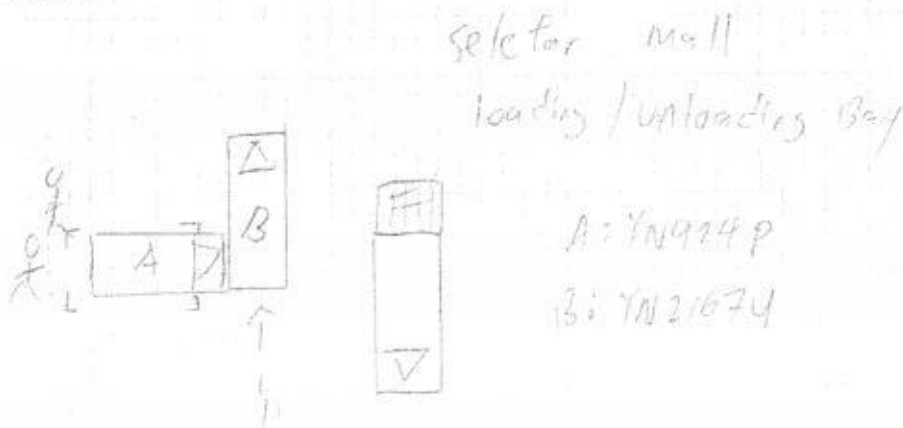
SKETCH PLAN

On 07/09/2018 at about 0300hrs, I stopped my vehicle (A: YN924P) at parking lot loading/unloading Bay at Seletar Mall in order to unloading goods. My colleague with me at behind of the vehicle unloading goods, suddenly heard the bang sound from my vehicle's front portion. I immediately go in front and discovered that vehicle (B: YN2167U) which was came out from loading/unloading bay and hit onto my vehicle's front portion. Nobody was injured in this accident. My vehicle have no driver and passenger on board. Vehicle B have no passenger on board.
