VEHICLE DAMAGE INSPECTION REPORT

Our File No: CS/CTI18016538/USBN2

Handling Insurer:	China Taiping Insurance (Singapore) Pte. Ltd.	Policy No:	DMPCSN1752631801
Claimant Vehicle No :	SLT3023S	Insured Vehicle No :	SLG2812G
Date of Loss:	07/09/2018	Nature of Claim:	TP
		Claim No:	SNM18D04366

Reg No:	SLT3023S	Engine No:	P520450332
Make & Model:	MAZDA 3, 1.5 (A)	Chassis No:	JM6BN22A8H0157579
Reg. Date:	25/10/2017 (Man. Year: 2017)	Odometer:	79699 km
Colour:	Silver		
Engine Capacity:	1496 cc		
Market Value/New Car Price:	N/A		
Sum Insured (S\$):	Market Value/New Car Price

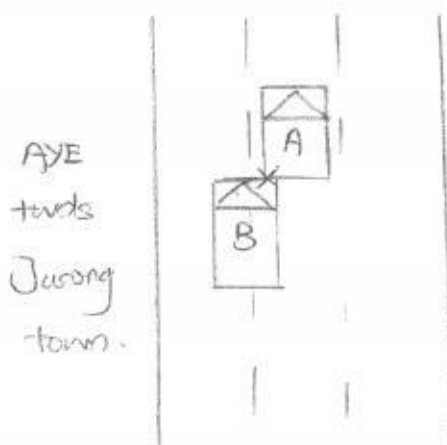
SKETCH PLAN

veh A: SLT30238
veh B: SLG2812G

On 07/09/2018, time about 9.45am, I was driving my vehicle SLT30238 along AYE towards Jurong town at lane 2, suddenly vehicle B (SLG2812G) hit onto my vehicle rear portion, after we driving to under the bridge and check my car damage at left hand side rear portion.
