VEHICLE DAMAGE INSPECTION REPORT

Our File No: CS/CT118016616/NCD3E2
Date: 29/03/2019

Handling Insurer:	China Taiping Insurance (Singapore) Pte. Ltd.	Policy No:	DMCVSN1659601802
Claimant Vehicle No :	SLK1884J	Insured Vehicle No :	XE2161U
Date of Loss:	05/09/2018	Nature of Claim:	TP
		Claim No:	SNM18D04338C02

Reg No:	SLK1884J	Engine No:	2NR8713097
Make & Model:	TOYOTA SIENTA, 1.5 X CVT (A)	Chassis No:	NSP1707070322
Reg. Date:	09/01/2017 (Man. Year: 2016)	Odometer:	40064 km
Colour:	Silver		
Engine Capacity:	1496 cc		
Market Value/New Car Price:	N/A		
Sum Insured (S\$):	Market Value/New Car Price

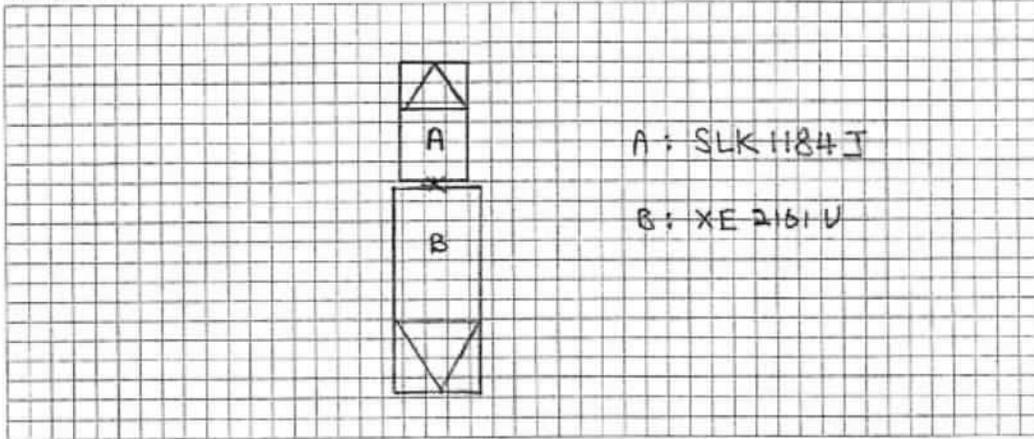
Sketch Plan #2

ON 5/9/18, AT AROUND 5.15PM, MY VEHICLE SLK 1884J WAS PARKED WITHIN THE PREMISES OF 18 SUNGEI KADUT AVE S(729489). UPON HEARING A LOUD BANG, I WALK TOWARDS THE CARPARK AND REALISED VEHICLE XE 2161U REVERSED AND HIT ONTO THE REAR PORTION OF MY VEHICLE.
