VEHICLE DAMAGE INSPECTION REPORT

Our File No: CS3/AIG18016624/R1CD3S2
Date: 02/10/2018

Handling Insurer: AIG Asia Pacific Insurance Pte. Ltd. Policy No: 2100436535
Claimant Vehicle No : SMD6498H **Insured Vehicle No :** SKW5170H
Date of Loss: 02/09/2018 Nature of Claim: TP Claim No: 6302934970SG

Reg No: **SMD6498H**
Make & Model: HONDA FREED HYBRID, 1.5 G (A) Engine No: LEB5599491
Reg. Date: 29/08/2018 (Man. Year: 2018) Chassis No: GB71066473
Colour: White Odometer: 610 km
Engine Capacity: 1496 cc
Market Value/New Car Price: N/A
Sum Insured (S\$): **Market Value/New Car Price**

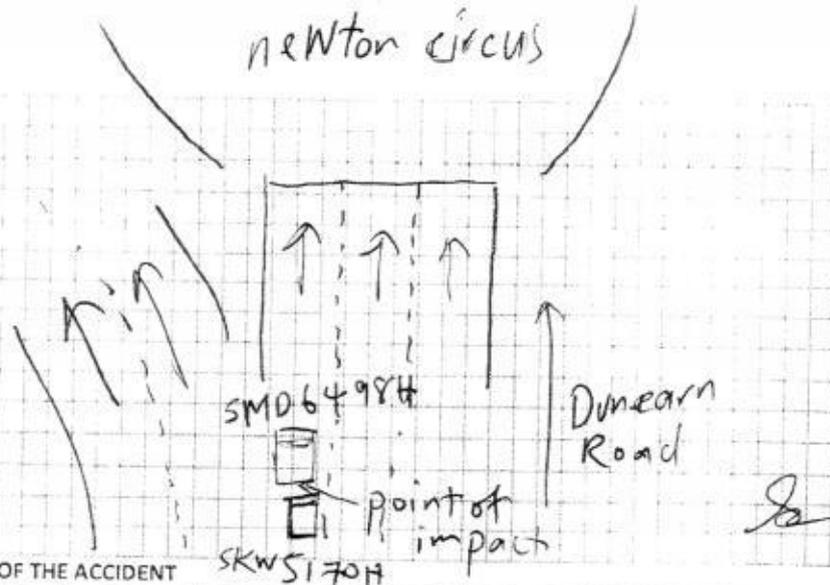
SKETCH PLAN

On 2nd Sept, ~~4th~~ 11:45am, I stopped my car at the traffic light junction at Dunearn Road towards Newton Circus. After few seconds, a car banged onto the back of my car. The driver has admitted that it was her fault. J

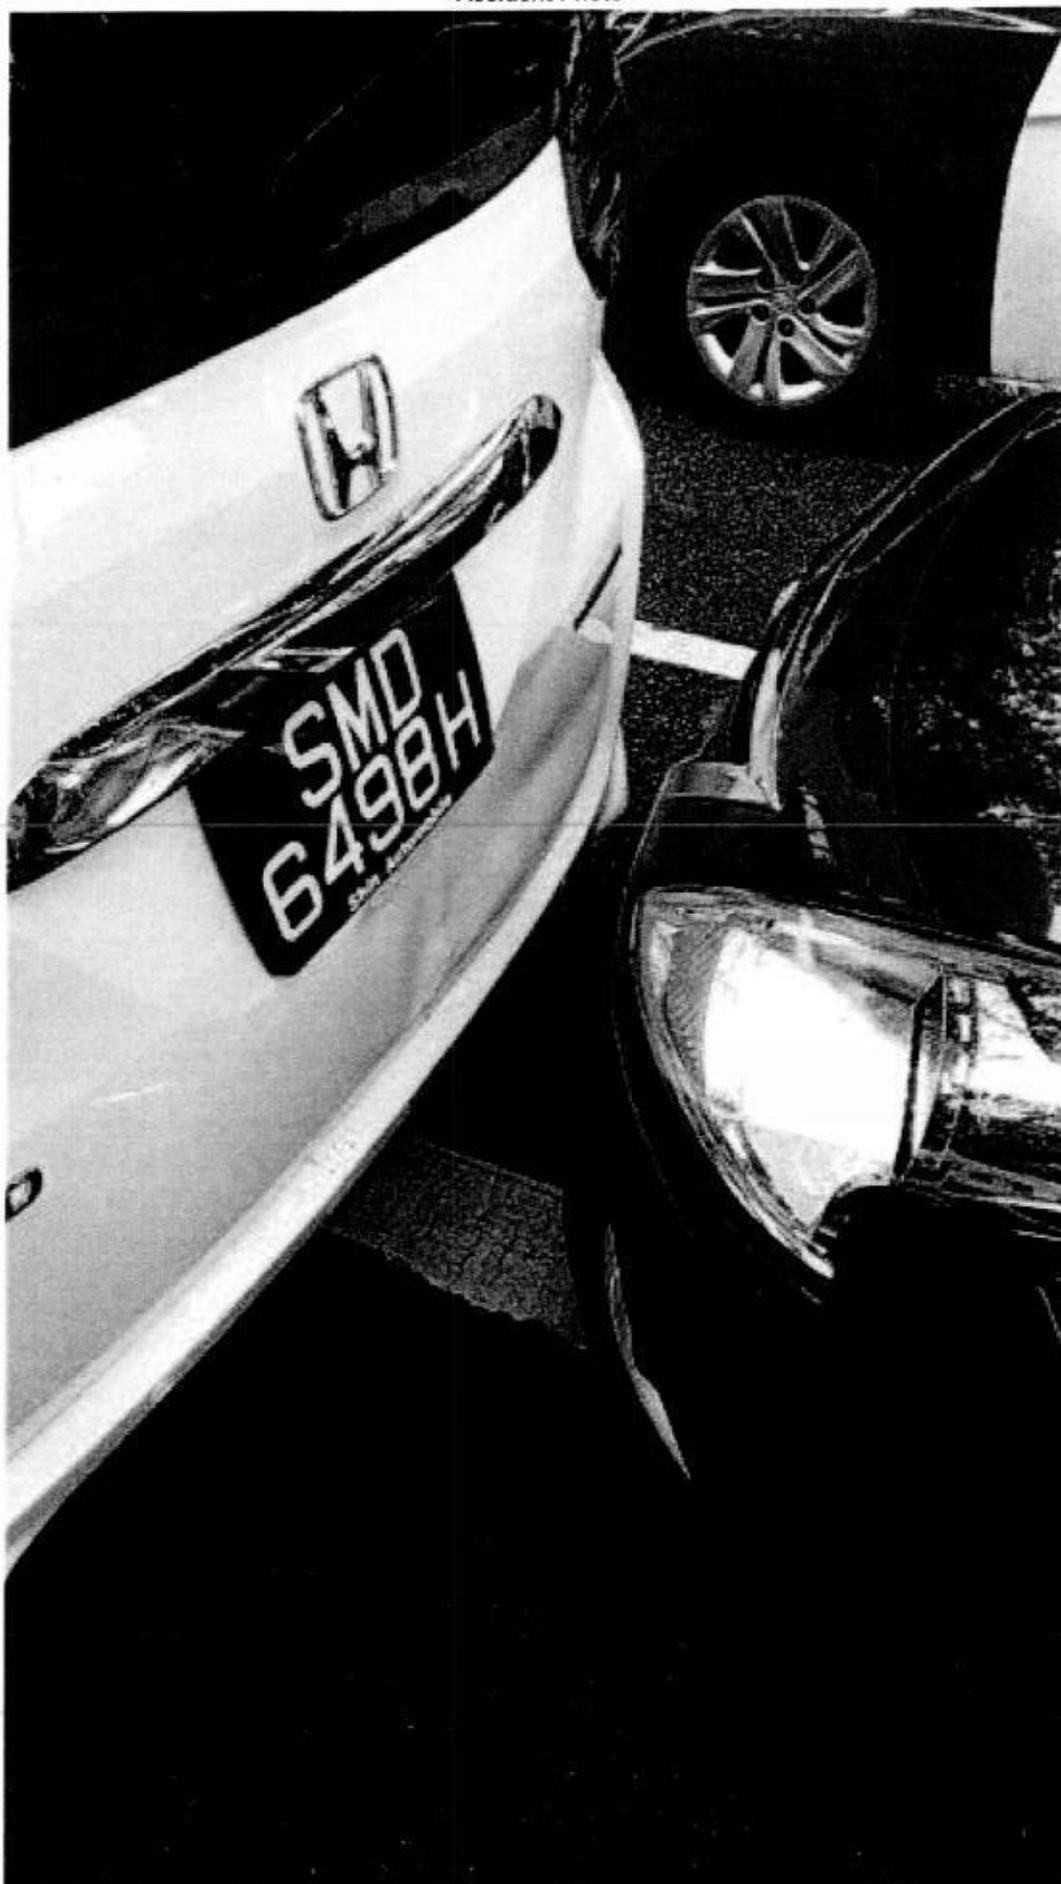
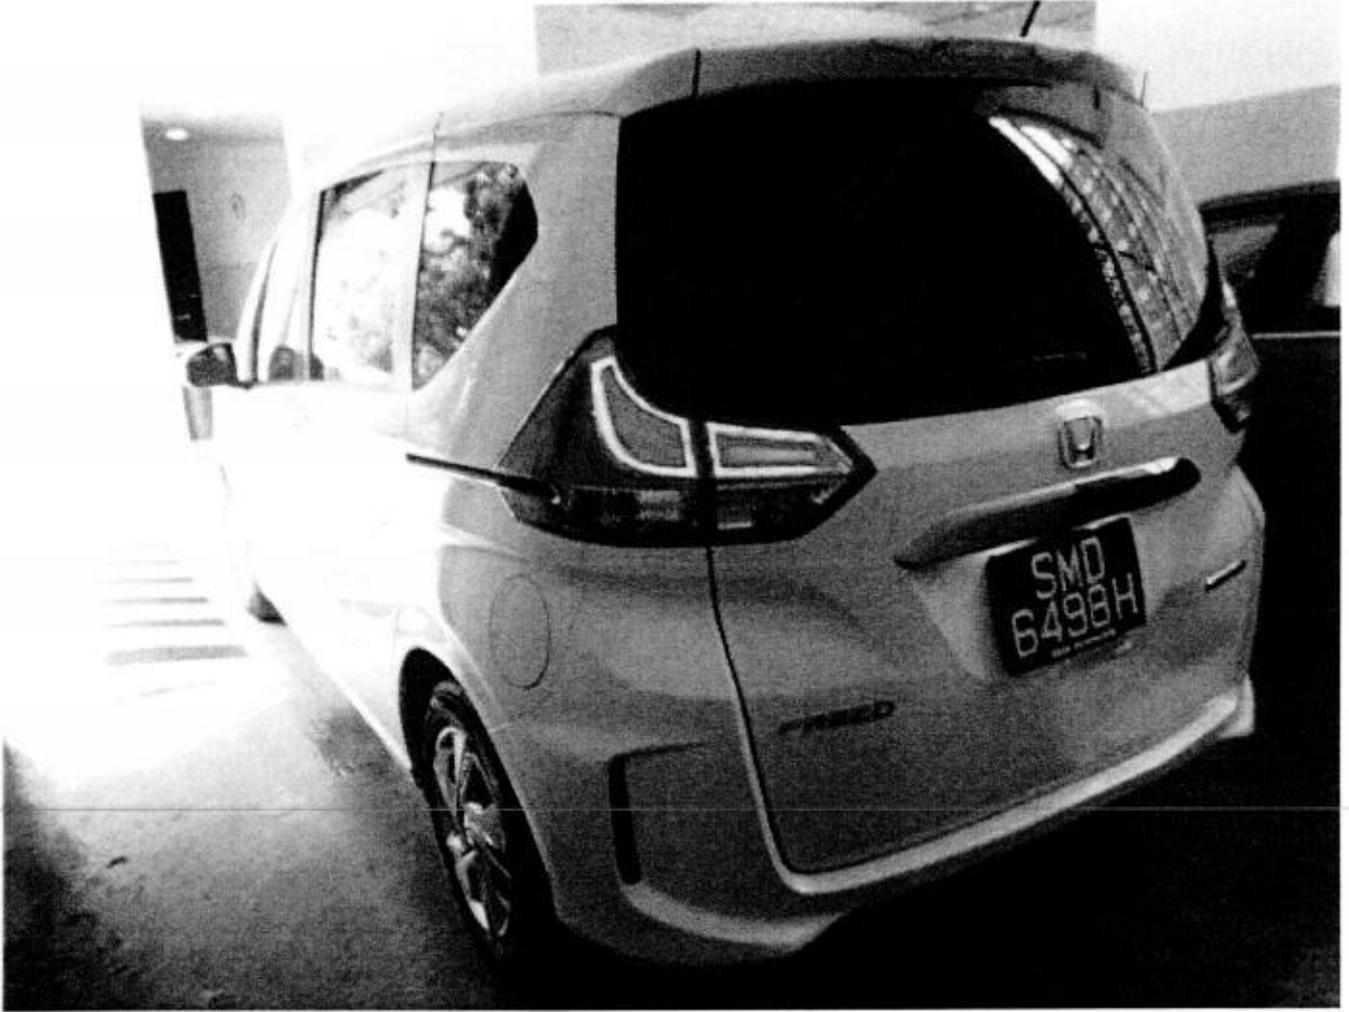
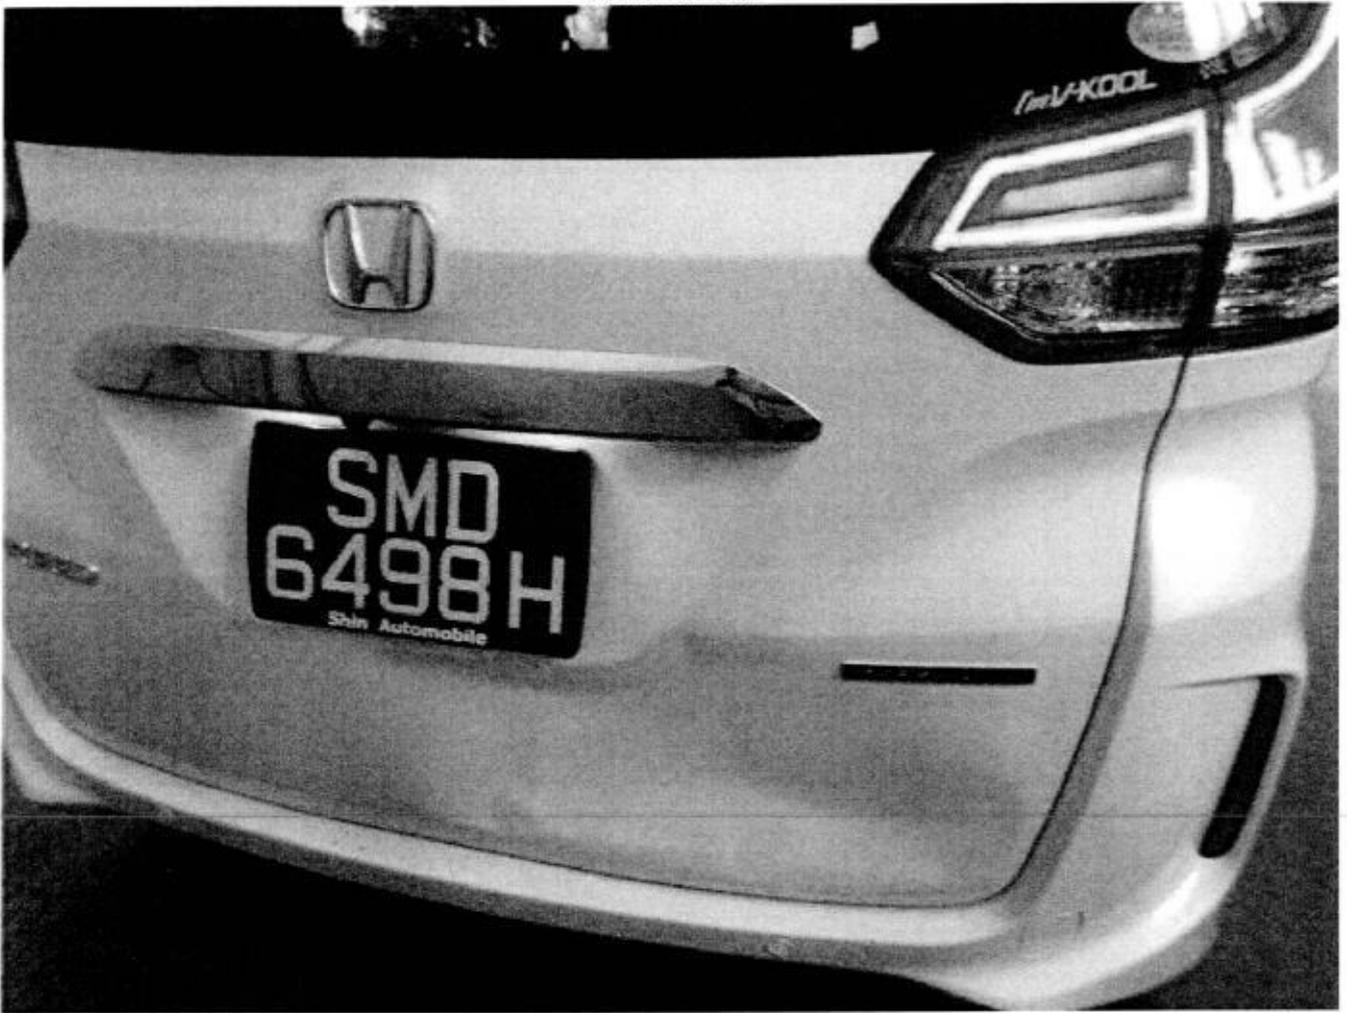
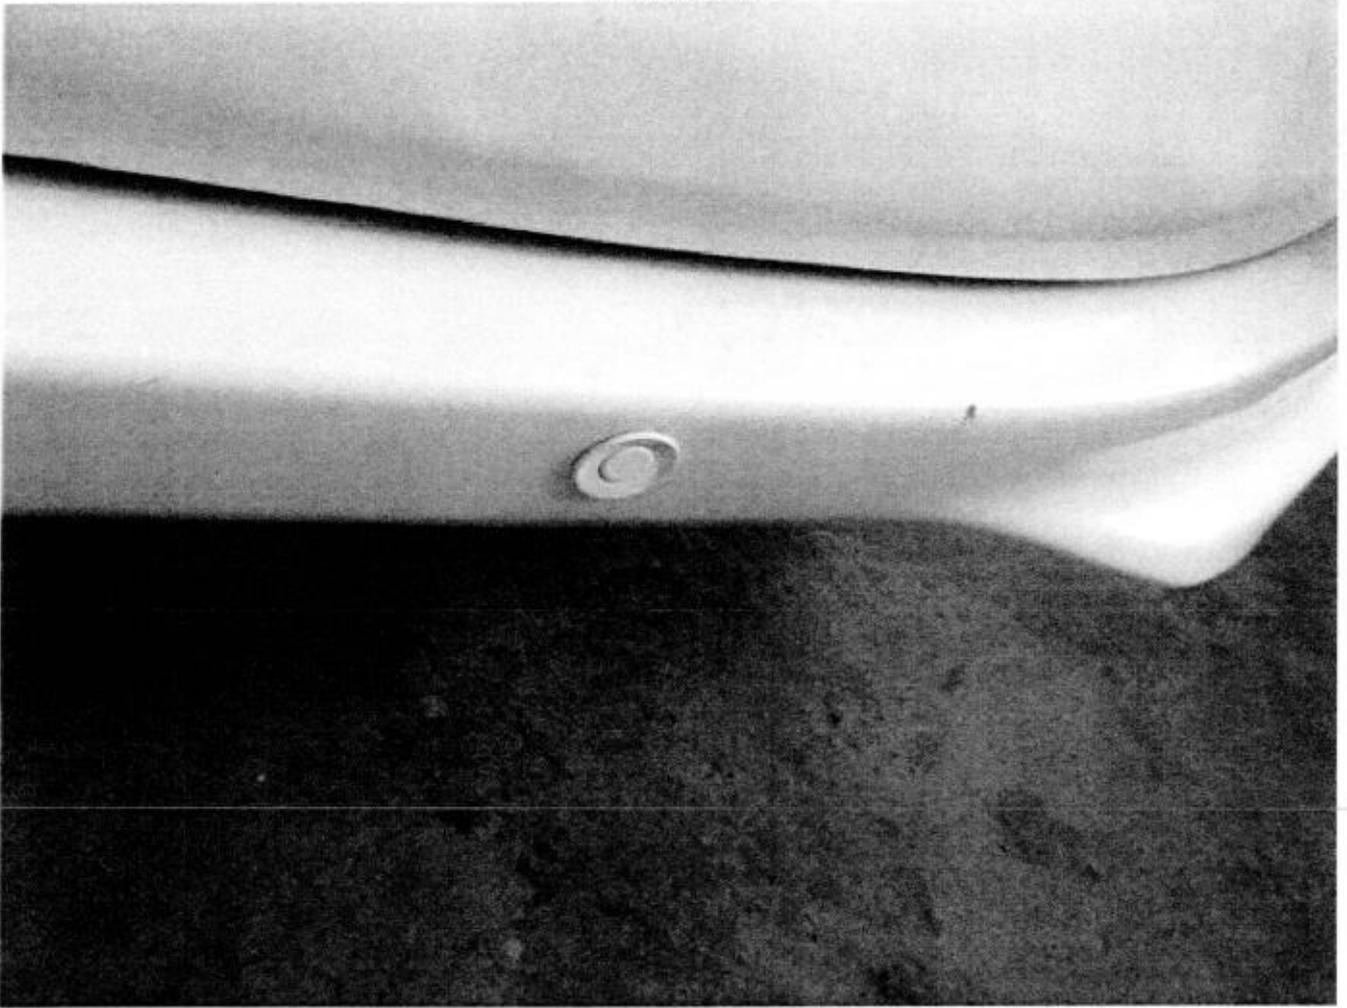
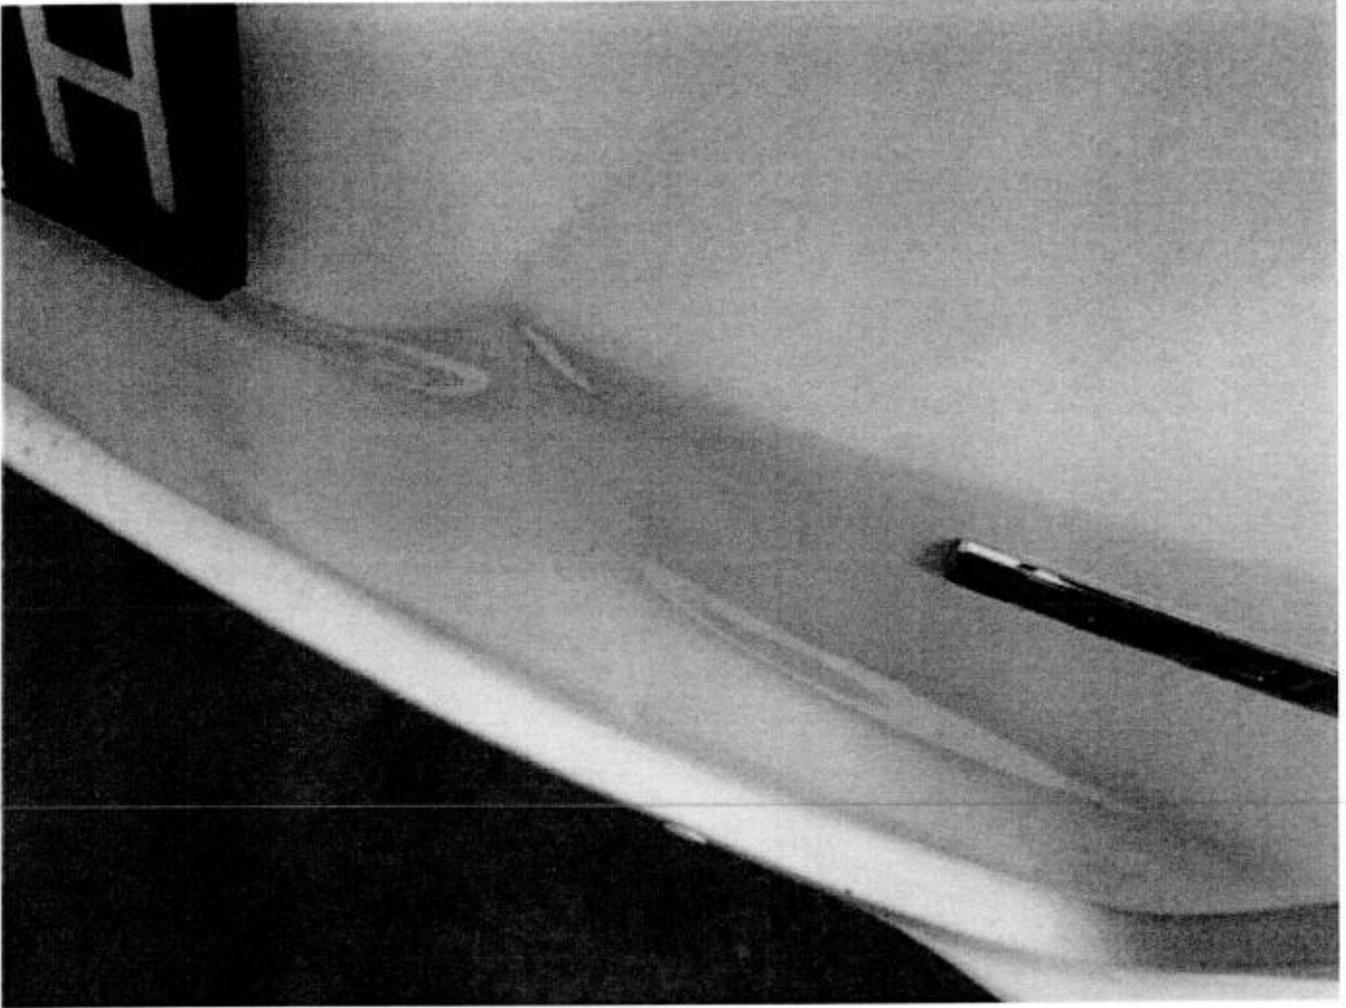
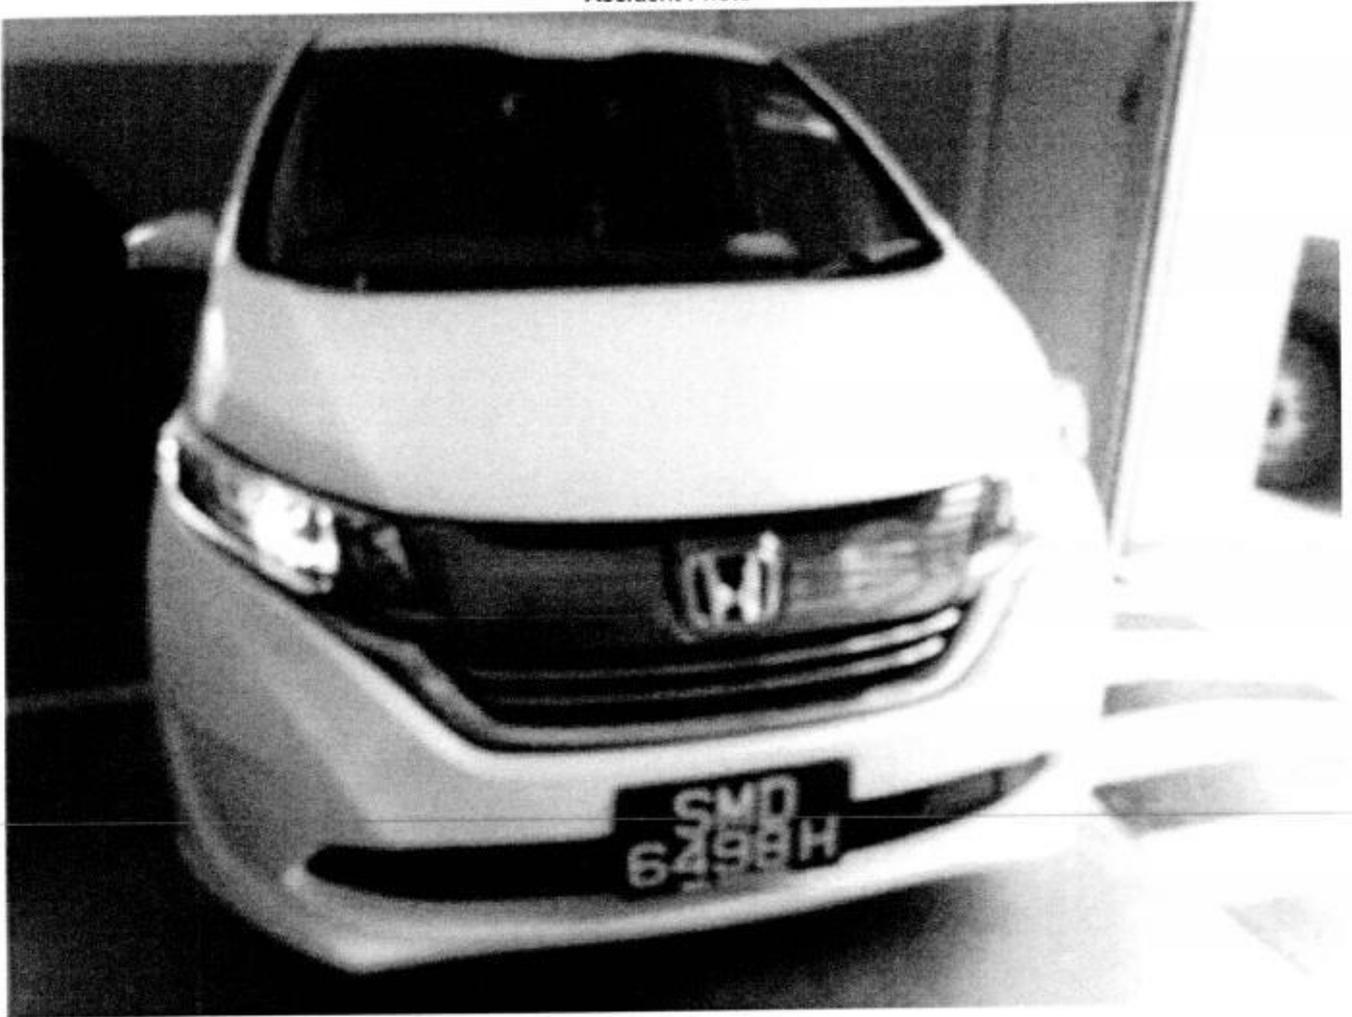
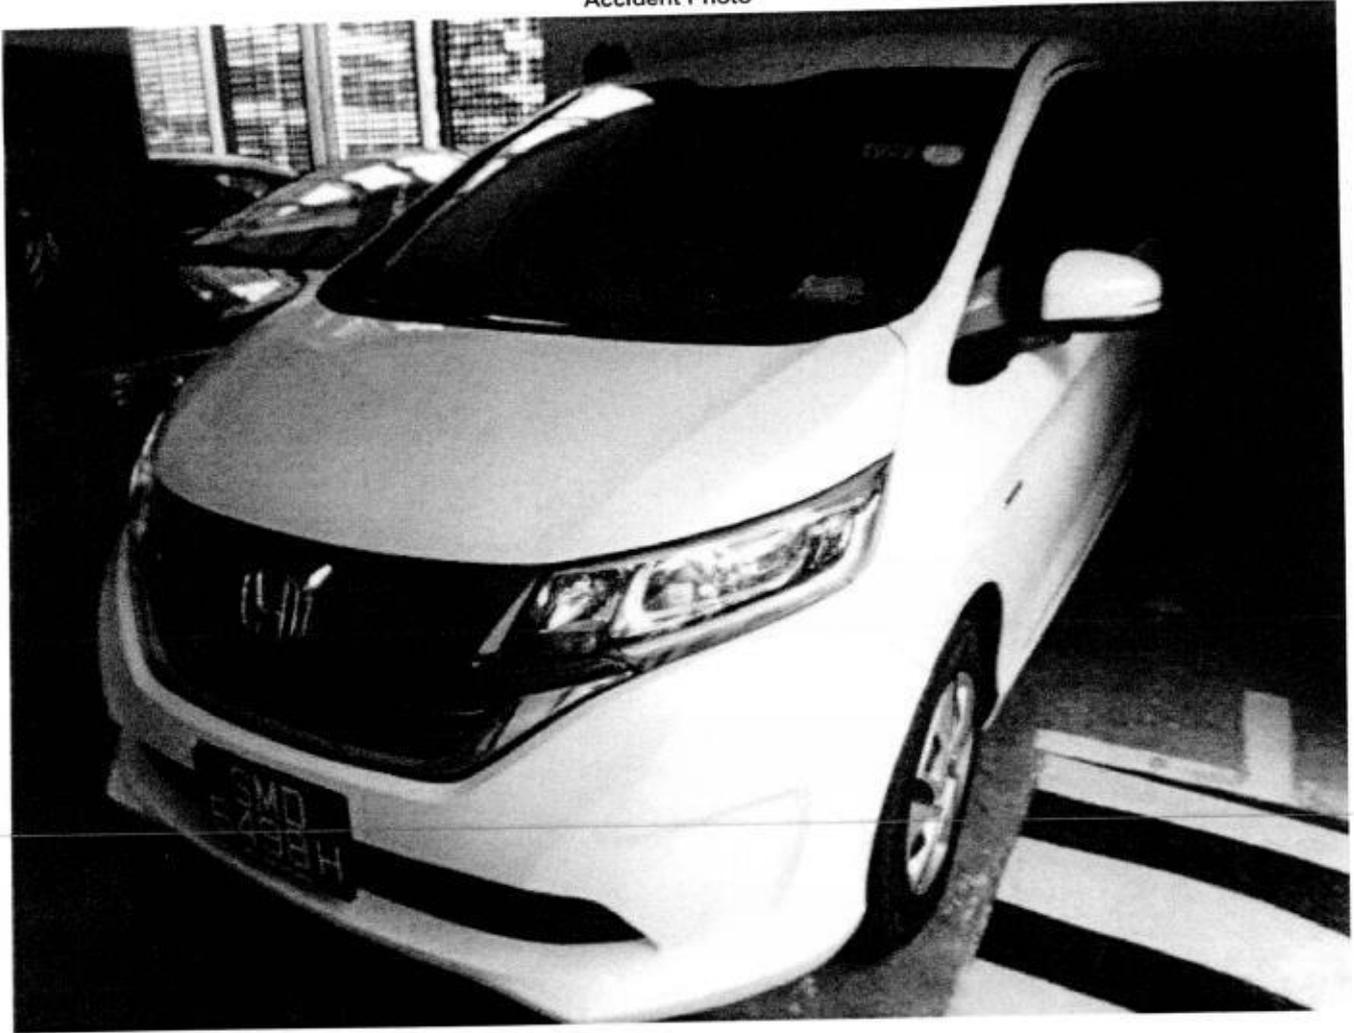
Accident Photo

The UIC / Chassis frame / Body Structure affected due to collision.

No.	Qty	Part No.	Particulars	Condition	Repairer's	Amount
1	1		*REAR BUMPER	Repair	0.00 F	*-F
2	1		*REVERSE SENSOR	Damaged	0.00 F	*-F
3	1		*REAR END PANEL	Repair	0.00 F	*-F
4	1		*REAR END PANEL TOP GARNISH	Cracked	0.00 F	*-F
5	1		*TAILGATE	Dented	0.00 F	*-F
6	3		*TAILGATE EMBLEM	Necessary	0.00 F	*-F
7	1		*TAILGATE GLASS MOULDING	Necessary	0.00 F	*-F
8	1		*TAILGATE GLASS SEALANT	Necessary	0.00 F	*-F
9	1		*TAILGATE LOCK	Bent	0.00 F	*-F
10	1		*TAILGATE INNER BOARD	Bent	0.00 F	*-F
