RE: Pre-Repair Inspection for SMA1937G Accident on 9 September 2018 at 12.50pm Along Elias Road Exit to TPE involving vehicle no: SKE9046C

VEHICLE DAMAGE INSPECTION REPORT

Our File No: CS/MSG18016626/R1RD3E2
Date: 18/10/2018

Handling Insurer: MSIG Insurance (Singapore) Pte. Ltd.	Policy No:	27311314SVP
Claimant Vehicle No : SMA1937G	Insured Vehicle No :	SKE9046C
Date of Loss: 09/09/2018	Nature of Claim:	TP
		Claim No: 569826

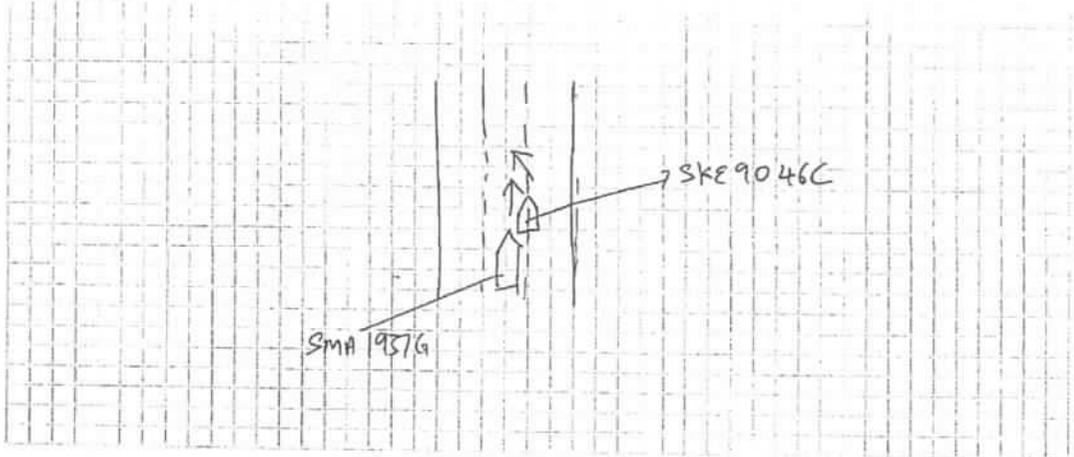
SKETCH PLAN

EXITING ~~SAHS~~ ^{ELATS} ROAD TO TPE. WHILE I HAVE COMPLETE CHANGE LANE AFTER EXIT, SKE 9046C SPEED UP BEHIND AND TRY TO CUT IN FRONT BY SWAYING INTO MY LANE HIT MY FRONT RIGHT TIRE.

I HAVE VIDEO ~~CHANGING~~ CAPTURING FROM EXIT TO IMPACT.
