ASSIGNMENT (Office)

G8H 3430G

| ACCIDENT STATEMENT | |
|--|---|
| Model | T6 VAN TDI NWB 110 (DSG) WGDR |

VEHICLE DAMAGE INSPECTION REPORT

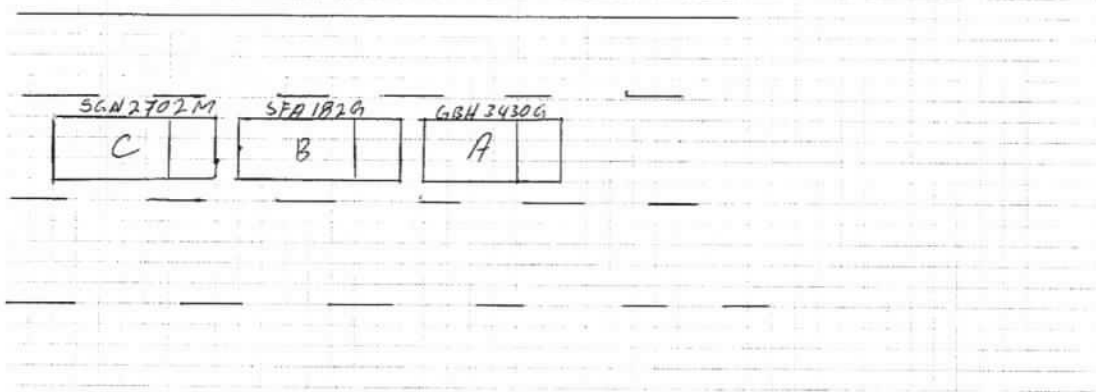
SKETCH PLAN

On 11/07/2018 at 4.54pm, before Hidy Rd traffic light, I stopped at before traffic light due to red light, while I stationary I feel a huge impact from behind.
