From: gary.ng@crawford.com.sg
Sent: Friday, 14 September, 2018 10:57 AM
To: assignments@lkkauto.com
Subject: Re: Our Principal : AXA Insurance Pte Ltd - Window dislodged and hit onto vehicle SLP1044R on 07/09/2018

SINGAPORE ACCIDENT STATEMENT

ADJUSTMENT ON REPAIR COST FOR VEHICLE NO. SLP 1044R

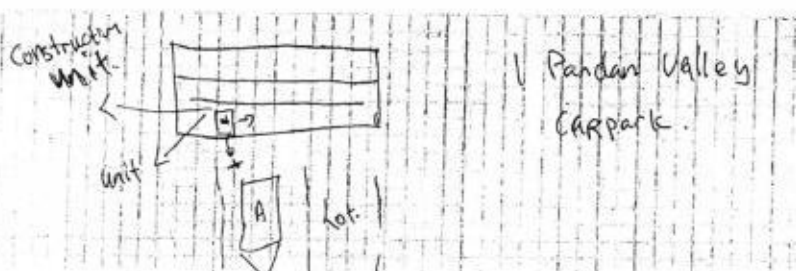
Policyholder's Signature / Date & Time	Driver's Signature (If driver is not the policyholder) / Date & Time	Witnessed by Reporting Centre Personnel
Sketch Plan

<p>Vehicle No <u>SLP 1044R</u></p>	<p>Amber E</p>
<p>Describe Circumstances of the Accident</p> <ul style="list-style-type: none"> • Car was parked at 1 Pandan valley Carpark. • Construction work was ongoing at #06-104 directly above car. • Toilet window was dropped & smashed the car windshield & roof. • Construction company (Bounty Design Pte Ltd) willing to pay for all damages. • No one was injured. 	
<div style="border: 1px solid black; padding: 5px; width: fit-content;"> <p>You had been advised by the workshop that in the event that you wish to claim against your own policy (OD claim), there is a <u>Fourteen (14) days clause</u> whereby the claim must be made within the stipulated timeframe from the day of occurrence.</p> </div>	
<p>Declaration</p> <p>We declare the foregoing particulars are true in every respect.</p>
