## VEHICLE DAMAGE INSPECTION REPORT

Our File No: CS/CTI18016808/KRBN2

Handling Insurer:	China Taiping Insurance (Singapore) Pte. Ltd.	Policy No:	DMCVSN3036161800
Claimant Vehicle No :	SGT877Z	Insured Vehicle No :	GBD5468G
Date of Loss:	11/09/2018	Nature of Claim:	TP
		Claim No:	SNM18D04403C02

Reg No:	SGT877Z	Engine No:	LEB5948243
Make & Model:	HONDA VEZEL, 1.5 X HYBRID CVT (A)	Chassis No:	RU31248227
Reg. Date:	06/12/2017 (Man. Year: 2017)	Odometer:	18014 km
Colour:	Metallic Blue		
Engine Capacity:	1496 cc		
Market Value/New Car Price:	N/A		
Sum Insured (S\$):	Market Value/New Car Price

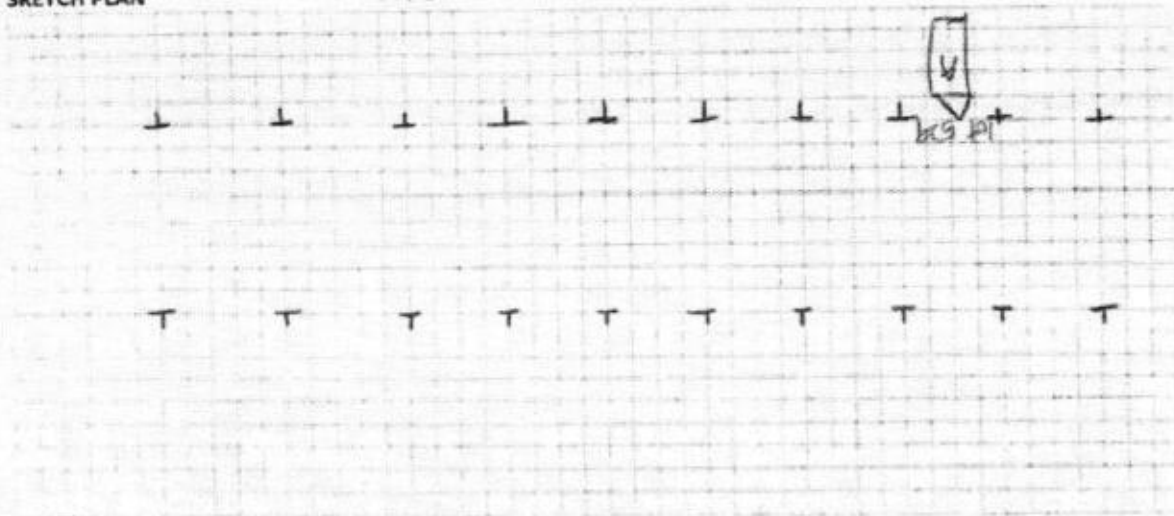
## SKETCH PLAN

## DESCRIBE CIRCUMSTANCES OF THE ACCIDENT

I went home at 11:30am and parked my car behind block 214  
 On 11/Sept/2018 at Lot 529. At 1:16pm I <sup>went</sup> to my car and  
 saw a note left there claiming that he had bumped my car and left  
 contact details. I called him and he claimed that his dad accidentally  
 bump hit my car and we both agree to also report to the  
 insurance
