## VEHICLE DAMAGE INSPECTION REPORT

Our File No: CS/CTI18016813/GQBN2

Handling Insurer:	China Taiping Insurance (Singapore) Pte. Ltd.	Policy No:	DMB1SN1725681801
Claimant Vehicle No :	SGE256U	Insured Vehicle No :	CB6343A
Date of Loss:	11/09/2018	Nature of Claim:	TP
		Claim No:	SNM18D04400C02

Reg No:	SGE256U	Engine No:	6ARP121136
Make & Model:	TOYOTA CAMRY, 2.0 (A)	Chassis No:	MR053DK5100105431
Reg. Date:	01/03/2016 (Man. Year: 2015)	Odometer:	82344 km
Colour:	Black		
Engine Capacity:	1998 cc		
Market Value/New Car Price:	N/A		
Sum Insured (S\$):	Market Value/New Car Price

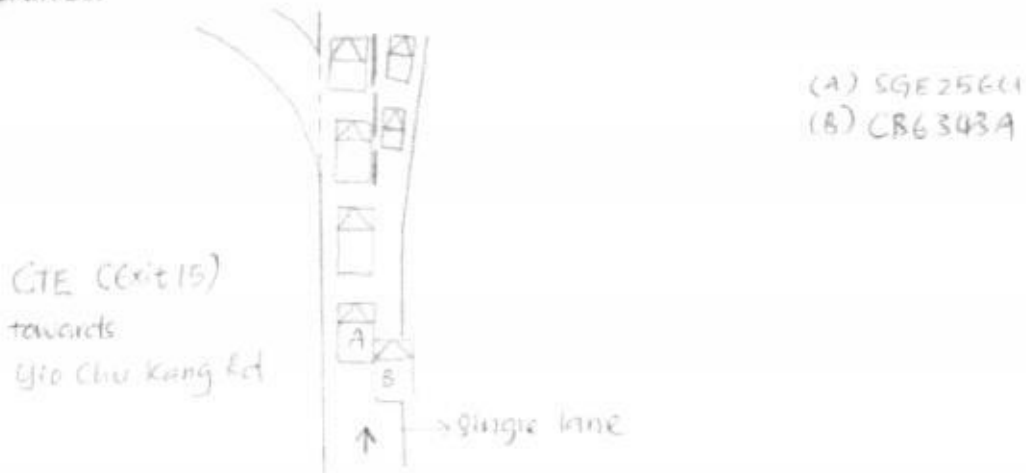
## SKETCH PLAN

On 11/9/2018 at about 9.01am, I was exiting CTE towards Yio Chu Kang Road (Exit 15). There is a single lane and heavy traffic. I was queuing to exit the lane. Suddenly, I heard a bang sound and realised a van (B) CB 6343A squeeze into my right lane (single lane). I stuck inside my vehicle due to the van (B) CB 6343A blocked my door. Therefore, I move my car (A) SGE256U to the left and alight from my car. No one was injured.
