Affiliated to Federation Internationale Des Experts En Automobile			
TRANS-CAB AUTO SERVICES PTE LTD		Ref : CS/TP18017042/Krbn2	
NO.2 ANG MO KIO STREET 63SINGAPORE 569111		Date : 25-10-2018

1. Policy Particulars :- THIRD PARTY CLAIM			
Insured Veh.		Veh. Inspected	SHB 7987B
Policy No.		Coverage (\$)	0.00
Claim No.		Excess (\$)	0.00
Assign From		Assign Date	17/09/2018

4. Description of Damages			
THE VEHICLE SUSTAINED DAMAGES AT THE N/S BODY. DAMAGES SEE DETAILS.			
5. General Information			
Accident Date	14/09/2018	Inspection Date	17/09/2018
Survey held at	TRANS-CAB AUTO SERVICES PTE LTD NO.2 ANG MO KIO ST 63 SINGAPORE 569111		
5a. Remarks			
A)THE INSPECTION WAS CONDUCTED ON A"WITHOUT PREJUDICE" BASIS. B)IN ACCORDANCE TO YOUR INSTRUCTIONS, WE HAVE NOT AUTHORISED REPAIRS.			
5b. Estimate Days of Repair			
ESTIMATED NORMAL PERIOD FOR REPAIR:		5 Working Days

## ADJUSTMENT ON REPAIR COST FOR VEHICLE NO. SHB 7987B

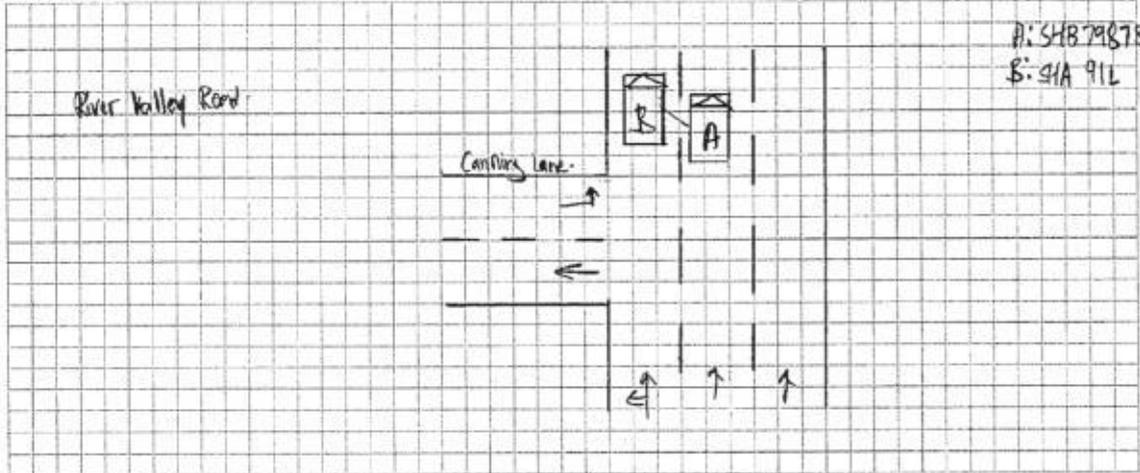
SKETCH PLAN

ON 14/09/18 AT ABOUT 0200HRS I WAS TRAVELLING STRAIGHT ALONG THE SECOND LANE OF RIVER VALLEY ROAD. SUDDENLY I FELT AND IMPACT FROM THE LEFT SIDE OF MY TAXI, THE PASSENGER OF VEHICLE B(SHA91L) DID NOT CHECK FOR ONCOMING VEHICLES AND OPENED THE DOOR AND HIT ONTO MY TAXI'S LEFT SIDE PORTION.
