Ref : CS/TP18017070/Uvd3n2

4. Description of Damages

THE VEHICLE SUSTAINED DAMAGES AT THE N/S FRONT PORTION. DAMAGES SEE DETAILS.

ADJUSTMENT ON REPAIR COST FOR VEHICLE NO. GBE 1769J

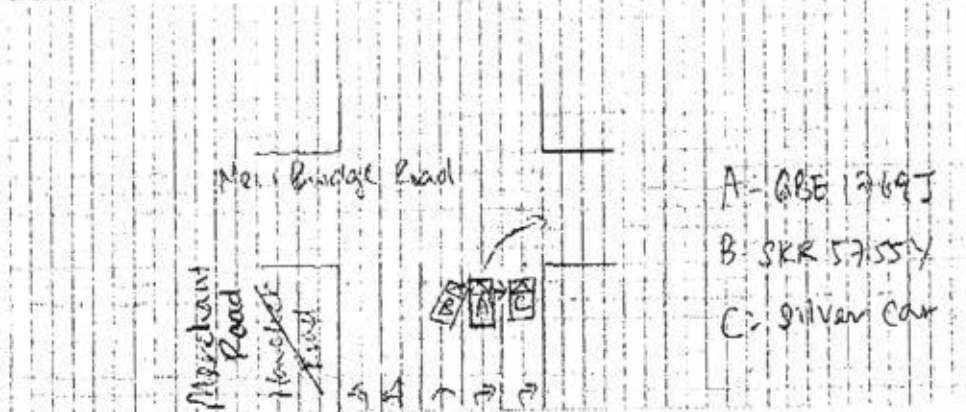
SKETCH PLAN

At 9:20am on 28th August 2018 along ~~Merchant Road~~ 'T' junction
 Turning Right towards New Bridge Road while all vehicles were about
 to take off as the traffic light turn green. CAR B that was on third
 lane turn/cut into second lane ^{very} (CAR A GBE 1769J) direction abruptly
 Thus hitting the front left of CAR A (GBE 1769J). THERE WAS AN
 EYE WITNESS when accident happened. Her name is Jamie (HP: 96453685)

- ① Location of Accident should be:
Junction of New Bridge Road and Merchant Road
- ② Enclosed witness statement.
- ③ I wish to state that there was another vehicle (Veh C) beside my vehicle, which was ^{lightly} touched by my vehicle wingmirror due to the impact from Veh B. However, Vehicle C driver did not express any intention to claim. (Amended sketch plan enclosed)
