**NOTICE OF ACCIDENT PURSUANT TO THE NIMA PROTOCOL
ACCIDENT AT T-JUNC OF PIONEER RD NORTH & JURONG WEST AVE 4
ON 04.06.18 INVOLVING YL9340A & SJZ3345E**

VEHICLE DAMAGE INSPECTION REPORT

Our File No: CS3/AIG18017307/GCD3S2
Date: 02/10/2018

Handling Insurer: AIG Asia Pacific Insurance Pte. Ltd. Policy No: 2100237127
Claimant Vehicle No : YL9340A **Insured Vehicle No :** SJZ3345E
Date of Loss: 04/06/2018 Nature of Claim: TP Claim No: 1199019187SG

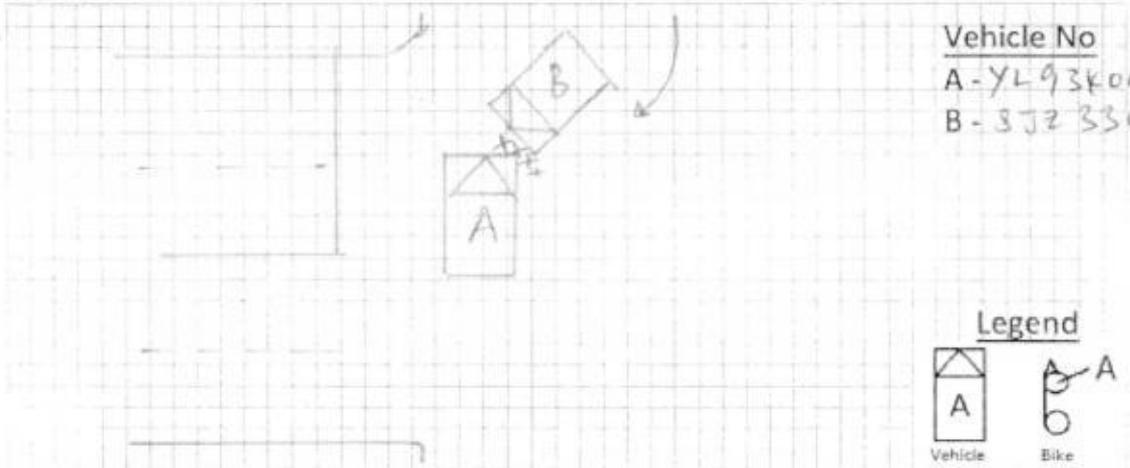
SKETCH PLAN

Vehicle No
 A - YL93K0A
 B - 3JZ 3345E

I come from Pioneer North Rd. toward to Pioneer Rd. Before toward Pioneer Rd. got traffic light function. My way that time is a green light. Then suddenly the car from the other side to turn right by the time green light for me I head then break I bang in front of the car.
