## ESTIMATE REPAIR BILL FOR KIA OPTIMA REGN NO: SHC 6025 D

## 1. Policy Particulars :- THIRD PARTY CLAIM

## **ACCIDENT INVOLVING SHC6025D, SHD6614Z & SHD242C ALONG CTE – CITY ON 28.09.18**

## VEHICLE DAMAGE INSPECTION REPORT

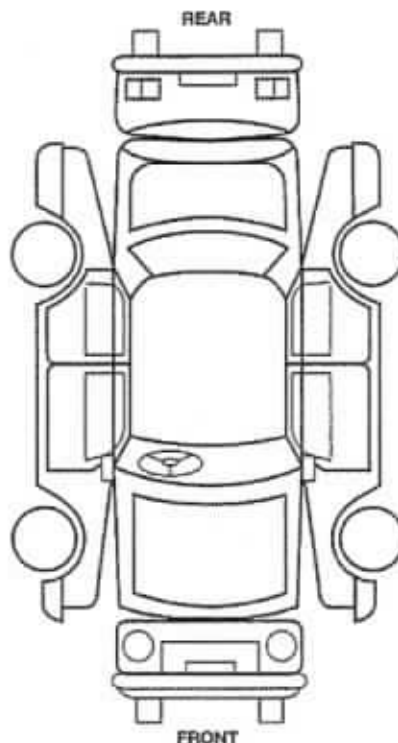
INDICATE AREA OF DAMAGE HERE:

1 - Light Dent  
2 - Serious Dent  
3 - Light Scratch  
4 - Serious Scratch5 - Damaged  
6 - Chip  
7 - Crack  
8 - Peeling
