The U/C / Chassis frame / Body Structure affected due to collision.

VEHICLE DAMAGE INSPECTION REPORT

Our File No: CS/CTI18017822/T1TD3E2

Date: 24/10/2018

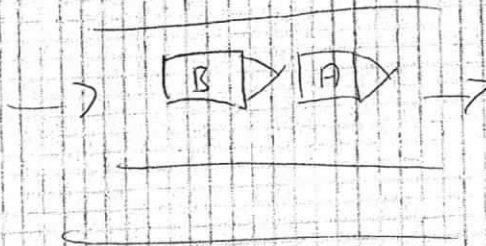
Sketch Plan

A = 28/A
 SLW 7714
 B = SLT 3258

Type Of Accident	COLLISION - HEAD TO REAR
Weather Conditions	CLEAR
Road Surface	DRY
