### Preliminary Advice

| Vehicle No | : XD7227L | Accident Date | : 15/09/2018 |
| Make | : AUDI A3 | Policy No. | : 0999994669 |

## VEHICLE DAMAGE INSPECTION REPORT

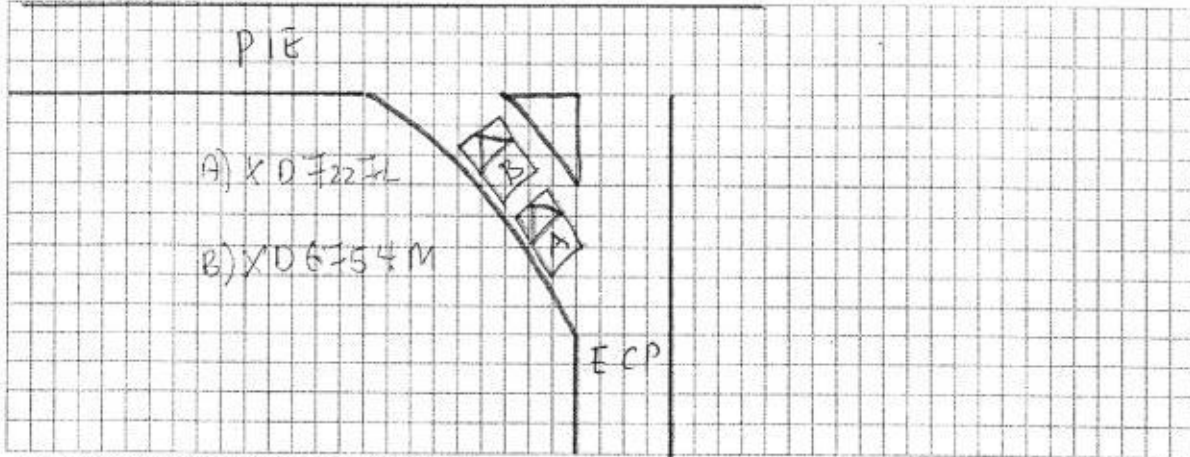
## SKETCH PLAN

On 15/09/2018, at around 2110hrs, I was making my way into PIE from ECP (Towards Airport) on my vehicle XD7227L. At I observed that the vehicle, a tipper truck in front me is some distance away, I accelerated my vehicle. However, as I was accelerating and getting closer to the tipper truck, I discovered that it had suddenly came to a stop. I tried to stop my vehicle, however, was to no avail. My vehicle collided on the rear of the front tipper truck(XD6754M). I alighted to make a check and discovered that the tipper truck in front of mine have collided to another car (SJD9672L). I went to the grass patch and sit down as I suffered abrasion on both of my knee, and I was bleeding on the knee and from the nose. After awhile, the ambulance arrived and I was informed that I need to be conveyed to hospital. Traffic police arrived and I handed over my particulars. Subsequently, I was conveyed by ambulance.
