## VEHICLE DAMAGE INSPECTION REPORT

Our File No: CS/CT118018078/GCD3N2

| Claimant Vehicle No : | SLN3024X | Insured Vehicle No : | GBC5078D |

| Make & Model: | HONDA SHUTTLE, 1.5 G CVT ABS (A) | Chassis No: | GK81006541 |

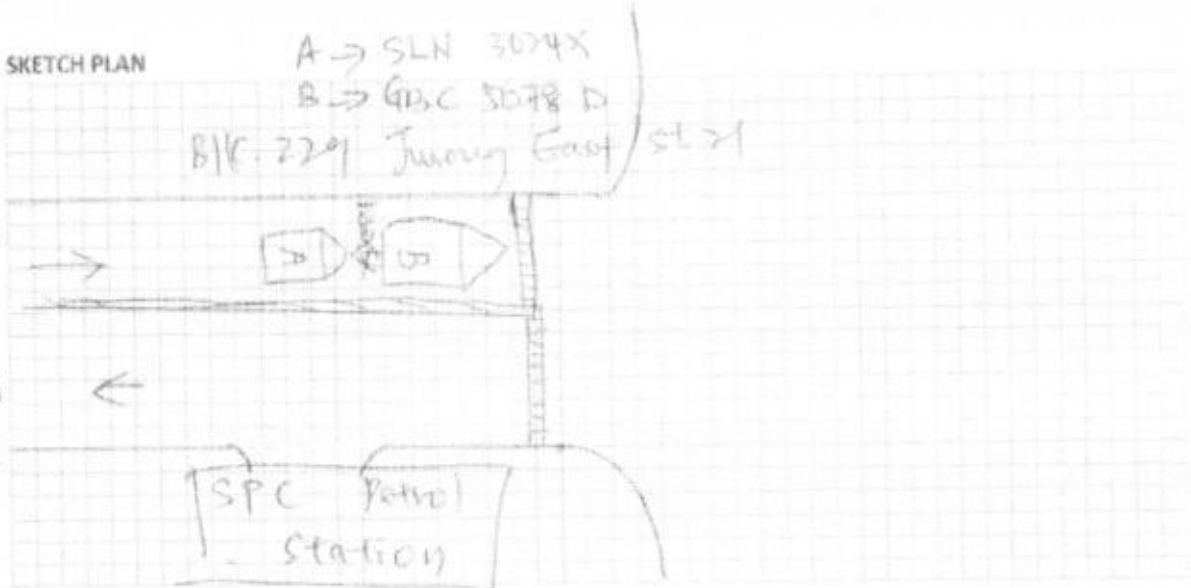
## SKETCH PLAN

On 2/10/18 @ 19.05 hours, I was stationary at the gateway of the carpark, the veh. B (GBC 5078D) suddenly reverse without checking and hit onto my front portion of my vehicle.
