**ACCIDENT INVOLVING SJN2722U AND GBH4070E ALONG DUNEARN ROAD TOWARDS UPPER  
BUKIT TIMAH ON 3 OCT 2018**

### VEHICLE DAMAGE INSPECTION REPORT

**Our File No:** CC4/AIG18018113/UJA3Q2  
**Date:** 17/06/2019

Handling Insurer: AIG Asia Pacific Insurance Pte. Ltd.	Policy No:	1800056010
<b>Claimant Vehicle No :</b> SJN2722U	<b>Insured Vehicle No :</b>	GBH4070E
Date of Loss: 03/10/2018	Nature of Claim:	TP
		Claim No: 5983354298SG

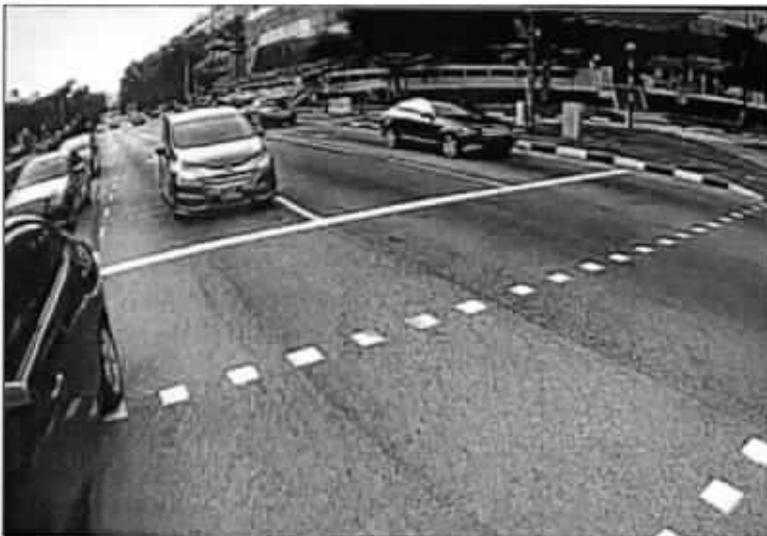
From insured's video, it can be observed that TP vehicle encroached lane.

We have reviewed the matter and noticed that your client had encroached into our insured's lane.

Please see screen shot below and attached video.

We regret to inform you that based on the evidence available, your client encroaching lane is more to be blamed for the accident.

In view of this, we have our principal's instruction to deny liability.
