## Preliminary Advice

Insured Vehicle No	: SJN860S	Accident Date	: 02/10/2018
TP Vehicle No	: SHD1177B	Assignment Date	: 05/10/2018
Make	: KIA OPTIMA	Est. Duration of Repair	: 2.00
Date of Inspection	: 17/10/2018		
Inspection At	: PREMIER TAXIS PTE LTD - CHANGI (HQ) 23 CHANGI SOUTH AVE 2 #03-02 SINGAPORE 486443

## VEHICLE DAMAGE INSPECTION REPORT

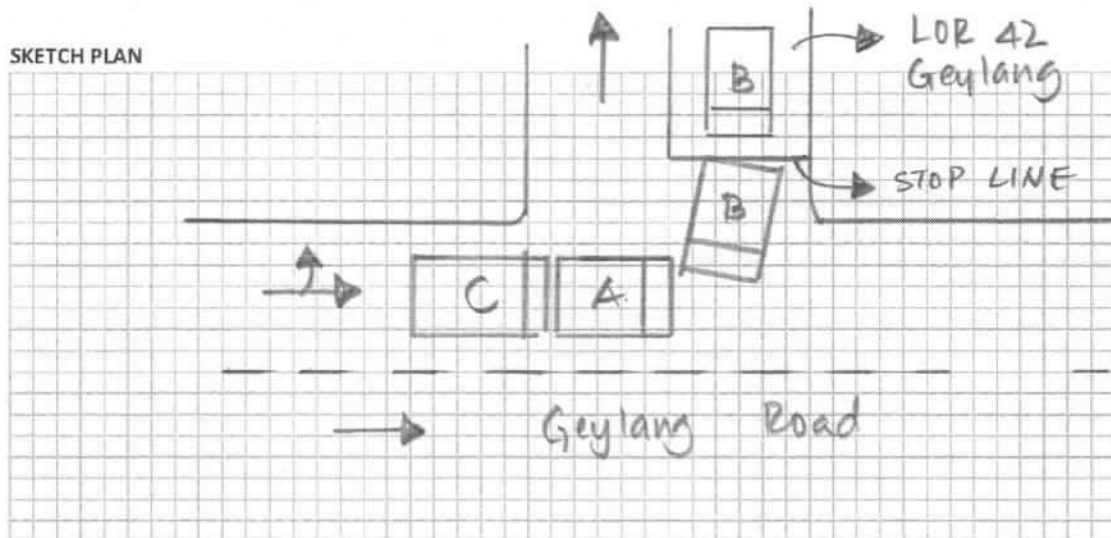
### SKETCH PLAN

**\* CHAIN COLLISION \***

ON 02/10/2018 @ 0540 HRS, I WAS DRIVING MY TAXI ( SHD1177 B )  
TRAVELLING ALONG GEYLANG ROAD IN THE EXTREME LEFT LANE.

WHILE I WAS MOVING STRAIGHT AHEAD – WITHIN MY LANE, SUDDENLY VEHICLE B  
( SJN 860S – KIA ) WHICH WAS EXITING FROM LOR 42 GEYLANG (ON MY LEFT) –  
FAILED TO KEEP FOR PROPER LOOK OUT, FAILED TO STOP AT THE STOP LINE &  
FAILED TO GIVE WAY TO ONCOMING VEHICLES FROM MY ROUTE – HAD MOVED OFF  
AHEAD & ENCROACHED ONTO MY PATH ON MY FRONT LEFT ABRUTPLY.

AS SUCH, THE FRONT RIGHT PORTION OF VEHICLE B COLLIDED ONTO THE FRONT  
LEFT PORTION OF MY TAXI – WHILE HE WAS MOVING OFF/TURNING INTO GEYLANG  
ROAD AND SUBSEQUENTLY I FELT AN IMPACT FROM THE REAR.

WHEN INSPECTED, I DISCOVERED THAT VEHICLE C ( GBD 6098 J – NISSAN  
VAN ) WHICH WAS BEHIND ME, HAD COLLIDED ONTO THE REAR OF MY TAXI.

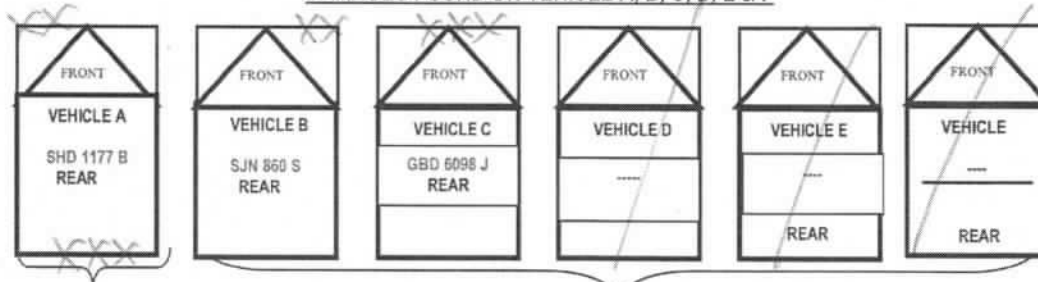
## DAMAGES FOUND ON VEHICLE A, B, C, D, E &amp; F

DUE TO THE IMPACT, MY TAXI HAD DAMAGES ON THE FRONT LEFT PORTION & THE  
REAR PORTION. VEHICLE B HAD DAMAGES ON THE FRONT RIGHT PORTION AND  
VEHICLE C HAD DAMAGES ON THE REAR PORTION.

PREMIER TAXI

THIRD PARTY VEHICLES

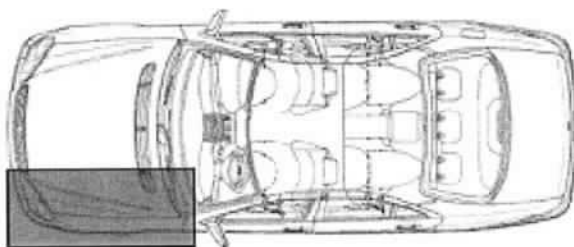
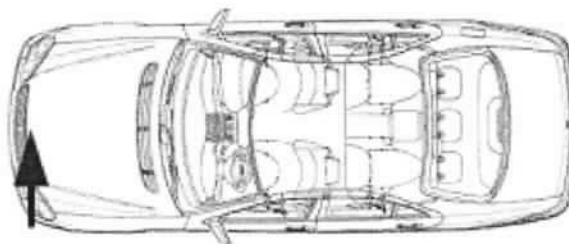
The vehicle sustained impact / damages front n/s portion and parts claimed are consistent to the accident.

Guide Number Repair Details  
 0283 REPAIR FRONT BUMPER

WU	Cost Price (\$)
0283 REPAIR FRONT BUMPER	20.0*	100.00
<b>LABOUR COST</b>		
Total Work Units	20.0	
Corrosion Protection External Labour	0.0HRS	0.00
Corrosion Protection Internal Labour	0.0HRS	0.00
Sub Total	2.0HRS	\$100.00
Paint Labour	4.1HRS	\$205.00
Total Labour	6.1HRS	\$305.00
