- PRE-REPAIR INSPECTION - ACCIDENT INVOLVING OUR INSURED VEHICLE SLE8128U AND SLH7759P ON 03/10/2018

Vehicle No: **SLH 7759P**

VEHICLE DAMAGE INSPECTION REPORT

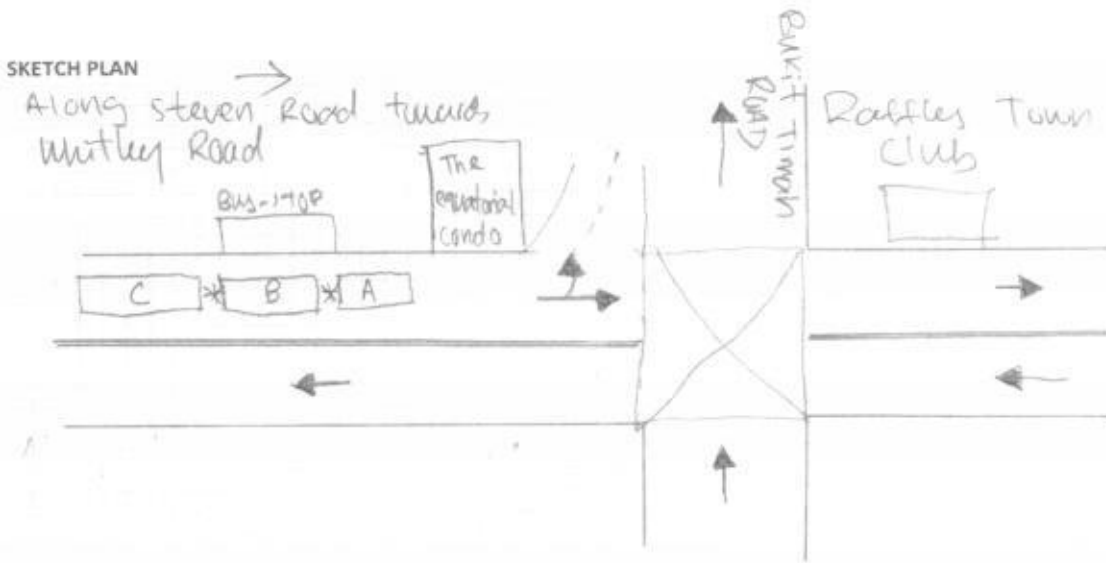
Sketch Plan #4 Pg. 1

I was driving SLH7759P along Steven Rd towards Whitley Rd at abt 7:16pm. At the point of time, my vehicle was stopped at the traffic light is red. While I was waiting for traffic light to turn green, suddenly a vehicle C - SLE 8128U ramped to the rear of my vehicle. As the bang was very impactful, my vehicle was pushed toward vehicle A SMD 2737 U and hit on its bumper.
