Preliminary Advice

Vehicle No	: SLM594S	Accident Date	: 03/10/2018
Make	: AUDI A1	Policy No.	: 2100504230
Assignment Date	: 09/10/2018	Excess	: S\$300.00
Date of Inspection	: 08/10/2018	Est. Duration of Repair	: 24.00
Inspection At	: PREMIUM AUTOMOBILES PTE LTD (UBI) 55 UBI ROAD 1 SINGAPORE 408699

VEHICLE DAMAGE INSPECTION REPORT

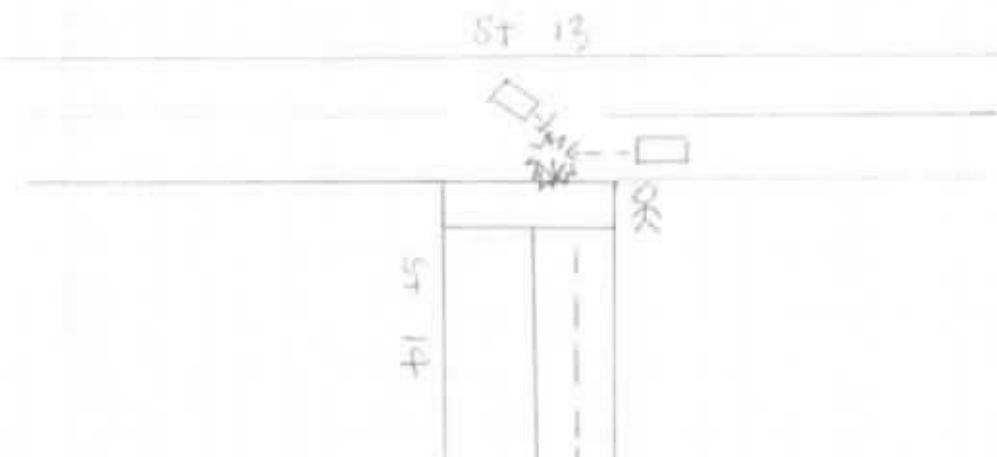
Sketch Plan #2

DESCRIBE CIRCUMSTANCES OF THE ACCIDENT

As I stopped at the T-junction turning into St 14, the traffic light was green but the car did not move off immediately. There was a pedestrian approaching the traffic lights to cross the road, I had the impression that the car did not move cos he was waiting for the pedestrian to cross the road so I went ahead to turn right. As I turned, the car proceeded to move and hit my car.

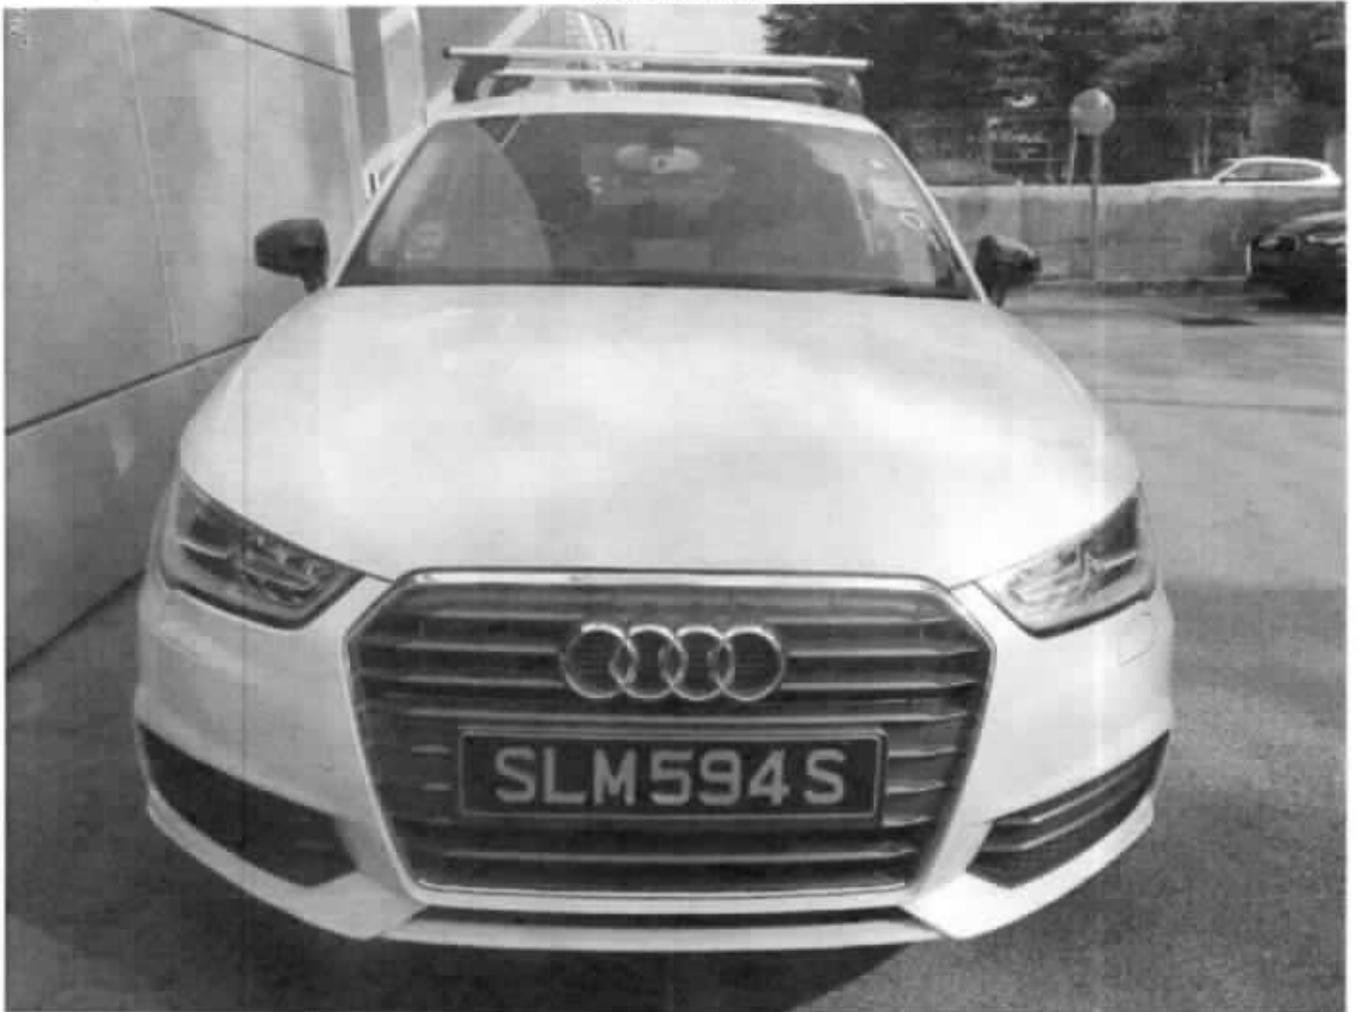
Accident Photo

The vehicle sustained impact / damages n/s body and parts claimed are consistent to the accident.

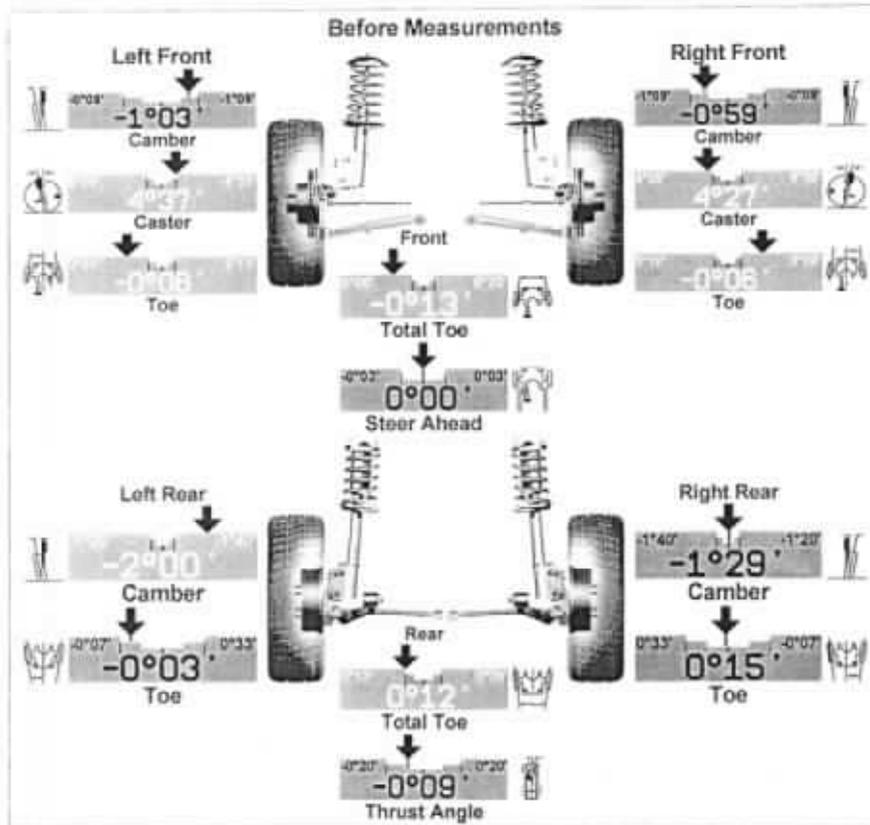
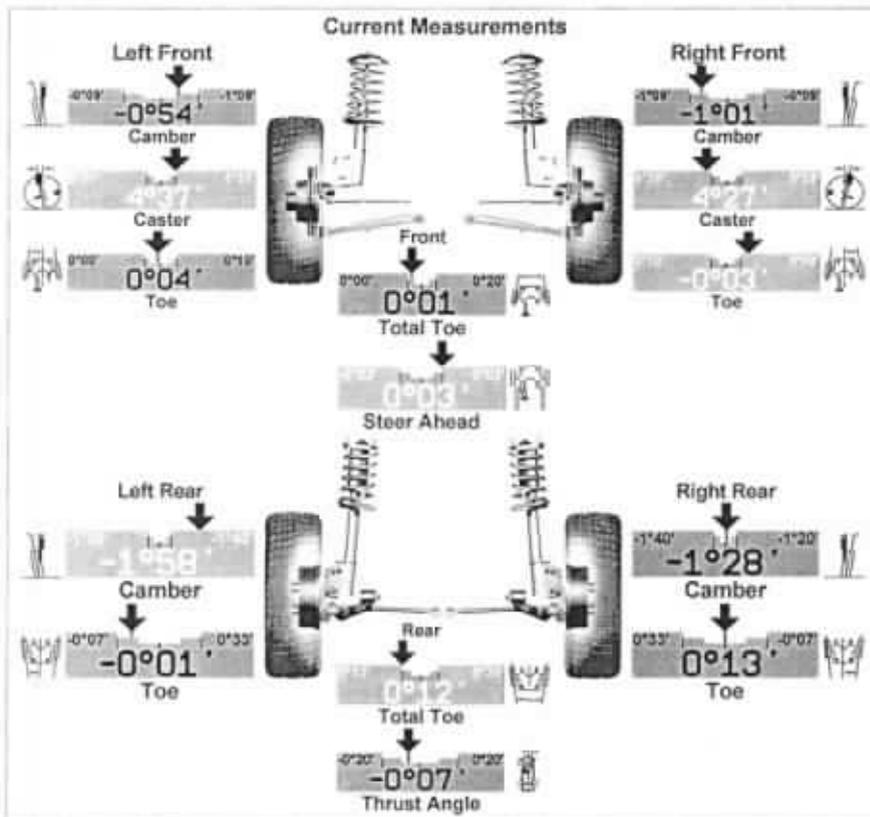
Audi : A1 : Standard Suspension (G22 G23) : 2011- (8X)

Technician: WAY
Mileage: SLM549S
Date: 28396
Time: 11.10.18 10:36
