## VEHICLE DAMAGE INSPECTION REPORT

Our File No: CC3/TMI18018236/K1TBE2

Reg No: SHA7070B

Make &amp; Model: HYUNDAI SONATA, 2.0 CRDI (A)

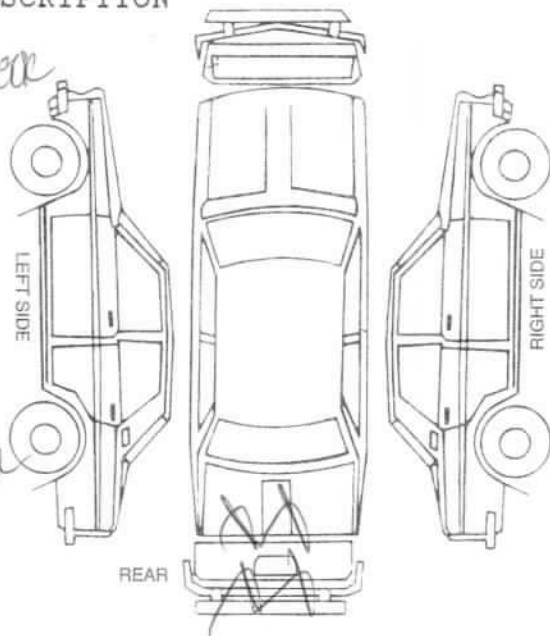
*Front View*

Remark: The veh had commenced its  
repair at the time of inspection.

ON 6-10-18 Q 2120hr, I was driving My taxi along Serangoon Rd toward PIE Tda Payoh and stop at Slip Road to check Oncoming traffic from right.  
Suddenly Vehicle (B) SMA5539X hit my taxi On the rear portion Cause damage.

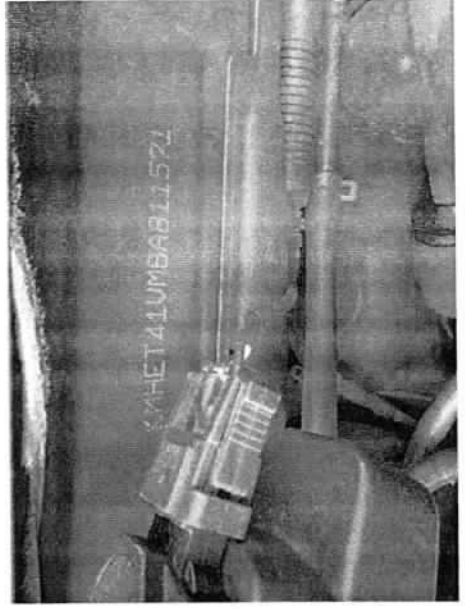
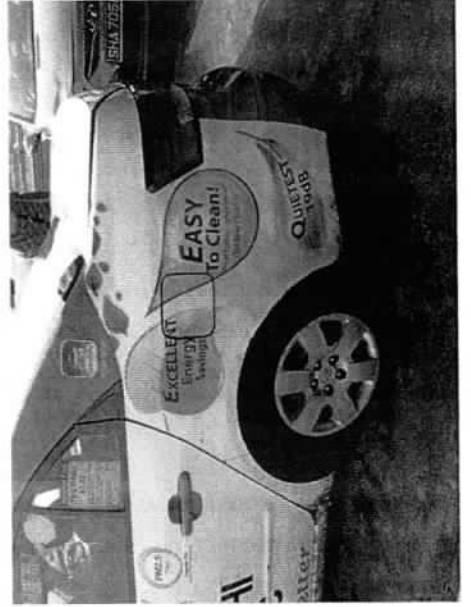
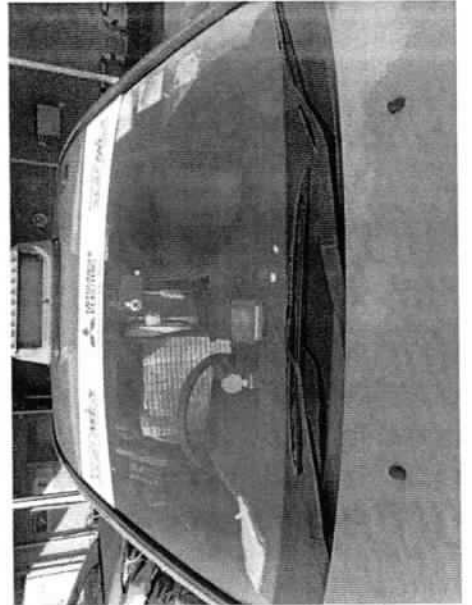
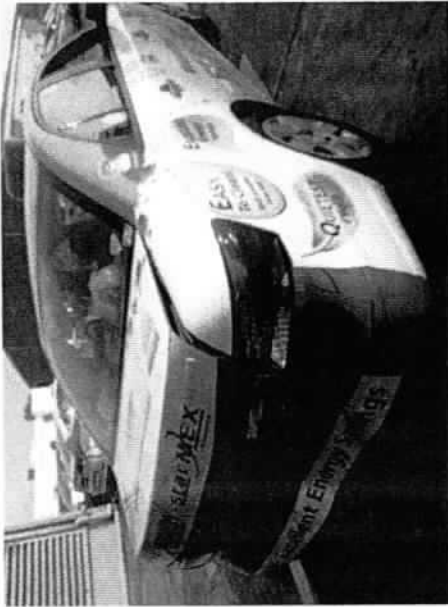
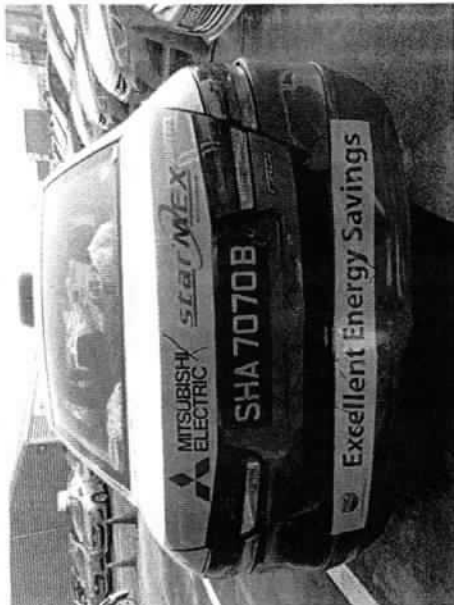
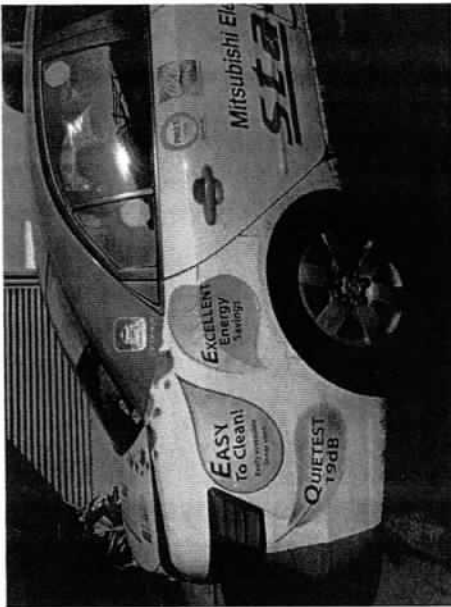
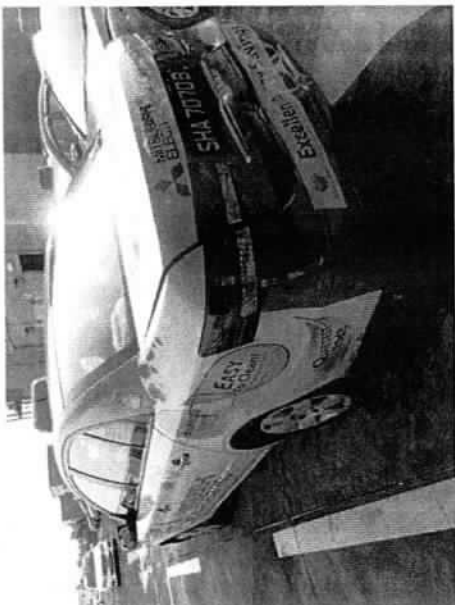
Rear

The U/C / Chassis frame / Body Structure affected due to collision.

No.	Qty	Part No.	Particulars	Condition	Repairer's	Amount
1	1		*BOOTLID	Dented	1,349.50 FL	*1,349.50 FL
2	1		*BOOTLID LOCK UPPER	Serviceable	132.10 FL	*- FL
3	1		*BOOTLID LOCK LOWER	Serviceable	30.30 FL	*- FL
4	1		*BOOTLID EMBLEM SONATA	Necessary	43.60 FL	*43.60 FL
5	1		*BOOTLID EMBLEM HYUNDAI	Necessary	24.20 FL	*24.20 FL
6	1		*BOOTLID EMBLEM H	Necessary	26.10 FL	*26.10 FL
7	1		*BOOTLID EMBLEM CRDI	Necessary	22.70 FL	*22.70 FL
8	1		*REAR BUMPER ASSY	Deformed	578.40 FL	*578.40 FL
9	1		*REAR BUMPER REINFORCEMENT	Cracked	483.30 FL	*483.30 FL
10	10		*REAR BUMPER CLIPS	Necessary	22.00 FL	*22.00 FL
11	1		*REAR BUMPER SPONGE	Serviceable	137.40 FL	*- FL
12	1		*REAR BUMPER UNDER COVER	Serviceable	185.80 FL	*- FL
13	2		*REAR BUMPER PROTECTOR LH/RH	Repair	76.00 FL	*- FL
14	1		*REAR PANEL	Repair	391.80 FL	*- FL
15	1		*REAR PANEL GARNISH	Serviceable	95.80 FL	*- FL
16	1		*BOOTLID COMFORT LOGO & TEL.NO STICKER	Necessary	30.00 F	*30.00 FS
