Preliminary Advice

Insured Vehicle No	: FBB6926E	Accident Date	: 05/10/2018
TP Vehicle No	: SHD1004S	Assignment Date	: 08/10/2018
Make	: KIA OPTIMA	Est. Duration of Repair	: 2.00
Date of Inspection	: 09/10/2018		
Inspection At	: PREMIER TAXIS PTE LTD - CHANGI (HQ) 23 CHANGI SOUTH AVE 2 #03-02 SINGAPORE 486443

VEHICLE DAMAGE INSPECTION REPORT

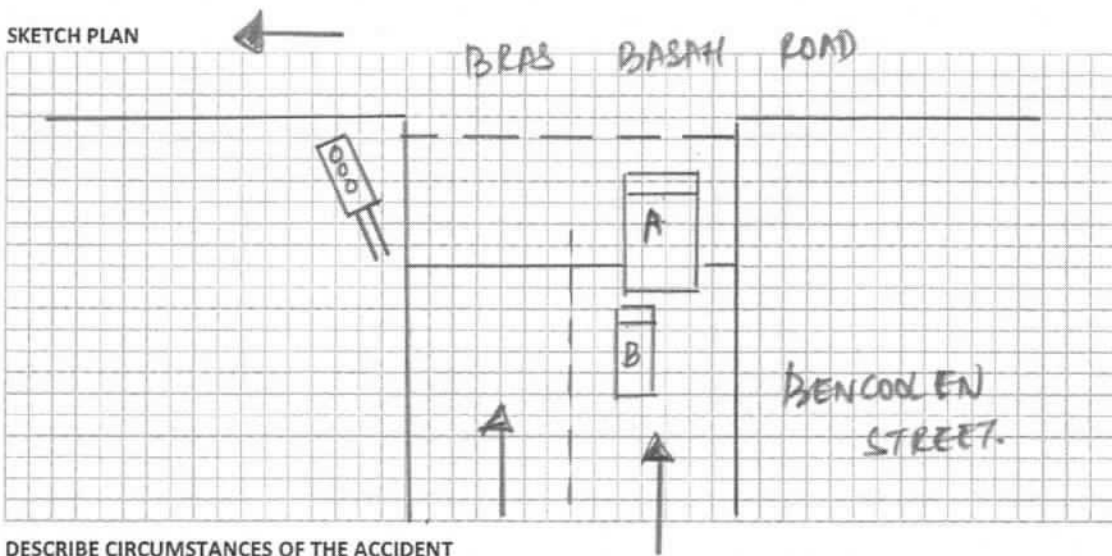
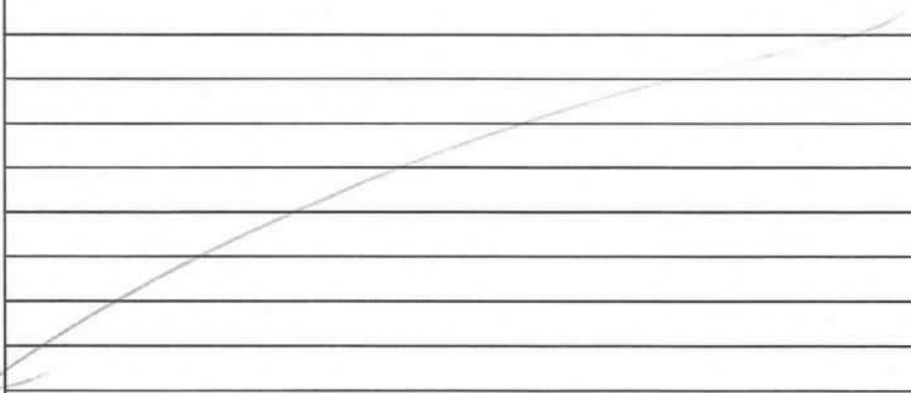
SKETCH PLAN

ON 05/10/2018 @ 1405 HRS, I WAS DRIVING MY TAXI (SHD 1004 S) ALONG THE TRAFFIC LIGHT JUNCTION OF BENCOOLEN STREET & BRAS BASAH ROAD, WITH A PASSENGER ONBOARD, IN THE RIGHT LANE.

I STOPPED MY TAXI AS TRAFFIC LIGHT AHEAD TURNED AMBER (ON MY ROUTE) BUT SUDDENLY I FELT AN IMPACT FROM THE REAR.

WHEN INSPECTED, I DISCOVERED THAT VEHICLE B (FBB 6926 E – M/CYCLE) WHICH WAS BEHIND ME, FAILED TO STOP IN TIME – HAD COLLIDED ONTO THE REAR LEFT OF MY TAXI.

DUE TO THE IMPACT, MY TAXI HAD DAMAGES ON THE REAR LEFT PORTION & VEHICLE B HAD SOME DAMAGES AS WELL.
