To Inspect Vehicle No: SJN 7799R Insured: GR 7316R

Veh No: SIN 7799R Yr Regd: 2009 FEB
 Type: ☒ M. Car / ☐ M. Cycle / ☐ Bus / ☐ Van / ☐ Lorry / ☐ Taxi / ☐ Prime Mover /
 Truck / Trailer or
 Make: Peugeot 308 1.6A CC: 1598
 Colour: BLACK A/C: Insured / Std / NI / NA
 Sp Reading: 158254 T/Ratio: Insured / Std / NI / NA
 Eng/No:
 C/No: VF34CFE55386710
 Gen. Cond: Good / ☒ Fair / ☐ Poor / ☐ Burnt
 Steering: ☒ Order / ☐ Jammed / ☐ Leaked / ☐ Burnt or
 Brake: ☒ Order / ☐ Jammed / ☐ Leaked / ☐ Burnt or
 Modi: Nil / ☒ Rrim / ☐ STD A/Rim or
 Tyre Size: F: 225/45 R17
 R: -

The UIC / Chassis frame / Body Structure affected due to collision

VEHICLE DAMAGE INSPECTION REPORT

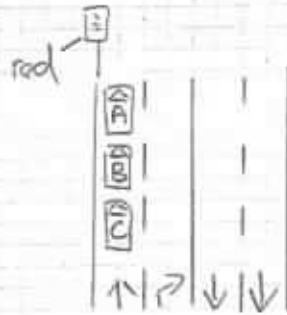
SKETCH PLAN

ON 02/10/2018 AT ABOUT 0900 HRS. WHILE MY VEHICLE IS STATIONARY AT PIONEER SECTOR 1 WAITING FOR THE TRAFFIC LIGHT. SUDDENLY I FEEL AN IMPACT FROM MY REAR. I NOTICED THAT REAR OF MY VEHICLE HAD HIT BY VEHICLE B . VEHICLE C HIT ONTO VEHICLE B AND CAUSED BY THE IMPACT ,VEHICLE B MOVE IN FRONT AND HIT ONTO MY VEHICLE .

A-SJN7799R
B-GR7316R
C-XD9297X

Pioneer Sector 1
