1. Policy Particulars :- THIRD PARTY CLAIM

2. Vehicle Particulars & Condition

ADJUSTMENT ON REPAIR COST FOR VEHICLE NO. SJM 5750Z

PHOTOGRAPHS FOR VEHICLE NO. SJM 5750Z

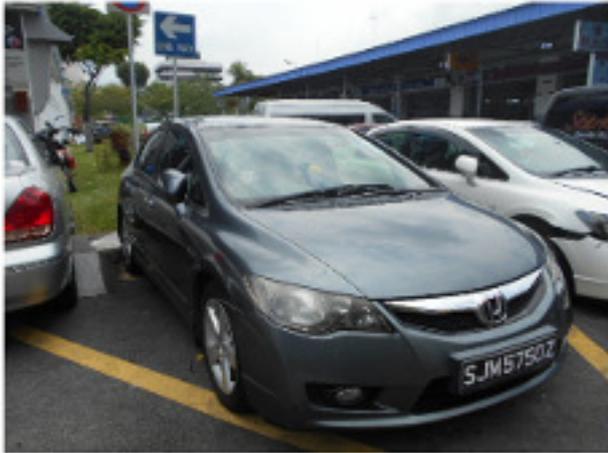
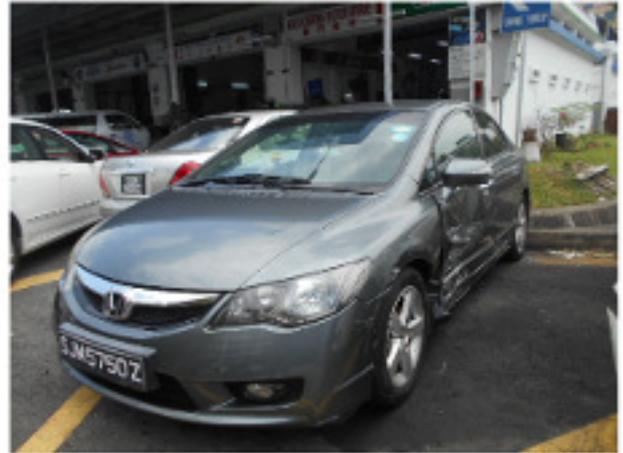
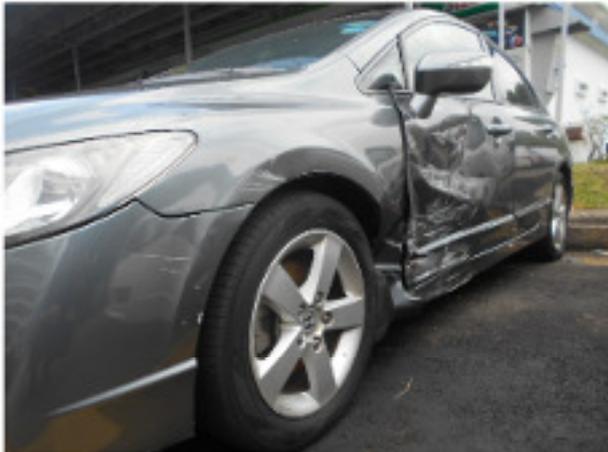
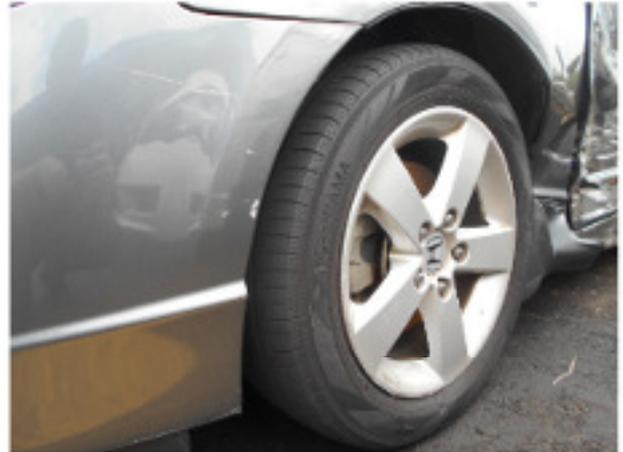
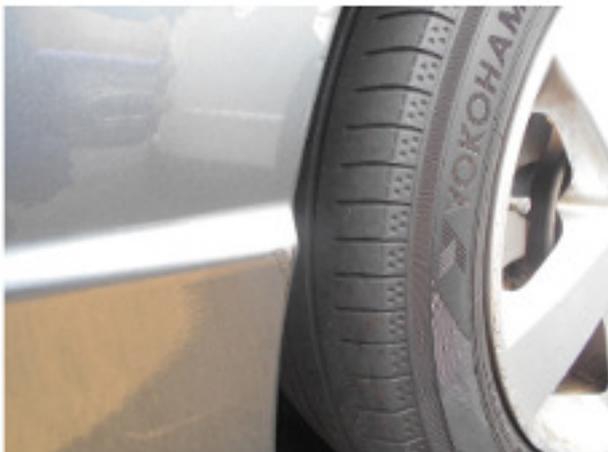
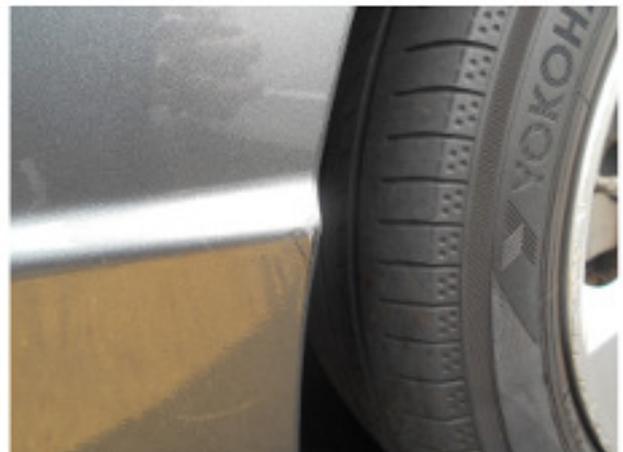
INSPECTION

THE VEHICLE SUSTAINED DAMAGES AT THE N/S FRONT PORTION AND N/S BODY. DAMAGES SEE DETAILS.
--	--

Qty	Description of Parts	Condition	Estimate By Workshop (\$)	Our Adjusted (\$)
REPLACEMENT OF PARTS				
1	FRONT BUMPER	CUT	576.00	576.00
2	FRONT BUMPER RETAINER @ \$42.00	SERVICEABLE	84.00	-
1	HEADLAMP, LH	NOT NECESSARY	242.00	-
1	FRONT FENDER, LH	DENTED	537.80	537.80
1	FENDER COWLING	DEFORMED	90.10	90.10
1	COWLING CLIP	NECESSARY	38.00	38.00
1	FRONT DOOR	DENTED	842.20	842.20
1	FRONT DOOR PROTECTOR N CHROME	BROKEN	90.40	90.40
1	ROCKER PANEL, LH	DENTED	243.10	243.10
1	SIDE SKIRT, LH	DENTED	566.60	566.60
	LESS 20% DISCOUNT		-662.04	-596.84
			2,648.16	2,387.36
LABOUR				
	TO TRANSFER DOOR BOARD, POWER WINDOW MECHANISMS, GLASS TO NEW DOOR.		160.00	60.00
	TO REMOVE DAMAGED PARTS AND ATTACHMENTS. CUT AND WELD DAMAGED PANEL. REPAIR / RESHAPE DAMAGED / DENTED AREAS. STRAIGHTEN FRONT PILLAR. REPLACE ABOVE PARTS.		1,100.00	800.00
	TO SPRAY PAINT.		1,200.00	800.00
			2,460.00	1,660.00
GRAND TOTAL			5,108.16	4,047.36
RECOMMENDED COST OF LUMP SUM REPAIRS (TO ITS PRE-ACCIDENT CONDITION)				2,600.00
