CS/CTI/8018539 / Nsd3ep

GBA 9845R

NISSAN CABSTAR

VEHICLE DAMAGE INSPECTION REPORT

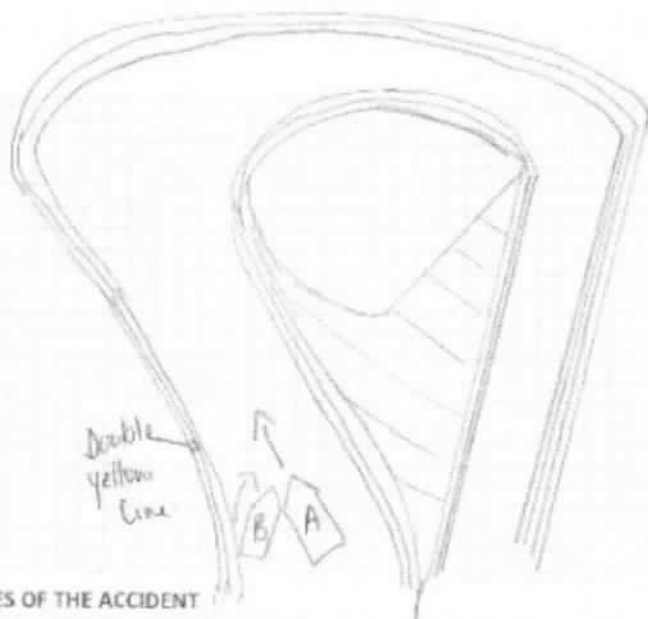
SKETCH PLAN

I was turning into Soon Lee Street to make a turned around when veh B without giving Signal drove out in a dangerous manner and hit onto my veh left hand corner.

* Third party vehicle B SLK 8084E was stationary when he suddenly drove out and hit my vehicle.
