PRELIMINARY ADVICE OF VEHICLE NO. SHA 1032B

Description of Damage:
The vehicle sustained damages at the rear o/s portion.

SURVEY OF CLIENT'S DAMAGED VEHICLE REG NO. SH A 1032B

ADJUSTMENT ON REPAIR COST FOR VEHICLE NO. SHA 1032B

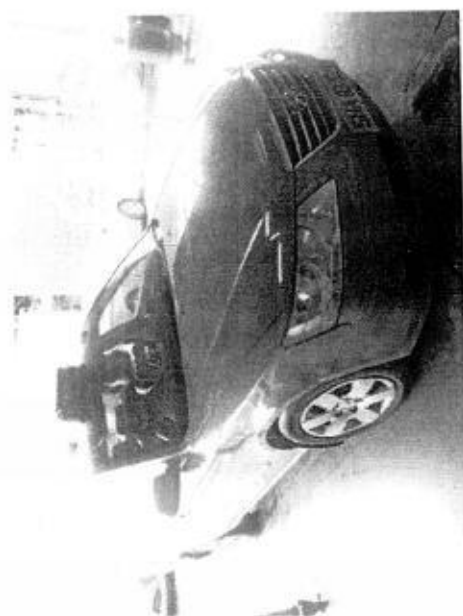
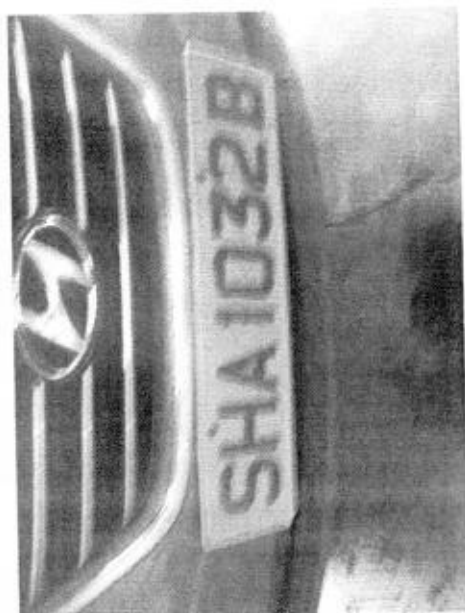
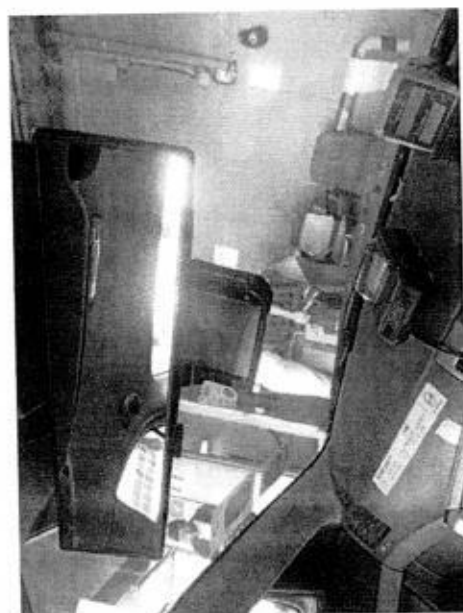
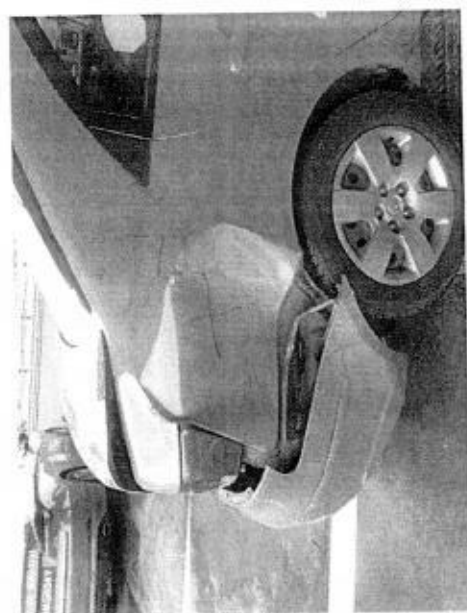
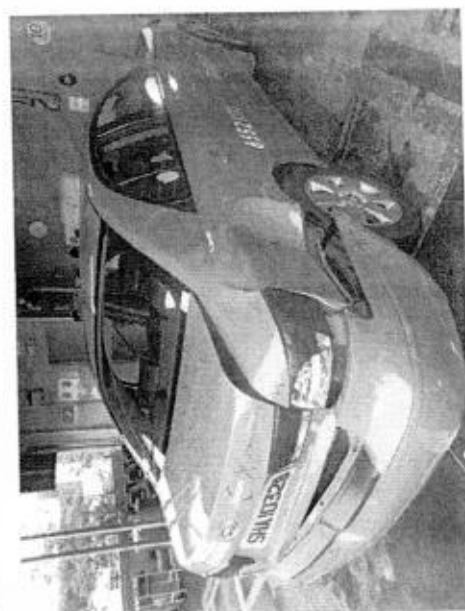
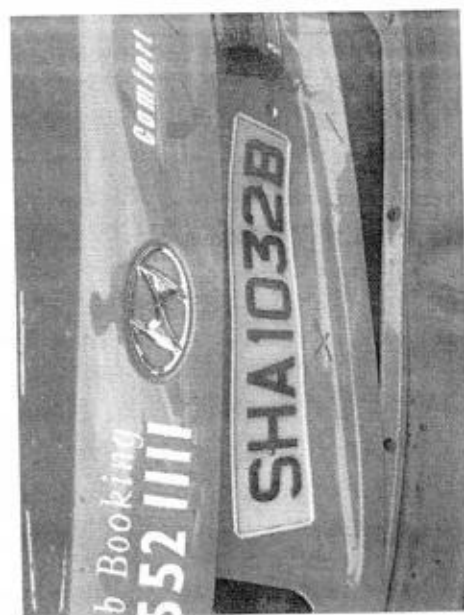
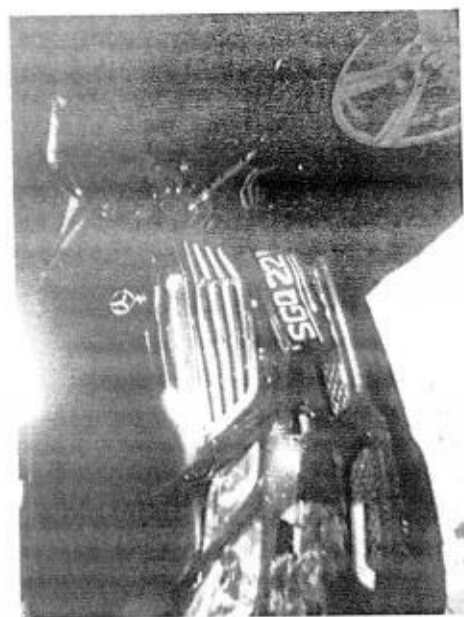
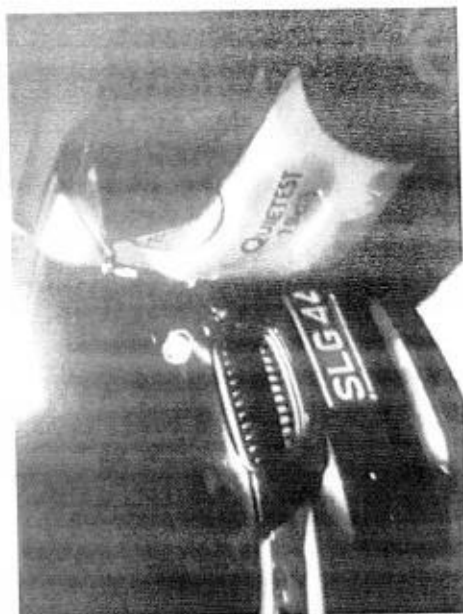
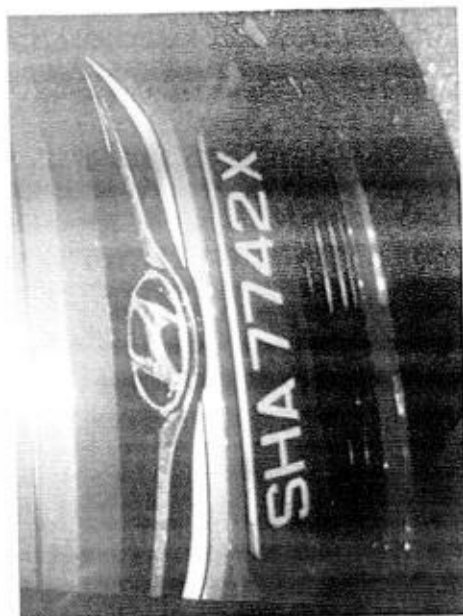
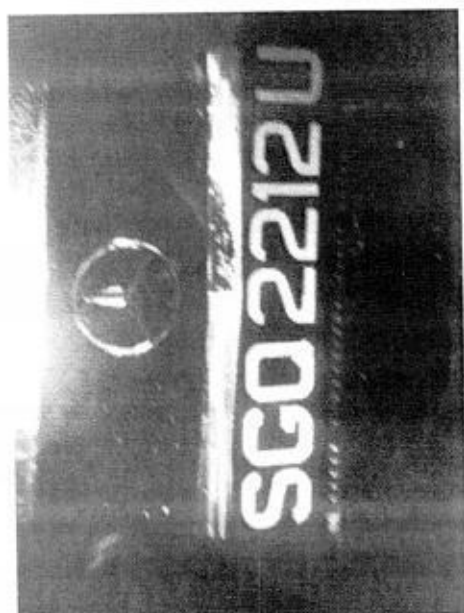
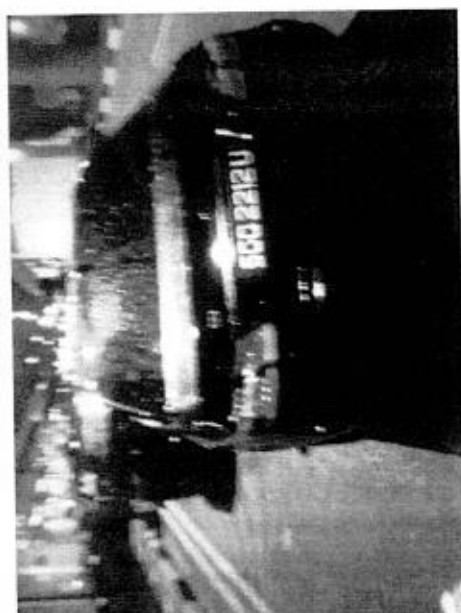
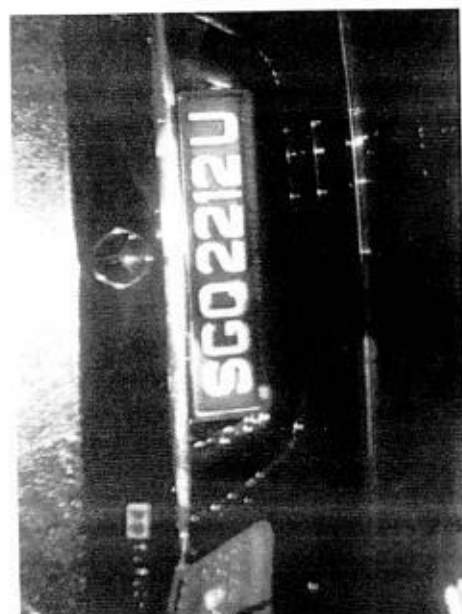
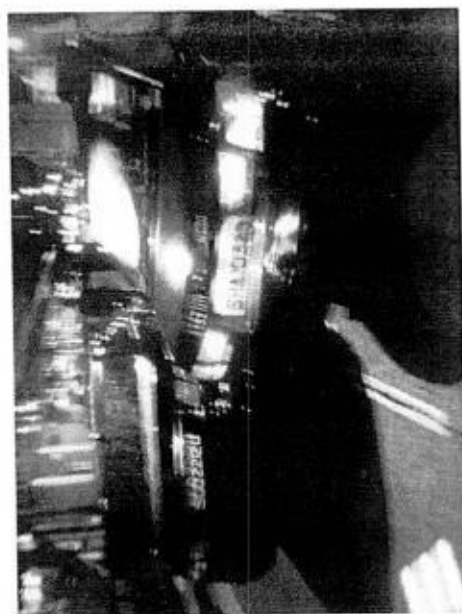
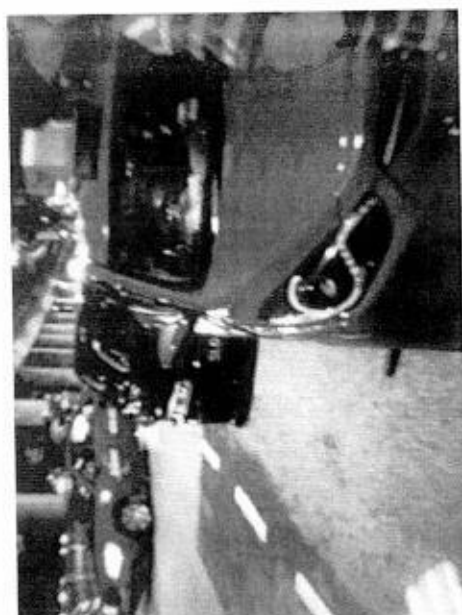
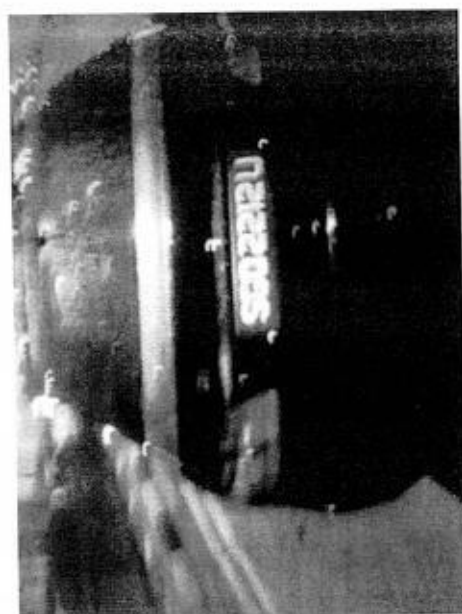
4. Description of Damages				
THE VEHICLE SUSTAINED DAMAGES AT THE REAR O/S PORTION. DAMAGES SEE DETAILS.				
5. General Information				
Accident Date	12/10/2018	Inspection Date	12/10/2018	
Survey held at	COMFORTDELGRO ENGINEERING PTE LTD 59 LOYANG DRIVE SINGAPORE 508969			
5a. Remarks

Qty	Description of Parts	Condition	Estimate By Workshop (\$)	Our Adjusted (\$)
REPLACEMENT OF PARTS				
1	BOOT LID	DENTED	1,349.50	1,349.50
1	BOOT LID RUBBER	SERVICEABLE	110.90	-
1	BOOT LID LOCK UPPER	SERVICEABLE	132.10	-
1	BOOT LID LOCK LOWER	SERVICEABLE	30.30	-
1	BOOT LID SONATA PLATE	NECESSARY	43.60	43.60
1	BOOT LID HYUNDAI PLATE	NECESSARY	24.20	24.20
1	BOOT LID 'H' EMBLEM	NECESSARY	26.10	26.10
1	BOOT LID CRDI PLATE	NECESSARY	22.70	22.70
1	BOOT LID LAMP (RH)	SERVICEABLE	230.20	-
1	REAR BUMPER	DEFORMED	578.40	578.40
1	REAR BUMPER REINFORCEMENT	CRACKED	483.30	483.30
10	REAR BUMPER CLIP	NECESSARY	22.00	22.00
1	REAR BUMPER SPONGE	TORN	137.40	137.40
1	REAR BUMPER UNDER COVER	CRACKED	185.80	185.80
1	REAR BUMPER PROTECTOR (RH)	TO REPAIR SEE LABOUR	38.00	-
1	TAIL LAMP (RH)	CRACKED	344.00	344.00
1	REAR PANEL	DENTED	391.80	391.80
1	REAR PANEL GARNISH	CRACKED	95.80	95.80
1	SPARE TYRE HOLDER	BROKEN	27.60	27.60
1	REAR FENDER (RH)	BUCKLED	1,935.90	1,935.90

1	REAR FENDER INNER LINING (RH)	TORN	74.10	74.10
1	REAR WINDSCREEN MOULDING	NECESSARY	60.00	60.00
1	EXHAUST MUFFLER (ADDITIONAL)	BENT	773.50	773.50
	LESS 20% DISCOUNT		-1,423.44	-1,315.14
			5,693.76	5,260.56
SPECIAL NETT ITEMS				
1	BOOT LID COMFORT LOGO & TEL NO. STICKER (SN)	NECESSARY	30.00	30.00
1	REAR BUMPER REVERSE SENSOR (SN)	SHORTED	135.70	135.70
1	REAR BUMPER RUBBER MAT (SN)	NECESSARY	50.00	50.00

Comments/ Present Status:
Damages consistent.
We have NOT authorise repair.

Qty	Description of Parts	Condition	Estimate By Workshop (\$)	Our Adjusted (\$)
1	REAR WINDSCREEN SEALANT (SN)	NECESSARY	46.00	46.00
			261.70	261.70
	LABOUR			
	PANEL BEATING, INCLUSIVE OF THE REPAIR OF REAR BUMPER PROTECTOR (RH).		660.00	600.00
	SPRAY PAINTING CHARGE.		880.00	800.00
	WIRING CHARGE.		30.00	20.00
	TUFF KOTE.		50.00	20.00
	REMOVE / REFIX CUSHION & UPHOLSTERY REAR.		150.00	50.00
	REMOVE / REFIX REAR WINDSCREEN GLASS.		120.00	100.00
	REMOVE / REFIX REVERSE SENSOR.		80.00	30.00
			1,970.00	1,620.00
GRAND TOTAL			7,925.46	7,142.26
RECOMMENDED COST OF LUMP SUM REPAIRS (TO ITS PRE-ACCIDENT CONDITION)				5,700.00
