VEHICLE DAMAGE INSPECTION REPORT

Our File No: CS/CT118018651/GVD3S2

Reg No: ET8989K

Make & Model: HONDA VEZEL, 1.5 (A) Engine No: LEB5916293

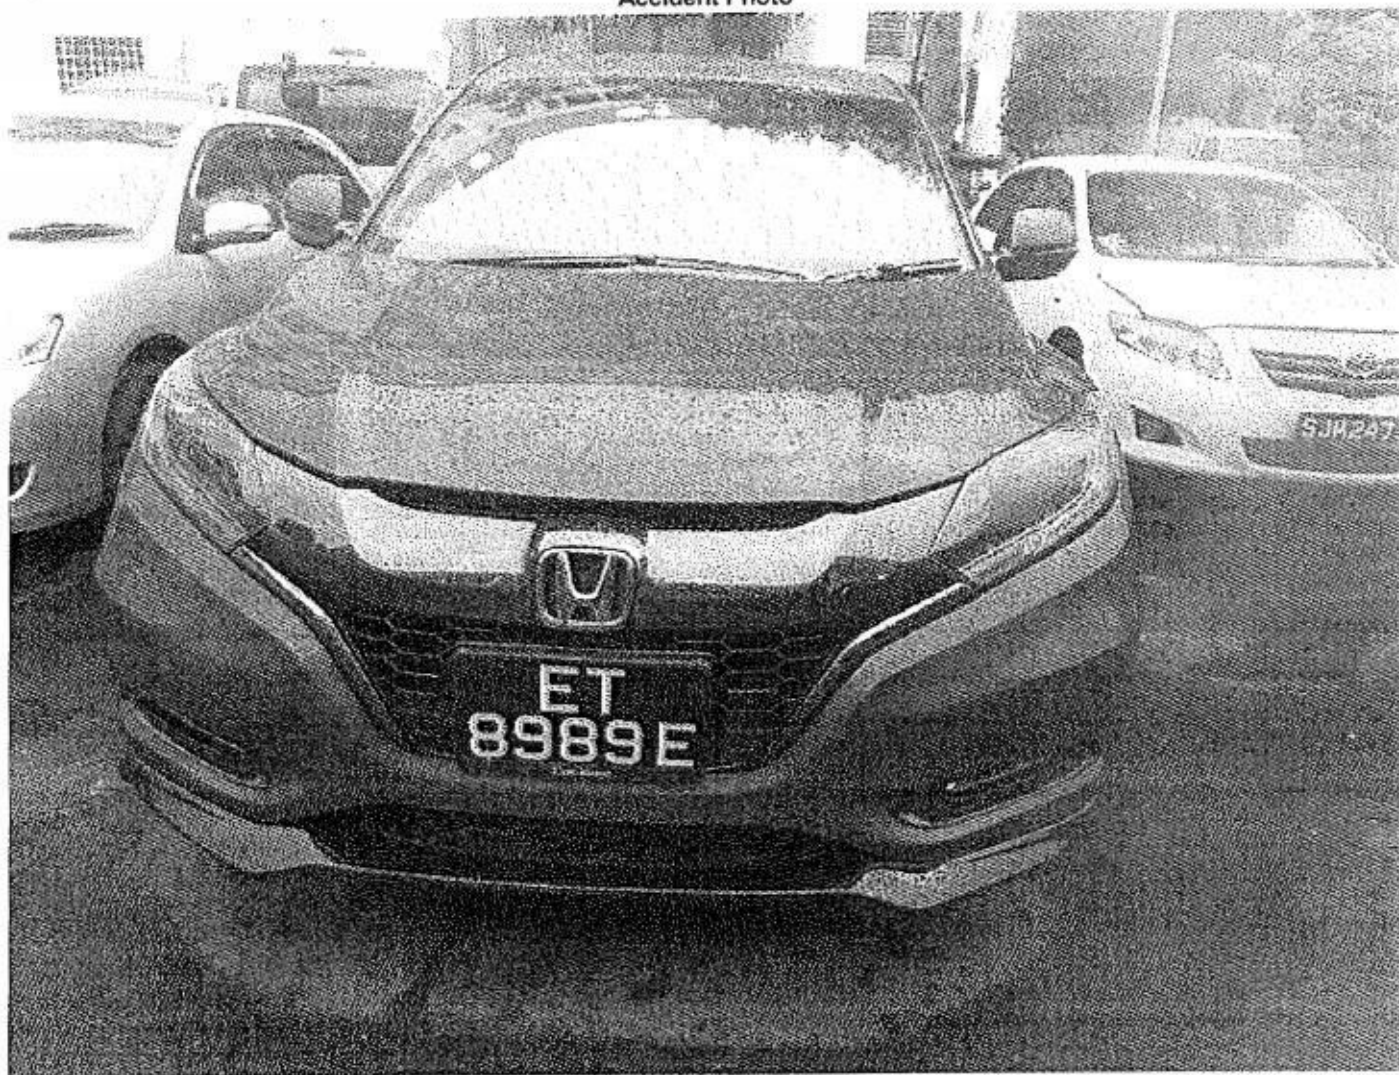
Accident Photo

The U/C / Chassis frame / Body Structure affected due to collision.

No.	Qty	Part No.	Particulars	Condition	Repairer's	Amount
1	1		*FRONT BUMPER	Cut	801.70 F	*801.70 FL
2	1		*HEAD LAMP BRACKET R/H	Not Necessary	65.00 F	*- FL
3	1		*FRONT BUMPER INNER BRACKET	Not Necessary	75.50 F	*- FL
4	1		*FRONT GRILLE	Cut	385.00 F	*285.00 FL

No	Particulars	Lab.Type	Repairer's	Amount
Labour Items				
1	LABOUR TO RE-SPRAY BONNET / FRONT BUMPER. COLOUR CODE (R565M)	New	900.00	200.00
2	TO RE-ALIGNMENT BONNET, LEFT & RIGHT FENDER, HEAD LAMP / REMOVE & INSTALL NEW PARTS.	New	400.00	200.00
Gross Labour Cost (S\$)			1,300.00	400.00
