Insured Veh.	SLK 4559D	Veh. Inspected	SHD 7183T
Policy No.	5097209192	Coverage (\$)	0.00
Claim No.	MT/1015454-002	Excess (\$)	0.00
Assign From		Assign Date	15/10/2018

4. Description of Damages

THE VEHICLE SUSTAINED DAMAGES AT THE O/S FRONT PORTION.
DAMAGES SEE DETAILS.

ADJUSTMENT ON REPAIR COST FOR VEHICLE NO. SHD 7183T

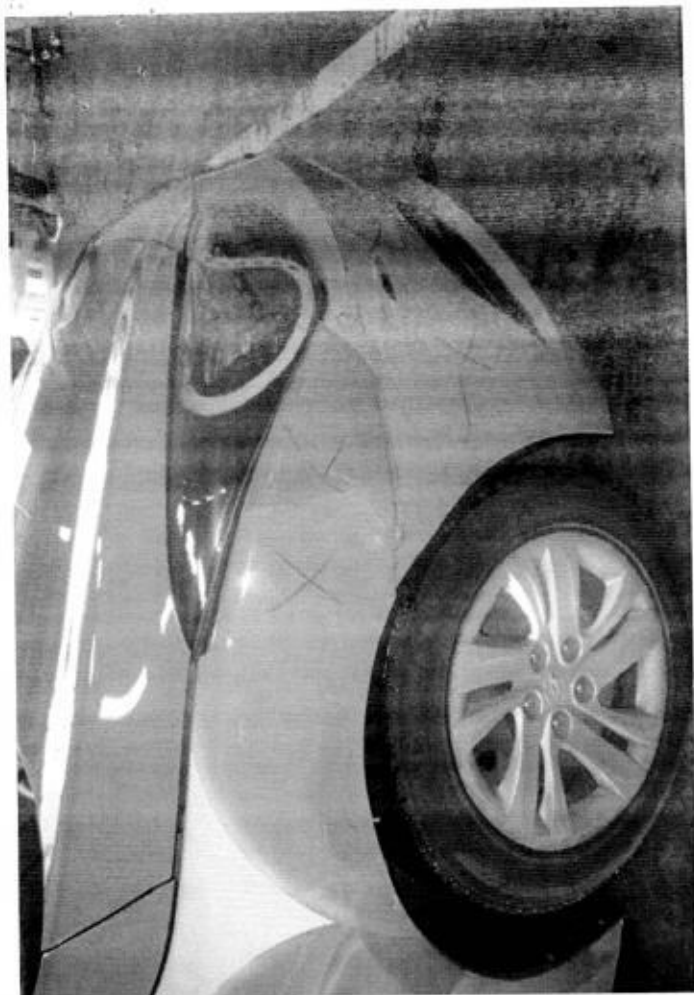
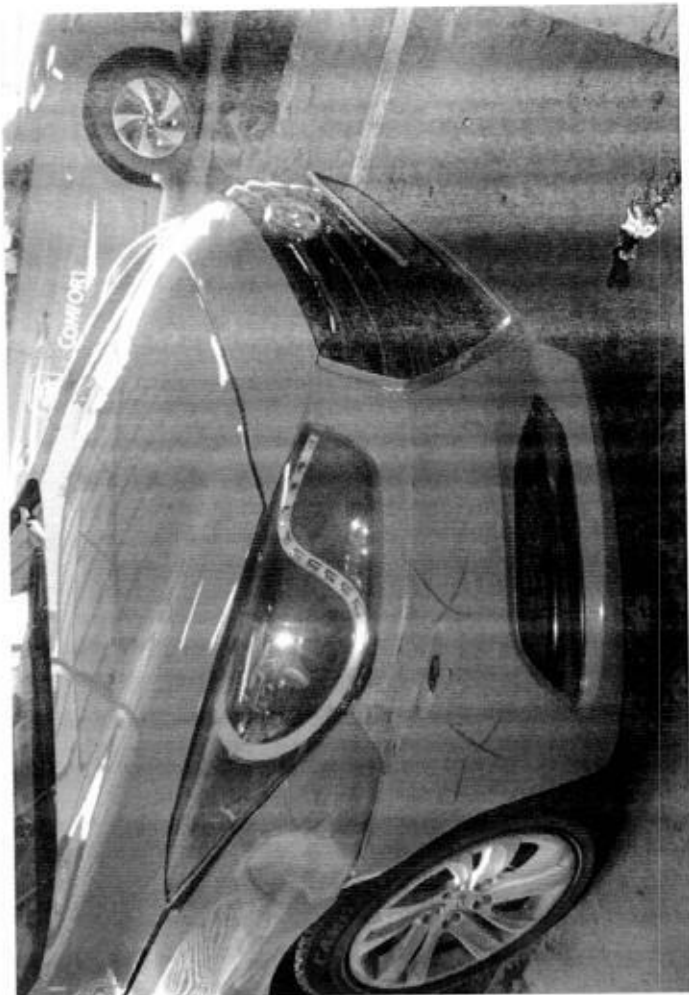
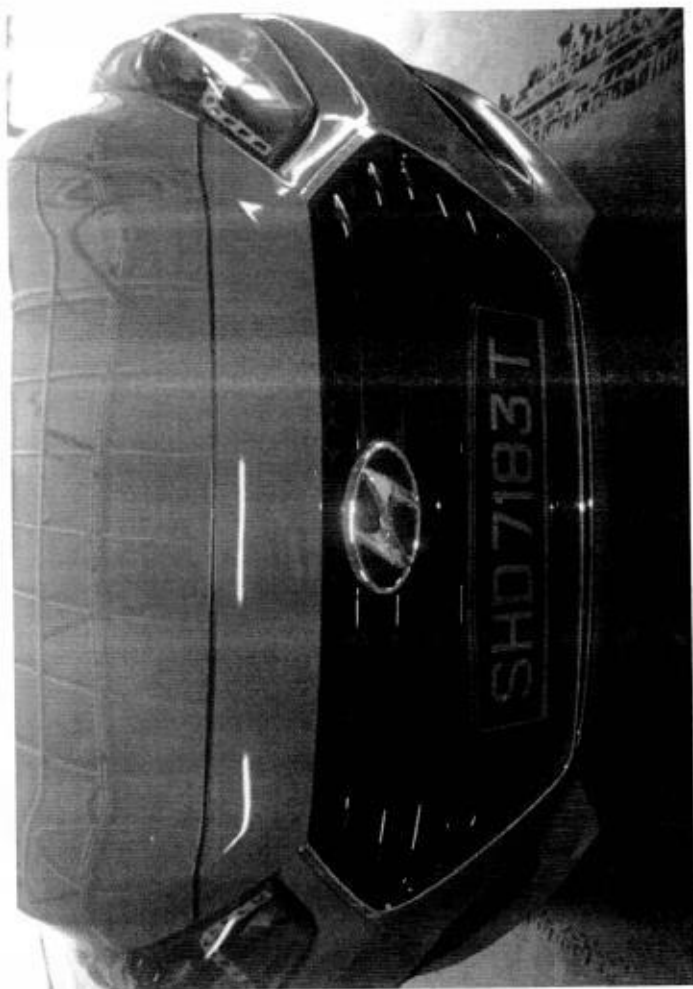
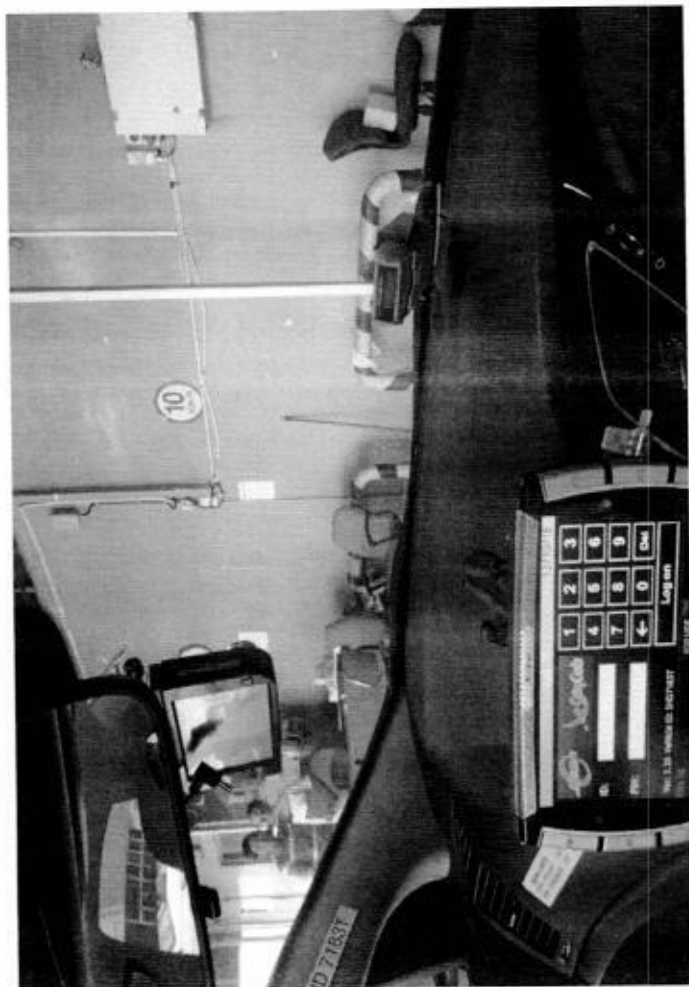
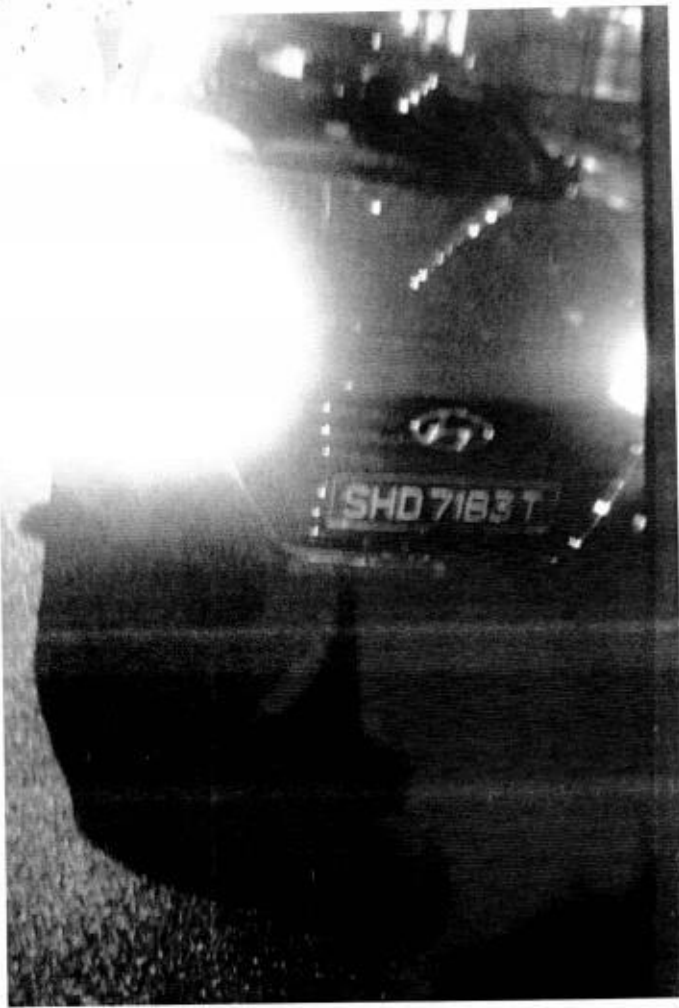
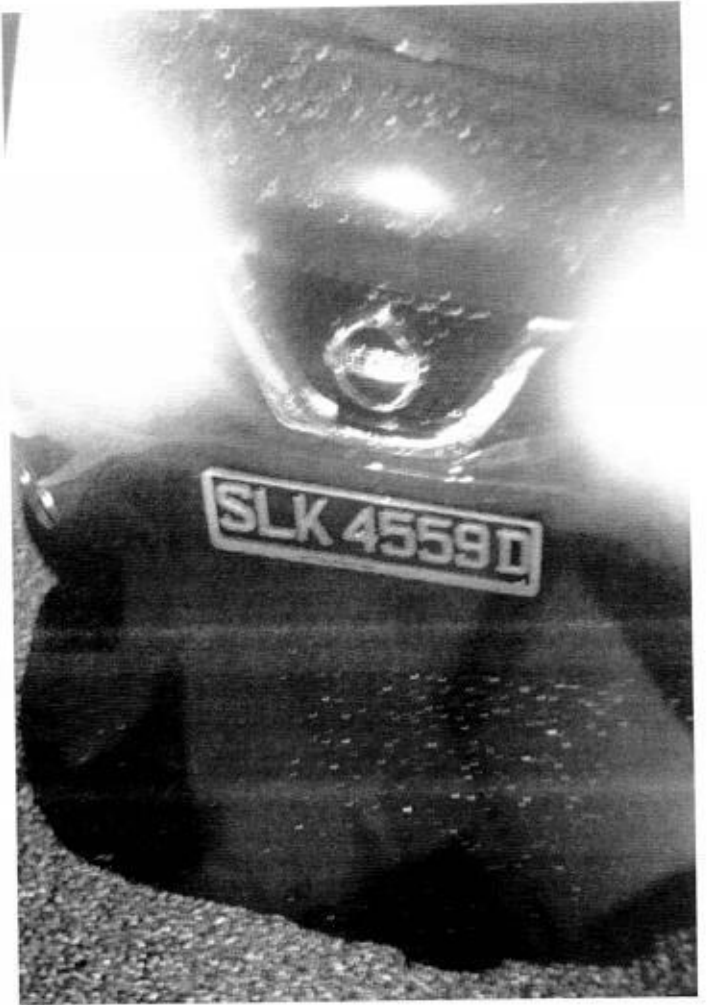
O/S Front

The U/C / Chassis frame / Body Structure affected due to collision.

Qty	Description of Parts	Condition	Estimate By Workshop (\$)	Our Adjusted (\$)
REPLACEMENT OF PARTS				
1	FRONT BUMPER COVER	CRACKED	544.50	544.50
1	FRONT BUMPER BRACKET TOP (RH)	SERVICEABLE	22.40	-
1	FRONT BUMPER BRACKET (RH)	CRACKED	24.60	24.60
1	HEADLAMP (RH)	CRACKED	1,388.00	1,388.00
1	FRONT FENDER (RH)	DENTED	566.30	566.30
1	FRONT FENDER SHIELD (RH)	SERVICEABLE	175.90	-
1	FRONT FENDER RETAINER	SERVICEABLE	24.60	-
	LESS 20% DISCOUNT		-549.26	-504.68
			2,197.04	2,018.72
SPECIAL NETT ITEMS				
1	FRONT FENDER ADVERTISEMENT LOGO (RH)(SN)	NECESSARY	100.00	100.00
			100.00	100.00
LABOUR				
	PANEL BEATING.		440.00	300.00
	SPRAY PAINTING CHARGE.		440.00	400.00
	WIRING.		30.00	20.00
	TUFF KOTE.		50.00	20.00
			960.00	740.00
GRAND TOTAL			3,257.04	2,858.72
RECOMMENDED COST OF REPAIRS (CONFIRMED)				2,858.72
