ASSIGNMENT

4. Description of Damages

THE VEHICLE SUSTAINED DAMAGES AT THE REAR PORTION. DAMAGES SEE DETAILS.
--

ADJUSTMENT ON REPAIR COST FOR VEHICLE NO. SBW 1619P

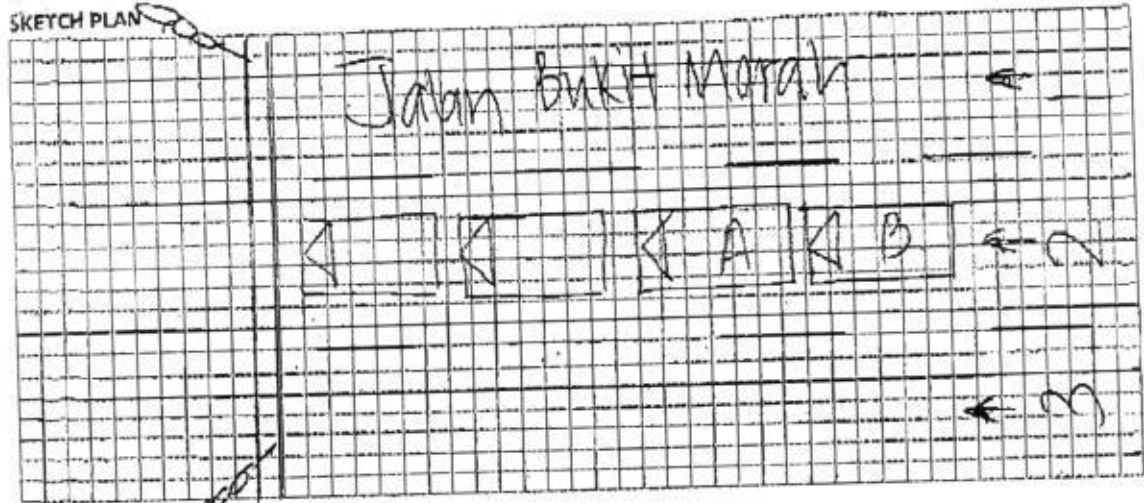
Sketch Plan #2 Pg. 1

On 10/10/18 at about 2:20pm, I stopped my car (A) along Jalan Bukit Merah waiting for traffic light to turn green. About few seconds later, car (B) came and hit the rear of my car (A).
