Our Ref: CS/FCI18018752/Uqd3

INITIAL INSPECTION REPORT OF VEHICLE NO. SGX 82D .

ADJUSTMENT ON REPAIR COST FOR VEHICLE NO. SGX 82D

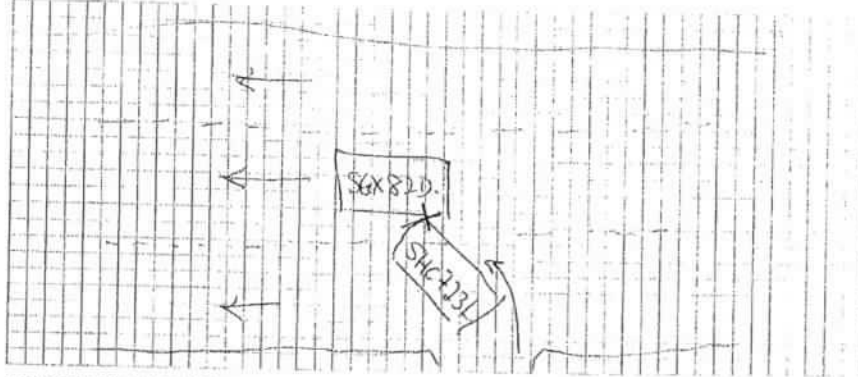
SKETCH PLAN

Travelling along Marine Parade Road (on the middle lane). This is a straight road with 3 lanes. Mentioned vehicle exiting from Parkway Parade and came into contact with left rear portion of SGX82D.
