VEHICLE DAMAGE INSPECTION REPORT

Our File No: CS/CTI18018902/UVD3E2

Reg No: **GBF508Y**

Make & Model: FIAT DOBLO CARGO MAXI, 1.6 D MTJ AMT GLAZE (M) Engine No: 263A50007512380

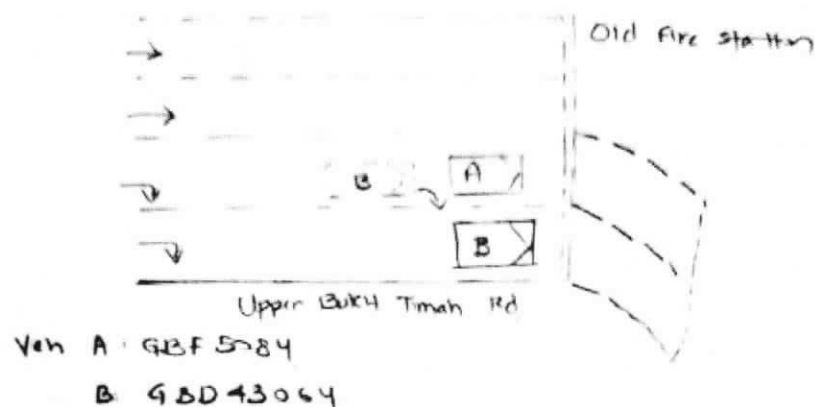
SKETCH PLAN

'A' stopped at traffic light junction. B collided into his vehicle's rear door glass. Before 'A' driver could alight to take photos, B had shifted his vehicle to the ~~the~~ right lane.
