**Preliminary Advice**

Vehicle No	: SKV7579E	Accident Date	: 16/10/2018
Make	: VOLKSWAGEN GOLF	Policy No.	: D18MTPV01014062
Assignment Date	: 18/10/2018	Excess	: S\$0.00
Date of Inspection	: 18/10/2018	Est. Duration of Repair	: 7.00
Inspection At	: COMPLETE VMS PTE LTD (HQ) 176 SIN MING DRIVE #03-14 SIN MING AUTOCARE COMPLEX SINGAPORE 575721

## ADJUSTMENT ON REPAIR COST FOR VEHICLE NO. SKV 7579E

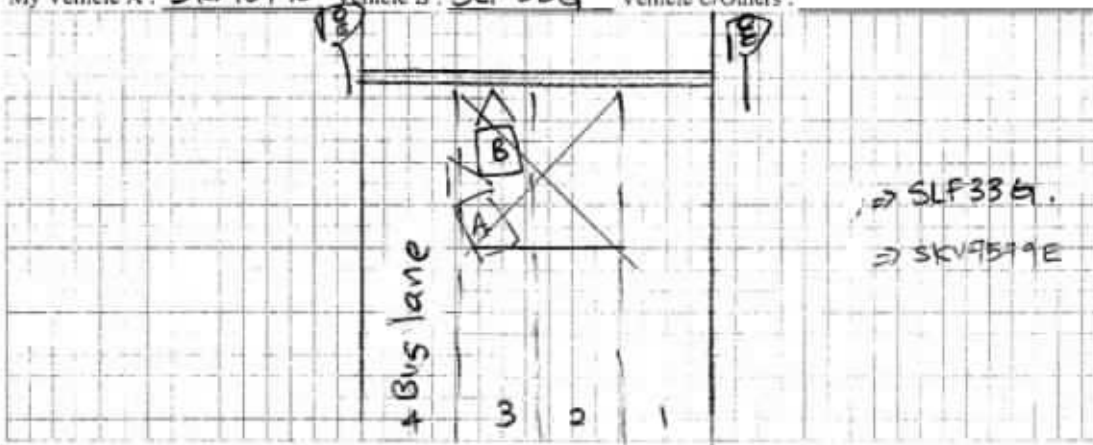
# Sketch Plan Pg. 2

Date of Accident: 16/10/18 Time: 7.15pm Location: Commonwealth Ave West.  
 My Vehicle A: SKV7579E Vehicle B: SLF33G Vehicle C/Others: \_\_\_\_\_

On 16 Oct 2018 at about 7.15pm, I was driving my car SKV7579E, along Commonwealth Ave West, between Clementi Ave 3 and Clementi Ave 6, towards Jurong. I was on 3rd lane and about 3-car length behind car SLF33G. As I was approaching the yellow box and traffic lights, the car SLF33G stopped suddenly. I immediately jammed my brakes and swerved to the left to avoid the car. This caused the front right-hand side of my car hitting the rear left-hand side of SLF33G. There were no injuries to both parties. My wife is the only passenger in my car. The driver of SLF33G was alone. The cars were towed away from the accident site same evening.
