# Estimate Repair For Vehicle SLF 33 G ( BMW 640i )

## VEHICLE DAMAGE INSPECTION REPORT

Our File No: CS/SMO18018951/GSD3N2

Handling Insurer:	Sompo Insurance Singapore Pte. Ltd.	Policy No:	D18MTPV01014062
Claimant Vehicle No :	SLF33G	Insured Vehicle No :	SKV7579E
Date of Loss:	16/10/2018	Nature of Claim:	TP
		Claim No:	CMTD1804541

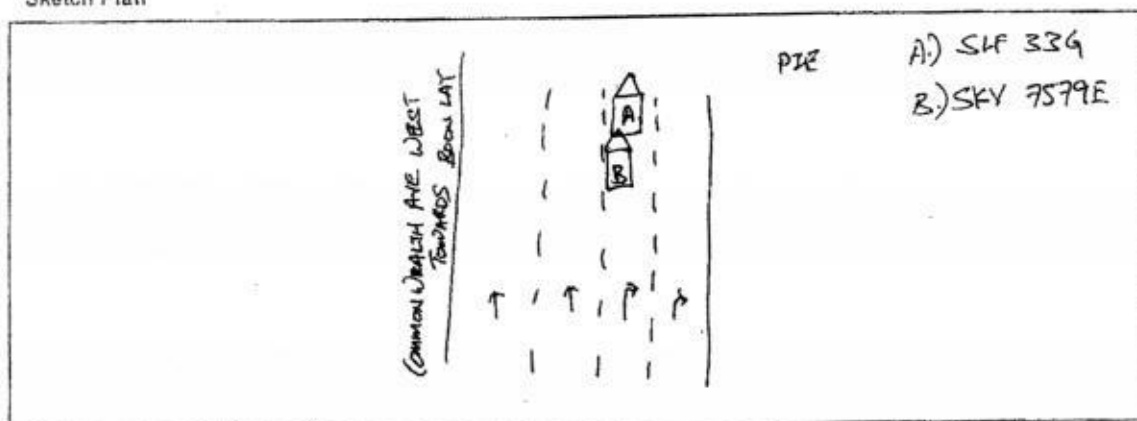
Sketch Plan

I was travelling along commonwealth ave west towards boon lay, i was preparing to turn right towards PIE as there was a red light ahead i slow down and stopped. suddenly there was a car (SKV 7579E) bang onto me.
