Main	Reference	Claim Details	Documents	<a href="#">Show All</a>					
<b>CLAIM SUBFOLDER DETAILS</b>									
Insured:	<b>SG LEASING PTE LTD</b> , Co. Reg. No.: -								
Main Claimant:	<b>UNIQUE AIR CONDITIONING SERVICES</b> , Co. Reg. No.: 52966495W								
Vehicle Reg. No.:	<b>GBG6672K</b>	Date of Loss:	17/10/2018 10:00 - :59 [12 Months and 19 Days From LTA Reg Date (Man Yr)]						
Claim Type:	<b>TP / SNM18D04968C02</b>	Policy/Cover Note No.:	DMCVSN1751051801						
Vehicle Reg. No. (Insured):	<b>GBA5128D</b>	Policy No. (Claimant):	DMCVSN3061011800						
		Excess:	S\$0.00						
Repairer:	<b>Jin Auto Services Pte Ltd (Defu)</b> Blk 14 Defu Lane 10, #01-410/412, 539195 Defu Lane - Tel: 6289 8126								
Handling Insurer:	<b>China Taiping Insurance (Singapore) Pte. Ltd. (HQ)</b> - Tel: 6389 6111 ... [Handled by <b>Elaine Cheong</b> ]								
Claimant's Insurer:	<b>China Taiping Insurance (Singapore) Pte. Ltd. (HQ)</b> - Tel: 6389 6111

Claim Type:	Third Party	Ref. No:	GBG6672K
Policy No:		Date of Loss:	17/10/2018
Vehicle Reg. No.:	GBG6672K	Driveable?	
Party At Fault:	THIRD PARTY		
Driver (TP):	YAP CHEE LENG	Driver (Insured):	AMIRRUL
Make/Model:	TOYOTA HIACE, 2.0 (M)	Vehicle Reg. Date

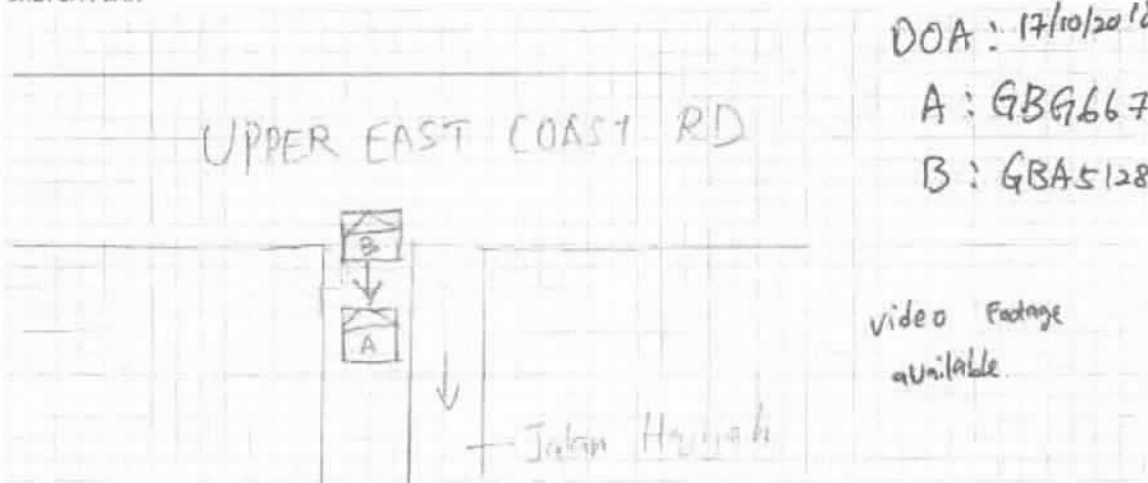
## SKETCH PLAN

I was Travelled, Jalan Haji, Toward Upper east coast road,

Suddenly Front vehicle B (GBA 5128D) reversed, and hit my vehicle

onto, Front portion, no one was injured.

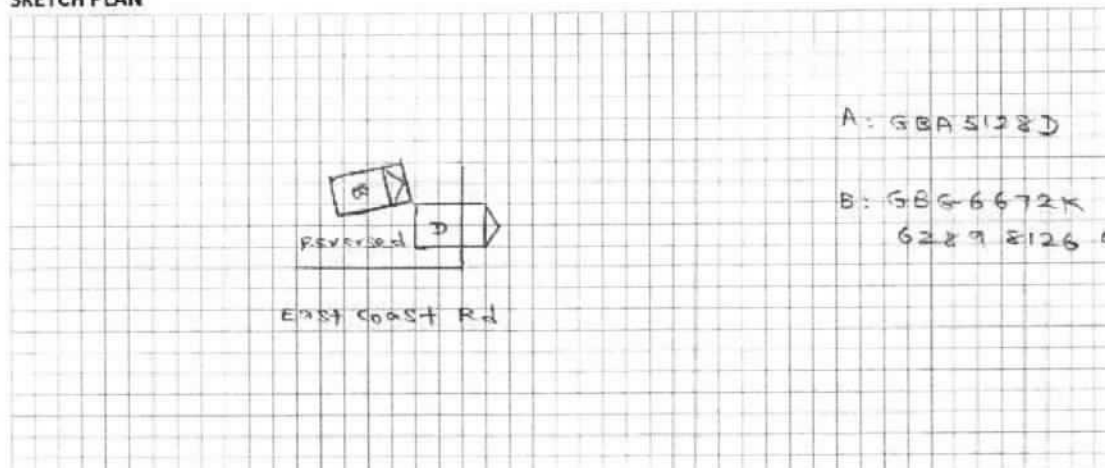
### SKETCH PLAN

Ins: China Taiping      Veh No: GBA5128D      30A-17/10/18 10:30am
