VEHICLE DAMAGE INSPECTION REPORT

Our File No: CS/MSG18019155/DCD3N2

Handling Insurer:	MSIG Insurance (Singapore) Pte. Ltd.	Policy No:	A29069766MKF
Claimant Vehicle No :	SHA7594G	Insured Vehicle No :	SLF4913R
Date of Loss:	19/10/2018	Nature of Claim:	TP
		Claim No:	573654

Reg No:	SHA7594G		
Make & Model:	HYUNDAI I40, 1.7 L CRDI AT ABS AIRBAG 4DR (A)	Engine No:	D4FDEU500055
Reg. Date:	07/05/2015 (Man. Year: 2015)	Chassis No:	KMHLB41UMFU068848
Colour:	Blue	Odometer:	378323 km
Engine Capacity:	1685 cc		
Market Value/New Car Price:	N/A		
Sum Insured (\$\$):	Market Value/New Car Price

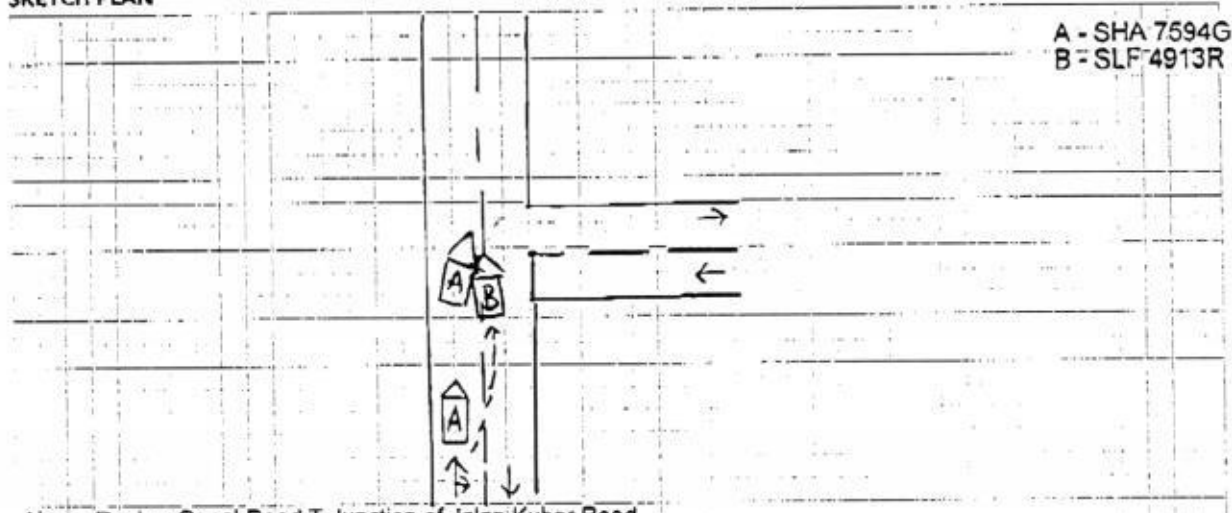
SKETCH PLAN

A - SHA 7594G
B - SLF 4913R

Along Rochor Canal Road T Junction of Jalan Kubor Road

On 19.10.2018 at about 14:50 hours I was travelling along Rochor Canal Road T Junction of Jalan
Kubor Road with one Female Passenger onboard .
I was travelling along Rochor Canal Road , while wanting to make a right turn to Jalan Kubor Road .
Suddenly Veh B - (SLF 4913R) try to overtake me from right and collided into my taxi A - Front Right Portion .
As it took place too fast I could not take evasive action to prevent this accident .
After the accident we then alighted and exchange our particulars .
No injury in this accident .
I have company videos and photos at scene to support my claims .
Veh B (SLF 4913R) - Mr Say See Lim Ronnie I/C : S1174348Z H/P : 9616 4288
