## ASSIGNMENT

Veh No: SDB1330H Yr Regn: 2018 March.  
Type: ☒ M/Car / M/Cycle / Bus / Van / Lorry / Taxi / Prime Mover /

### Estimated Labour Charges for Accident Vehicle SDB 1330 H

## VEHICLE DAMAGE INSPECTION REPORT

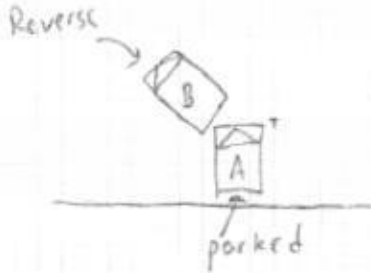
### Sketch Plan #2

A = 50B13304

$B = GU2733L$

On 17/10/18, night while washing my car no SDB1330H I found my car was damaged on car left bumper area and my 19 inch rim. I checked back on my car camera video. Found car no GU 2733L reversed and hit my car on 16/10/18, 12.25pm. I further proceed to make a report at Audi Centre for this hit and run cases on 18/10/18.

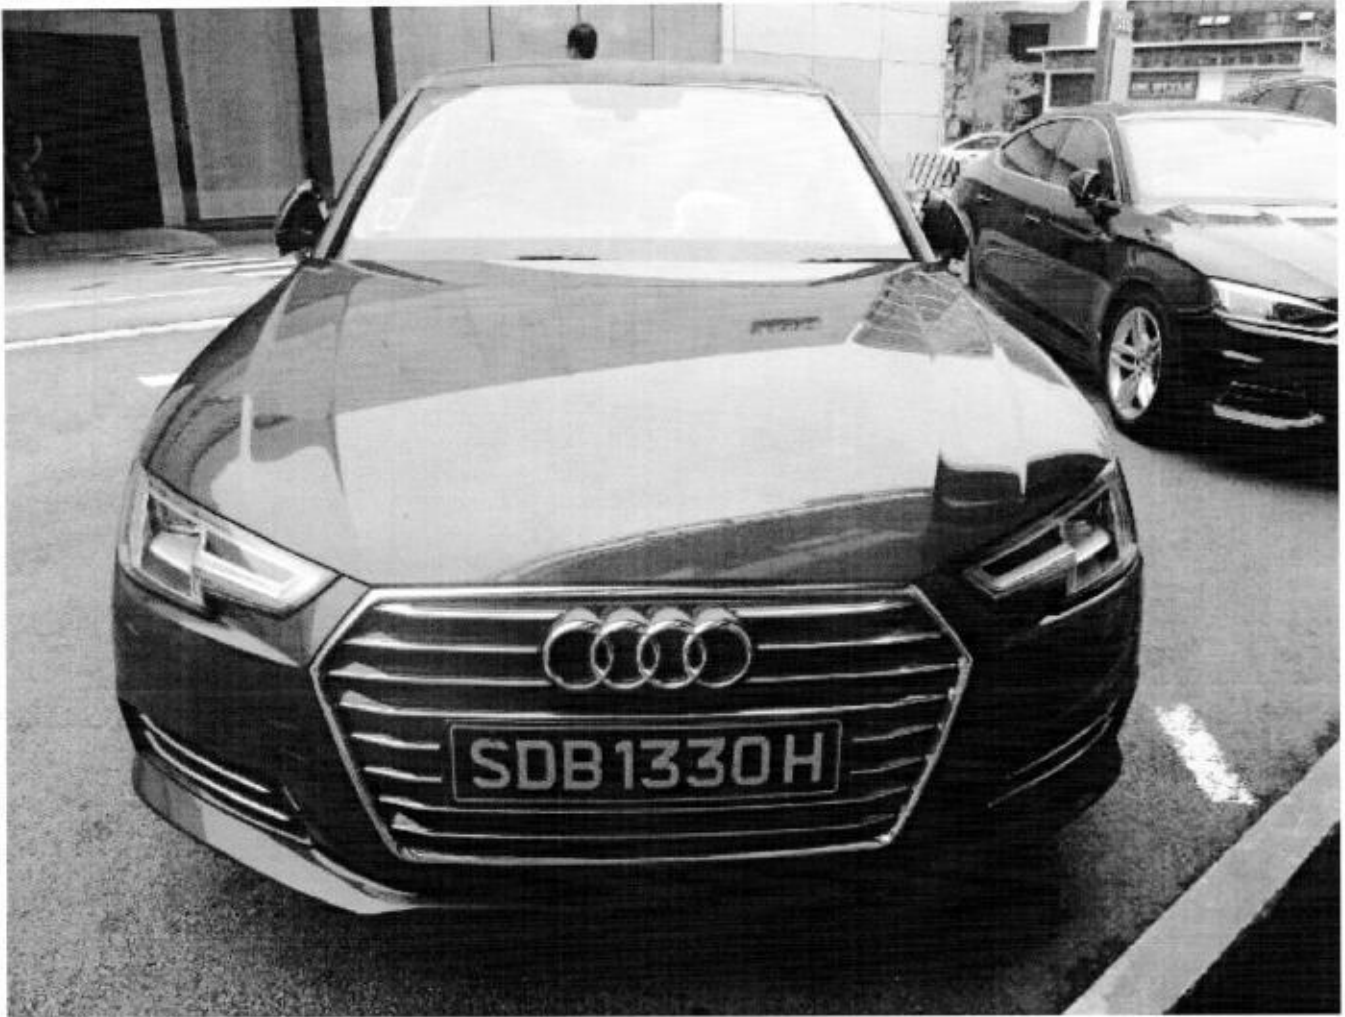
Accident Photo

ON 17/10/2018 NIGHT, WHILE WASHING MY CAR NO SDB1330H, I FOUND MY CAR WAS DAMAGED ON CAR LEFT BUMPER AREA AND MY 19 INCH RIM. I CHECKED BACK ON MY CAR CAMERA VIDEO. FOUND CAR NO GU2733L, REVERSED AND HIT MY CAR ON 16/10/2018, 12:25 PM. I FURTHER PROCEED TO A MAKE REPORT AT AUDI CENTRE FOR THIS HIT AND RUN CASES ON 18/08/18.

| S/n | Nature of Jobs | Estimated Charges | Surveyor's Recommendation |
|---|---|---|---|
| 1 | To remove and transfer front wire harness for headlights, horns, outside temperature sensor and headlight washer assy. | S/N \$ 360.00 ✓ | |
| 2 | To dismantle and renew front bumper, lhs front fender and lhs headlight. Re-organise front crash management components. Reinstall all parts removed. | \$ <del>1,800.00</del> 1200 | |
| 4 | To renew lhs front rim and carry out wheel alignment. | S/N \$ 280.00 ✓ | |
