REF: CS/CT118019310/Uqd322

SLW 8476 U

ASSIGNMENT

VEHICLE DAMAGE INSPECTION REPORT

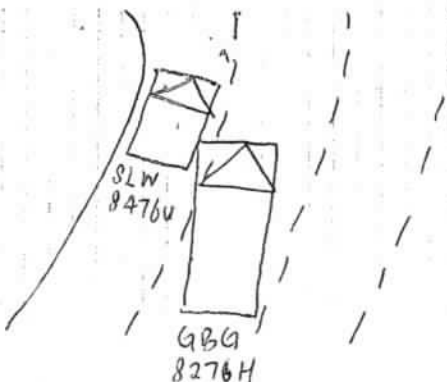
Sketch Plan

I was driving straight along the Bursley Flyover, heading towards CRE. I was driving on the extreme left lane. And suddenly a lorry GBG 8276 H came from the lane on my right and hit into my vehicle on the rear right.
