To Inspect Vehicle No:

GBH 752Y

Make: NISSAN NV200 C.C. 1,461

## VEHICLE DAMAGE INSPECTION REPORT

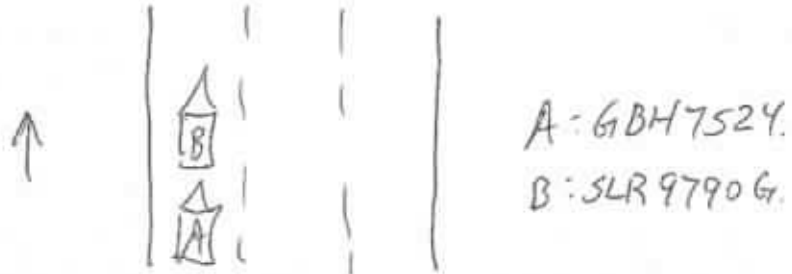
## SKETCH PLAN

most left lane of  
 Was driving along Ulu Pandan road, car 'B' had to emergency stop due to  
 taxi in front sudden stop without signalling to left to turn into T-junction  
 of pinegrove towards Clementi road, ~~car~~ step jam brake but car cannot  
 stop in time. bang into car 'B'.
