**Preliminary Advice**

Vehicle No	: GBA7936A	Accident Date	: 26/10/2018
Make	: NISSAN URVAN	Policy No.	: DMCVSN3040451800
Assignment Date	: 31/10/2018	Excess	: S\$500.00
Date of Inspection	: 01/11/2018	Est. Duration of Repair	: 7.00
Inspection At	: SNG AH TEE MOTOR & PANEL SERVICE PTE LTD (PIONEER) BLK 3 PIONEER ROAD NORTH, #01-18 SINGAPORE 628457

## VEHICLE DAMAGE INSPECTION REPORT

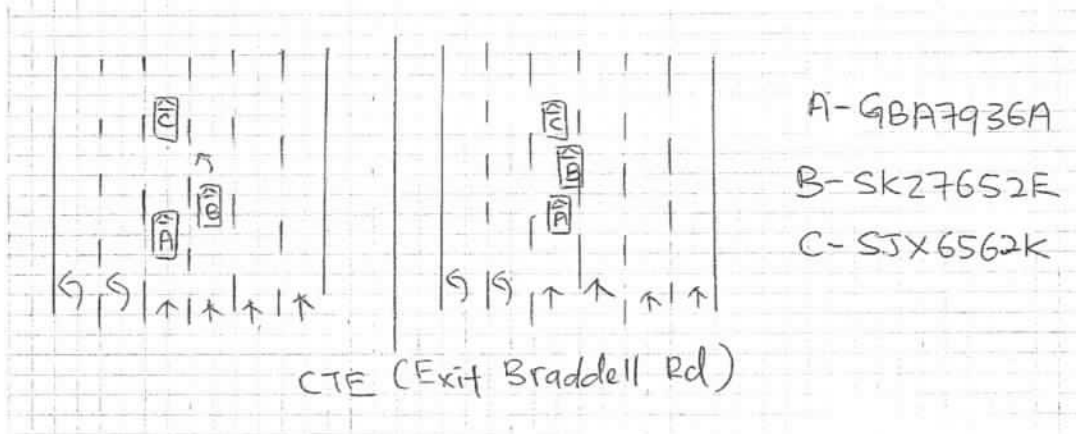
SKETCH PLAN

ON 26/10/2018 AT ABOUT 1600 HRS. WHILE I WAS TRAVELLING ALONG CTE BEFORE EXIT BRADDELL RD. MY VEHICLE HAVE TWO CAR DISTANCE WITH VEHICLE C. VEHICLE B SUDDENLY CUT IN FROM RIGHT LANE AND APPLY EMERGENCY BRAKE . I COULDN'T STOP IN TIME AND COLLIDED ONTO REAR LEFT PORTION OF VEHICLE B. VEHICLE B HAVEN'T FULLY IN THE LANE.VEHICLE B HAD COLLIDED ONTO RIGHT PORTION OF VEHICLE C.
