| Affiliated to Federation Internationale Des Experts En Automobile | | | | |
|---|---|---|---|---|
| BLUWEL AUTOMOTIVE SERVICE PTE LTD | | Ref : CS/TP18019865/Uqbn2 | | |
| <b>4. Description of Damages</b> | | | | |
| THE VEHICLE SUSTAINED DAMAGES AT THE N/S FRONT PORTION.<br>DAMAGES SEE DETAILS. | | | | |

## ADJUSTMENT ON REPAIR COST FOR VEHICLE NO. SKR 1327B

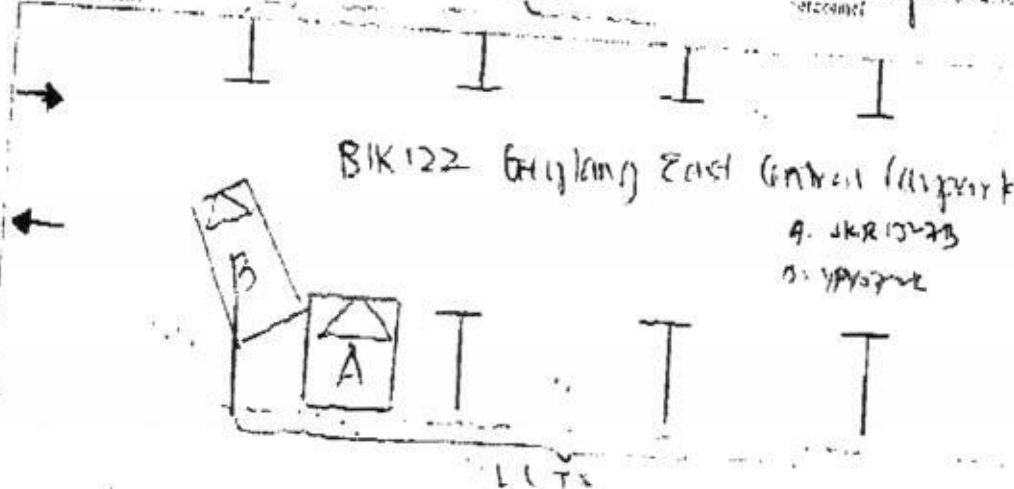
Sketch Plan

MY CAR WAS PARKED IN A LOT AT BLK 122 GEYLANG EAST CENTRAL CARPARK. AT ABOUT 4:30PM, MY SISTER WENT TO COLLECT MY CAR AND SAW A NOTE LEFT ON THE FRONT WINDSCREEN. I CALLED A GUY NAME SIRA AND HE TOLD ME THAT HIS DRIVER DOING REVERSING ACCIDENTALLY HIT THE FRONT LEFT HAND SIDE OF MY CAR.
