INSPECTION

ACCIDENT INVOLVING SJY8317J & SHD6652M ALONG TERMINAL 2 MULTI STOREY CARPARK ON 10TH MAY 2018 @ 12:20 HRS

ADJUSTMENT ON REPAIR COST FOR VEHICLE NO. SJY 8317J

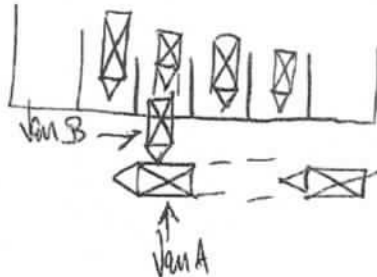
Sketch Plan #2 Pg. 1

Van A → SJY 8317J
 Van B → SHD 6652M

I was driving along Changi Airport Terminal 2 multi storey carpark going at 30 km/h. Suddenly I felt a huge impact from the right side of my veh. I quickly stopped to check, and realise veh B did not saw my veh crossing and dashed out. Thus hitting the right side of my vehicle.

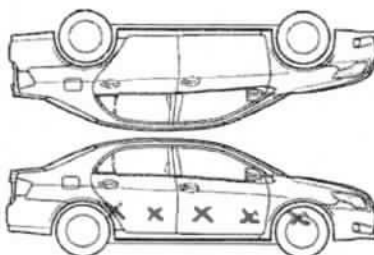
Damages sustained were consistent with the subject vehicle being involved in a collision with another vehicle and the impact was delivered

Squarely to the RH Side

portion of the vehicle.

The general area of damages is at the

RH Side Portion

The estimated repair costs submitted by Messrs **JD Motorsports Pte Ltd** is \$ 19,446.10 .
We have adjusted the cost to \$ 13,778.83 and the repairer has agreed to undertake the repairs at a
Contract Lump Sum of \$ 11,050.00 to a acceptable quality and standards.
However, we have not given authorization and instruction to the repairer to proceed with the repairs.

The repairs should be completed within a reasonable period of **9** working days.
