To Inspect Vehicle No: SDN 5600P Insured: GV 4071U

ACCIDENT INVOLVING SDN5600P & GV4071U AT WEST COAST PLACE ON 21.06.2018 @ 2100HRS

ADJUSTMENT ON REPAIR COST FOR VEHICLE NO. SDN 5600P

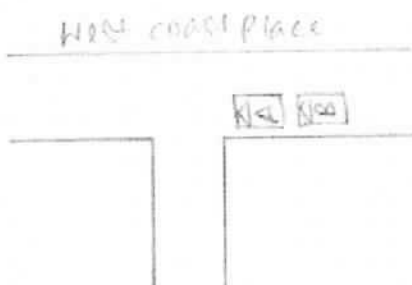
SKETCH PLAN

A: GV4671U

B: SDN 5600P

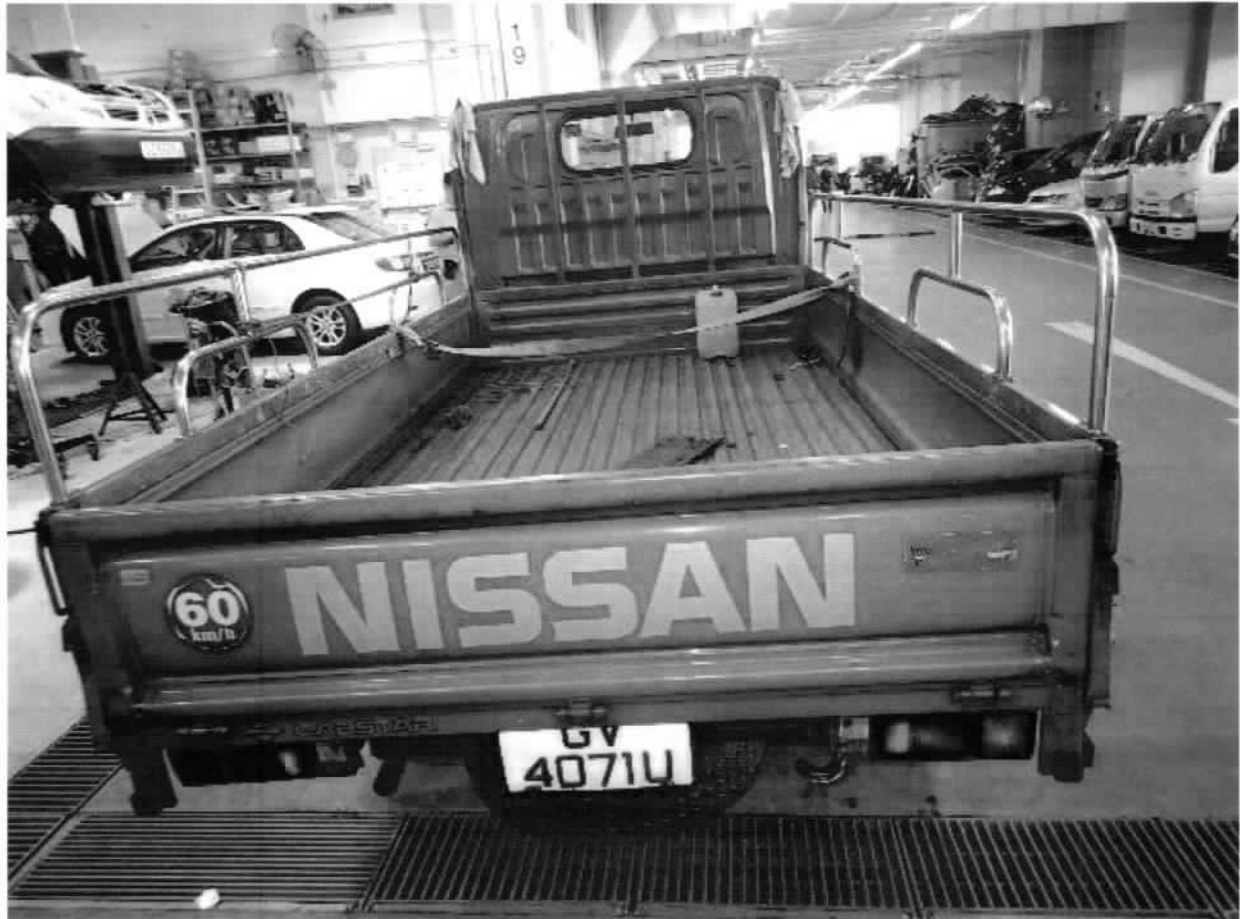
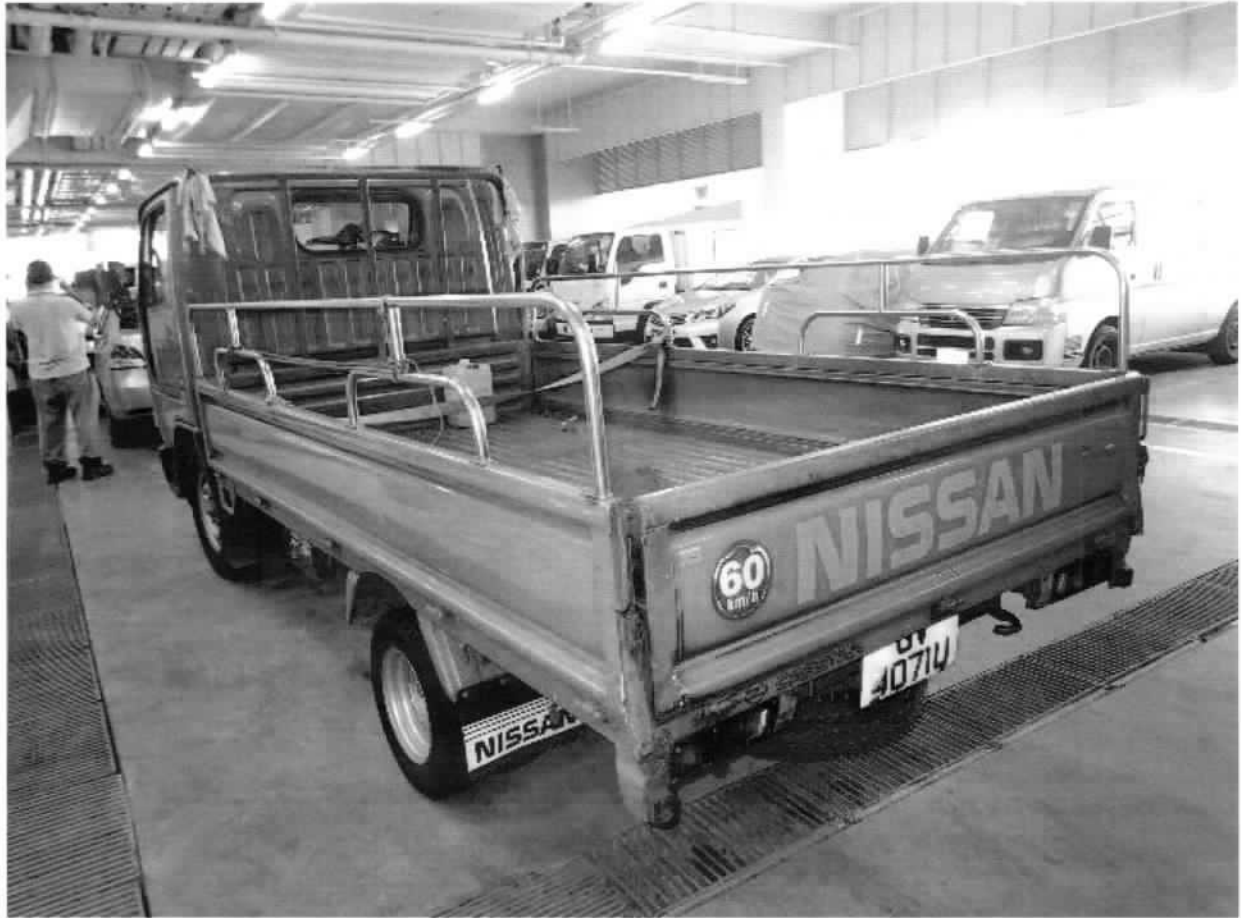
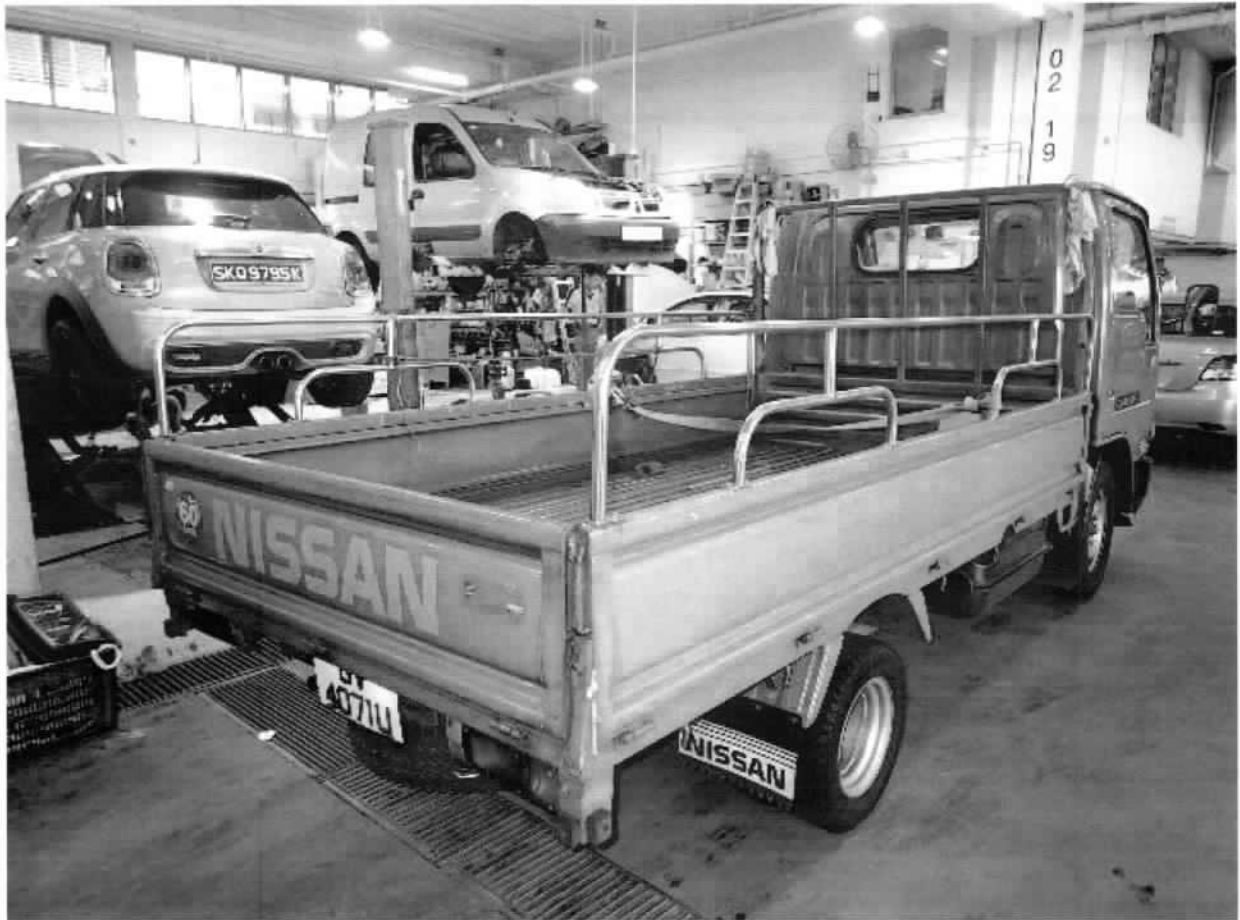
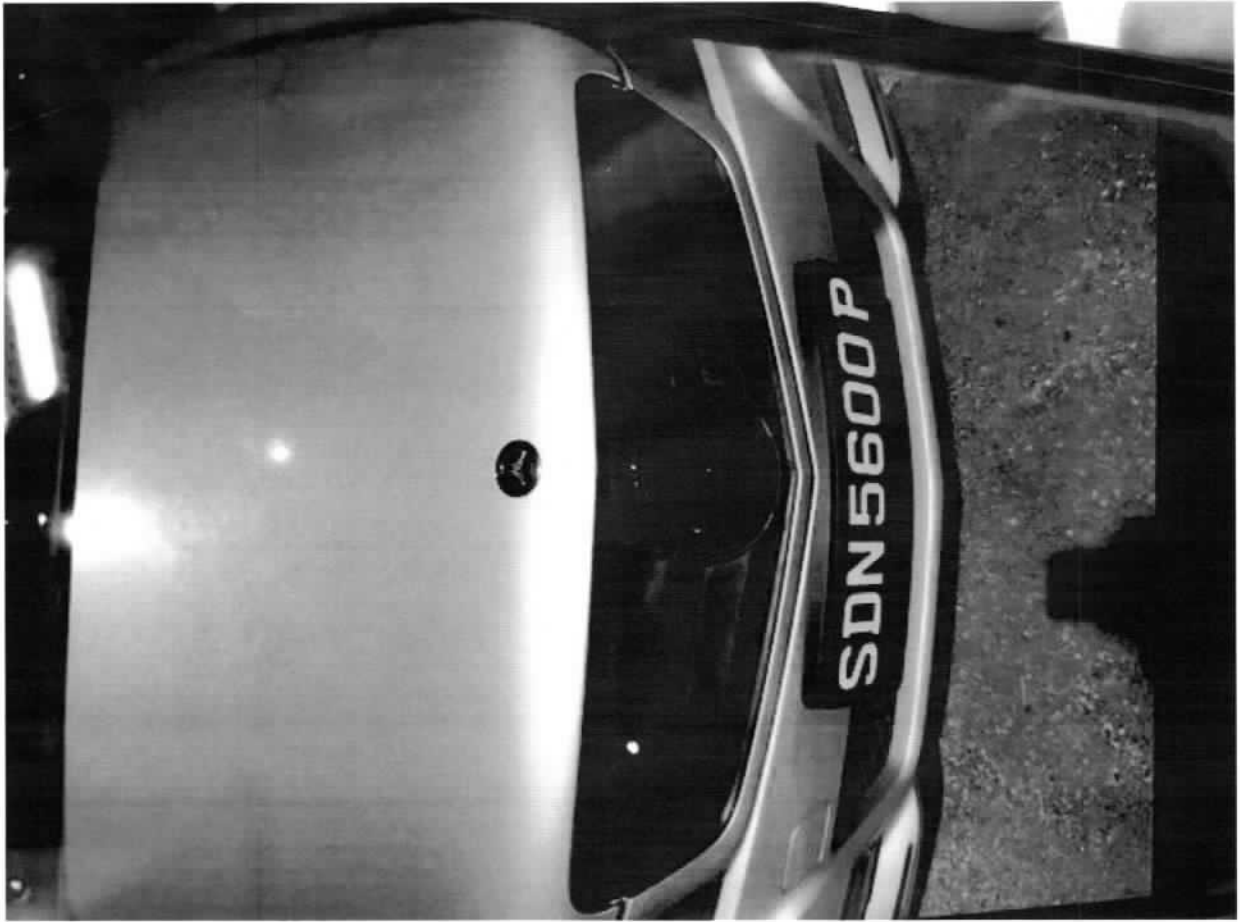
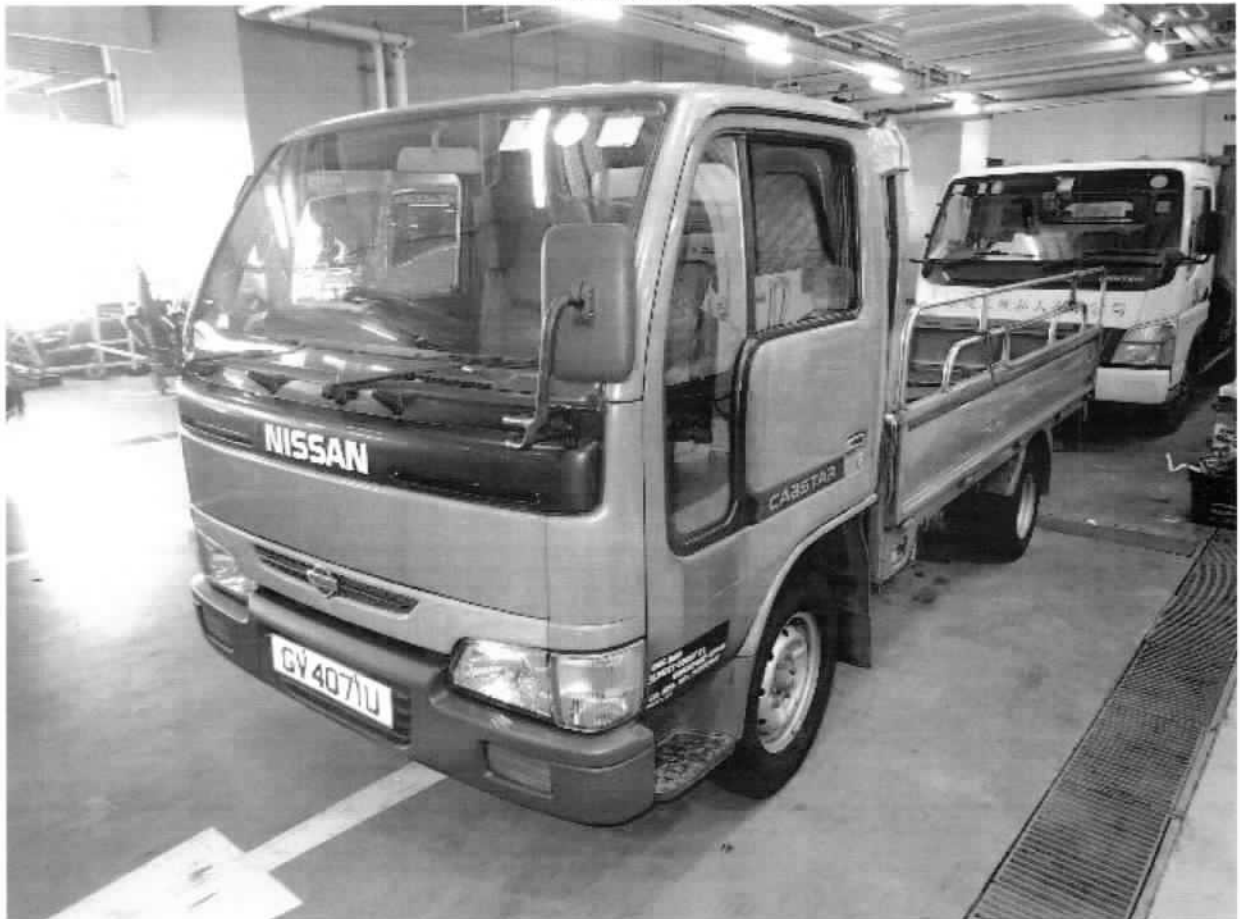
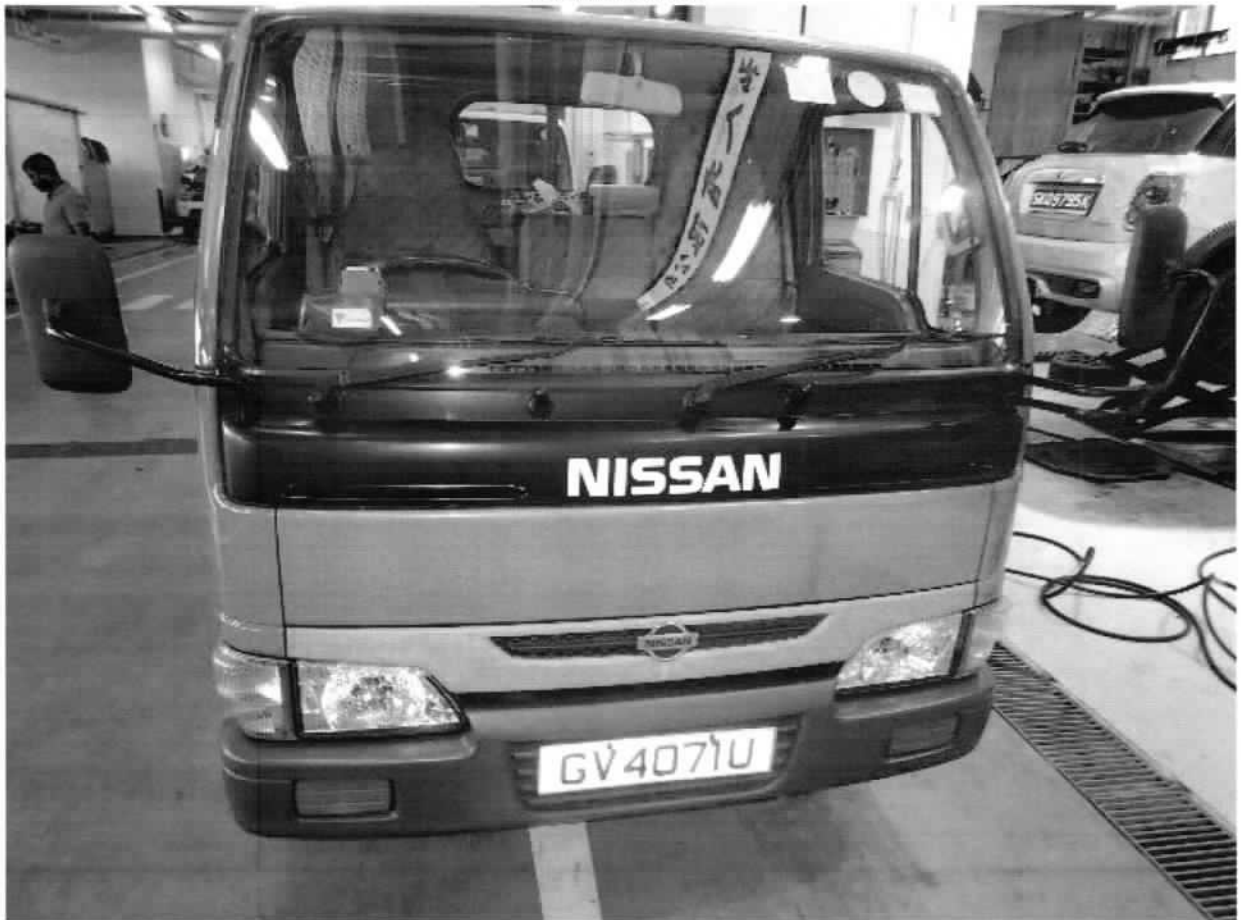
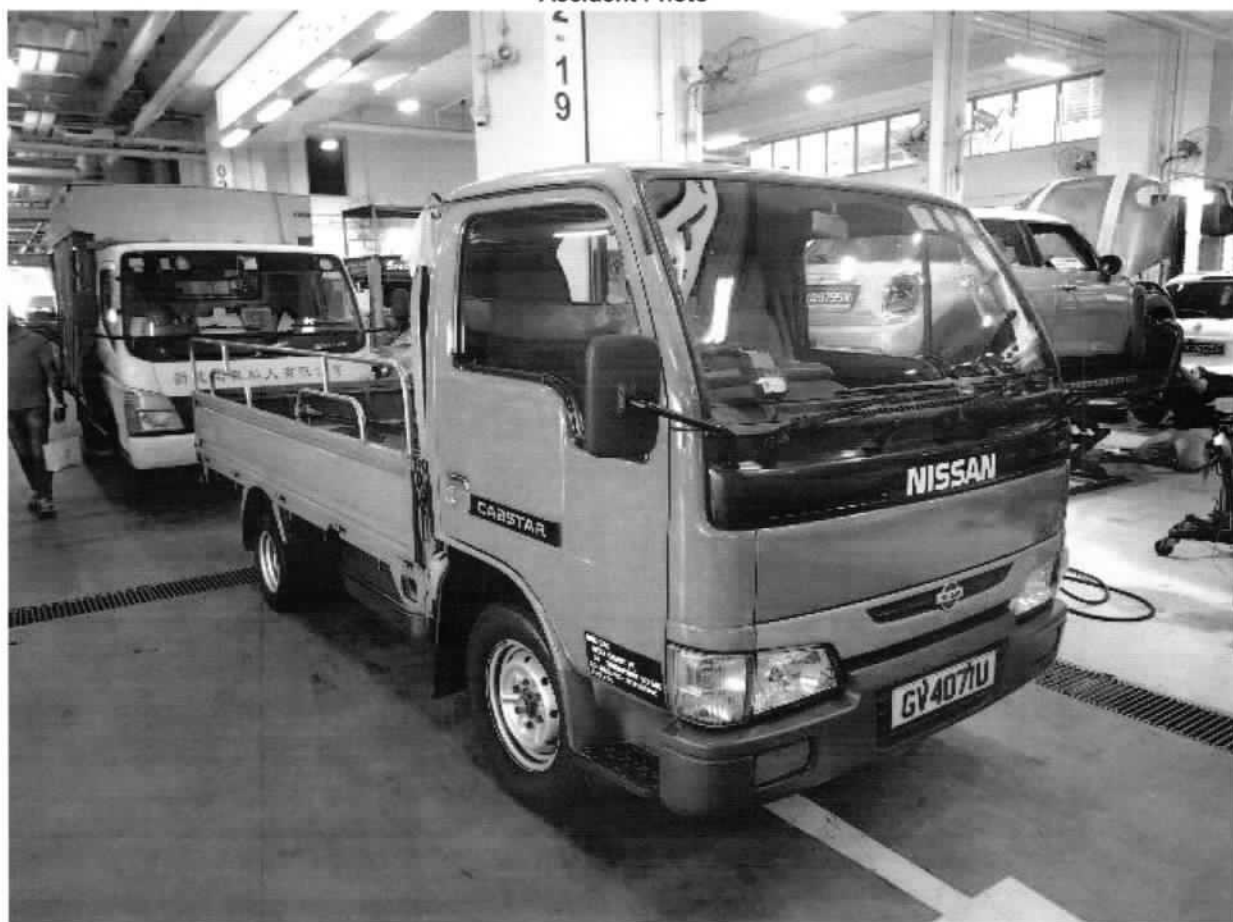
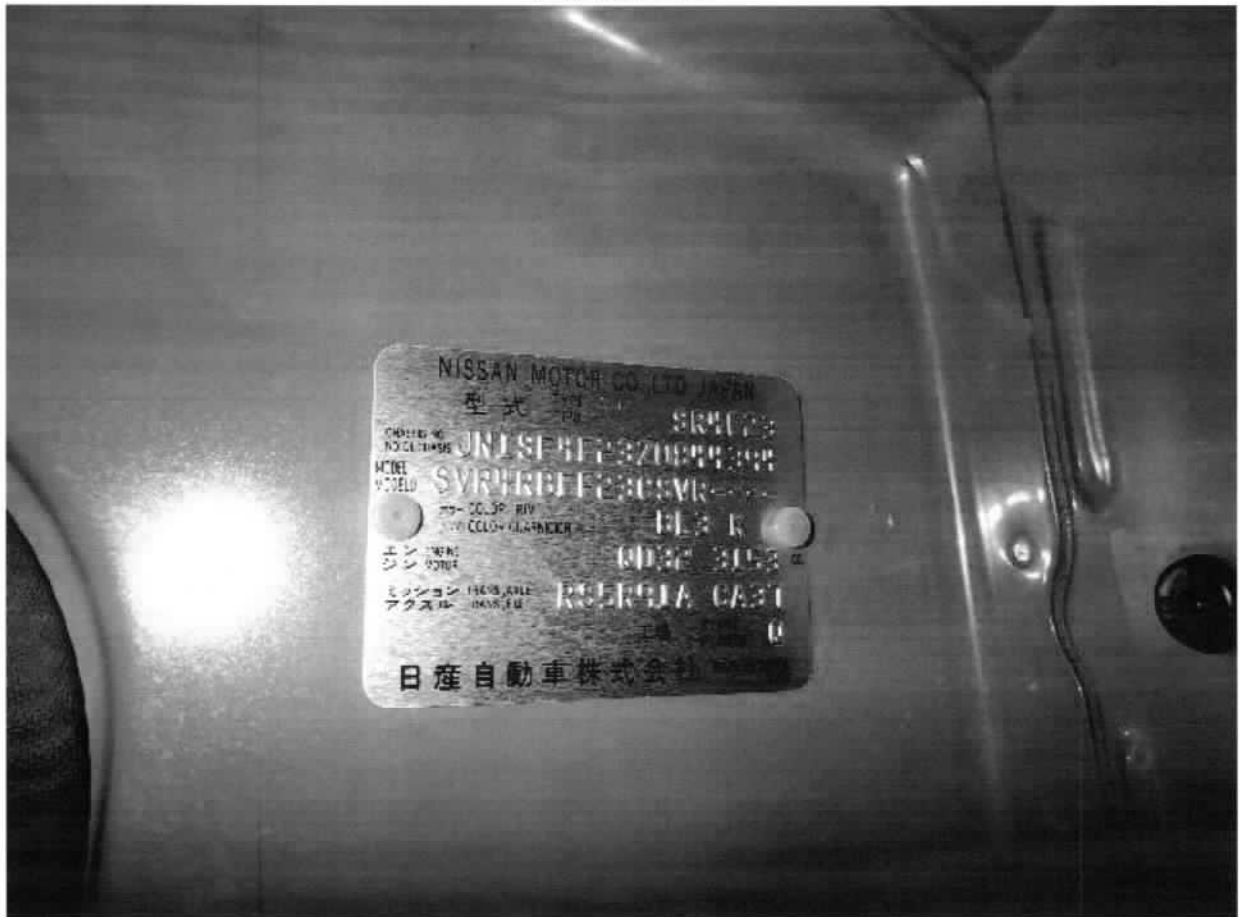
Accident Photo

Our surveyor is of the opinion that the damages to TP vehicle is minor as the impact was of low speed. The front grille of TP vehicle was damaged and recommended to be replaced.

This is consistent to the incident scene photo which showed contact at the front grille.

Our recommend COR is \$1000/-(Lump Sum)
